Daisybank Villas
5-7 Anson Road
Manchester
M14 5BR

Window Replacement
Justification

May 2018

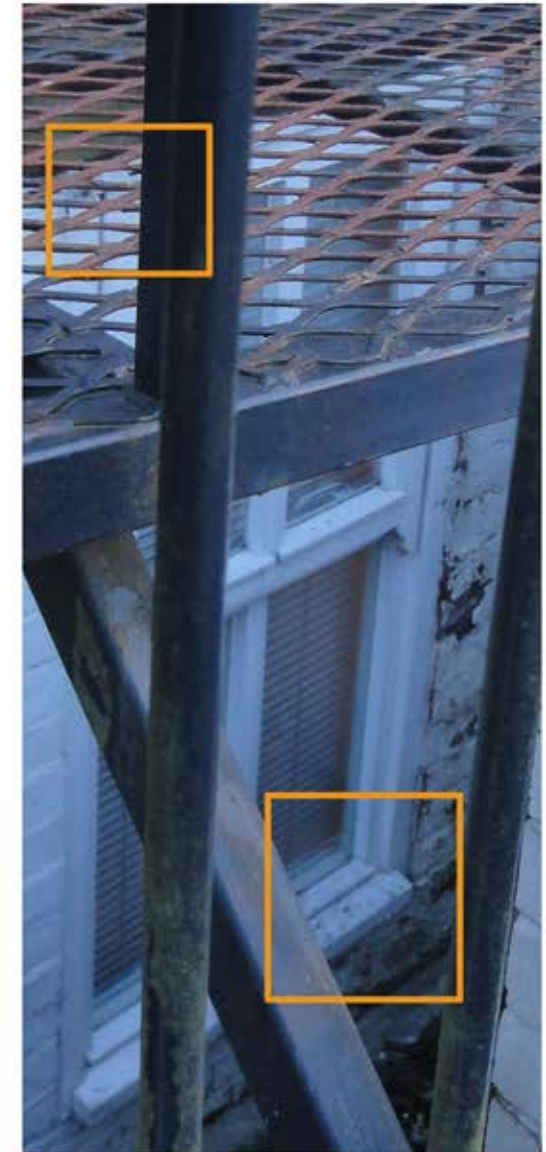
#3

Description: Top hung casement window, top half opening, styled to match sash windows with central bars and sash horns.

Defects: damaged hinge opening, window cannot open correctly which lets in moisture due to swollen timber frame

Joinery Fixing Option: top hung panel to be completely replaced

Draught-Proofing Option: repairs would have to be completed before adding draught-proofing to the openings

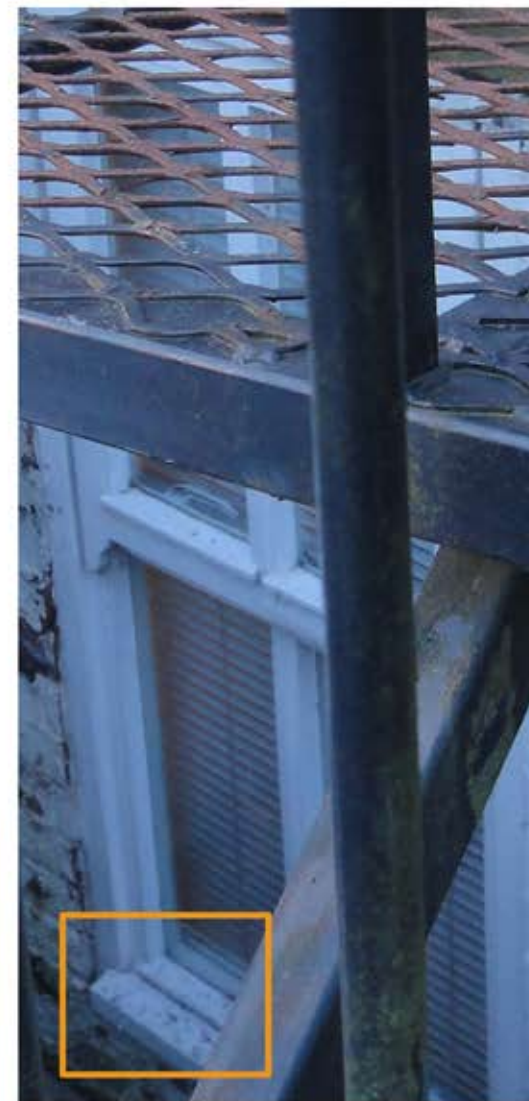
#14

Description: Top hung casement window, top half opening, styled to match sash windows with central bars and sash horns.

Defects: damaged hinge opening, cracked timber frame, mould and fungus growing into frame, gaps around bottom panes letting in moisture

Joinery Fixing Option: all timber frame to be replaced, bottom two glass panes to be replaced

Draught-Proofing Option: repairs would have to be completed before adding draught-proofing to the openings

uPVC Option: quickest option and would allow double glazing to be installed, style can be imitated to look exactly like the existing

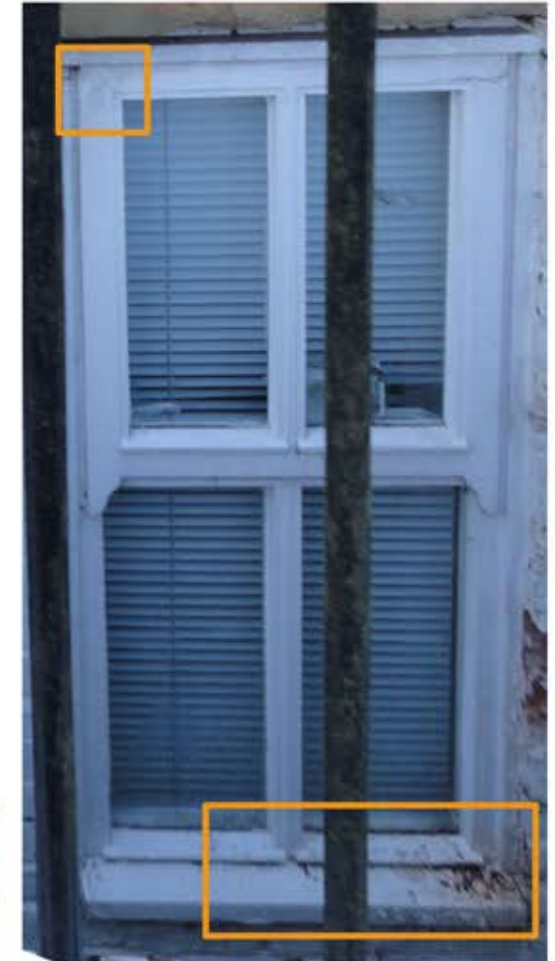
#15

Description: Top hung casement window, top half opening, styled to match sash windows with central bars and sash horns.

Defects: cracked timber frame, mould and fungus are growing into frame, gaps around bottom panes letting in moisture

Joinery Fixing Option: all lower timber frames to be replaced

Draught-Proofing Option: repairs would have to be completed before adding draught-proofing to the openings

uPVC Option: quickest option and would allow double glazing to be installed, style can be imitated to look exactly like the existing

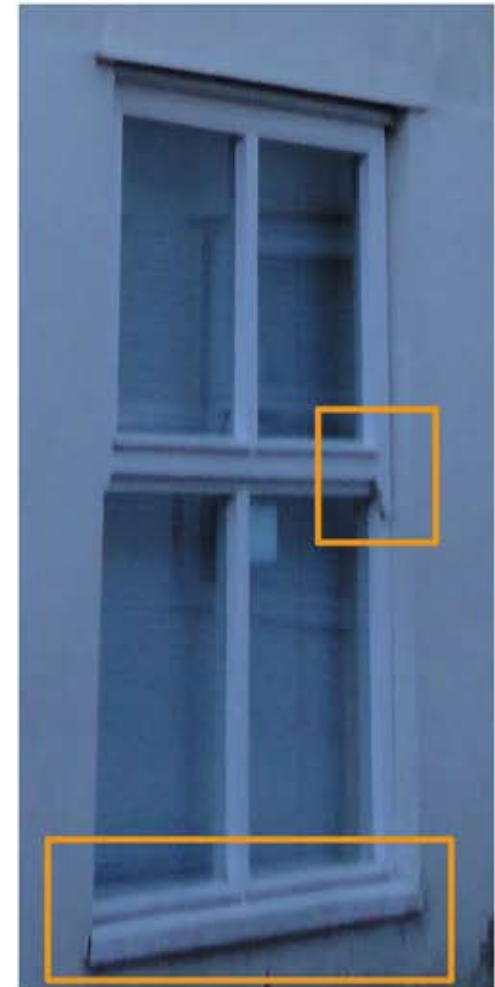
#16

Description: Top hung casement window, top half opening, styled to match sash windows with central bars and sash horns.

Defects: gaps around top hung panel will not allow the window to close properly and lets in moisture and heat escapes

Joinery Fixing Option: top hung panel and fixings to be replaced including seals

Draught-Proofing Option: repairs would have to be completed before adding draught-proofing to the openings

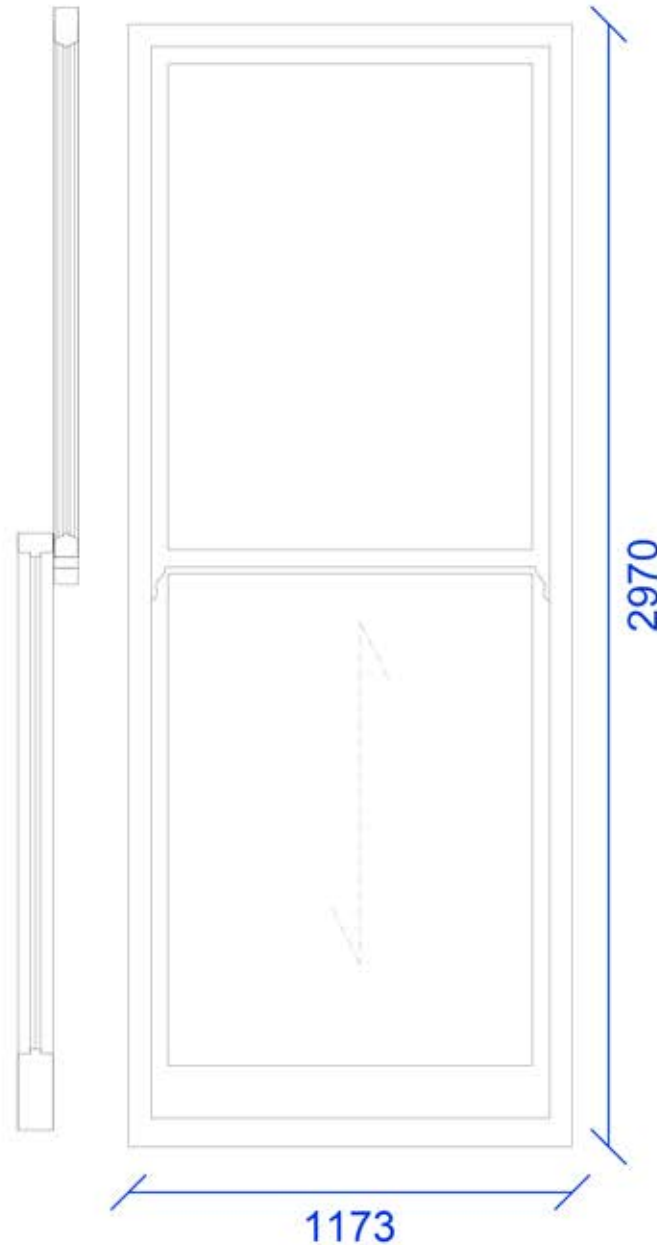
#21

Description: Non-bar floor to ceiling coupled sliding sash windows with sash horns

Defects: gaps between panes and sliding sections, build up of paint hides crack and heavy old windows do not open for ventilation, broken timber parts along sliding track and broken sliding ropes

Joinery Fixing Option: sand down paint and new sliding mechanisms replaced, removal of whole window would be necessary

Draught-Proofing Option: repairs would have to be completed before adding draught-proofing to the sliding panels

uPVC Option: quickest option and would allow double glazing to be installed, style can be imitated to look exactly like the existing

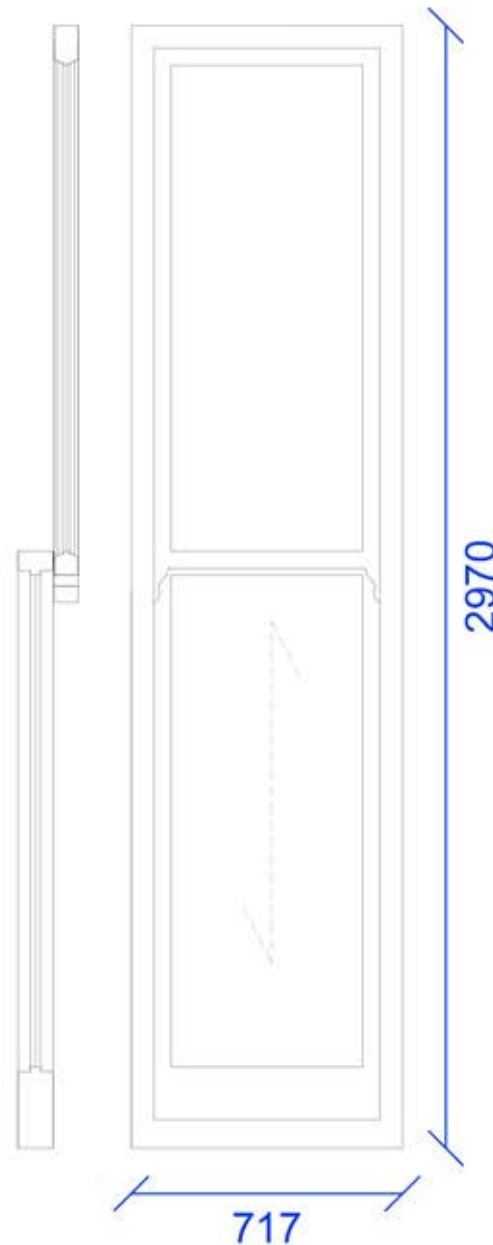
#22

Description: Non-bar floor to ceiling coupled sliding sash windows with sash horns with top arch

Defects: gaps between panes and sliding sections, build up of paint hides crack and heavy old windows do not open for ventilation, broken timber parts along sliding track and broken sliding ropes

Joinery Fixing Option: sand down paint and new sliding mechanisms replaced, removal of whole window would be necessary

Draught-Proofing Option: repairs would have to be completed before adding draught-proofing to the sliding panels

uPVC Option: quickest option and would allow double glazing to be installed, style can be imitated to look exactly like the existing

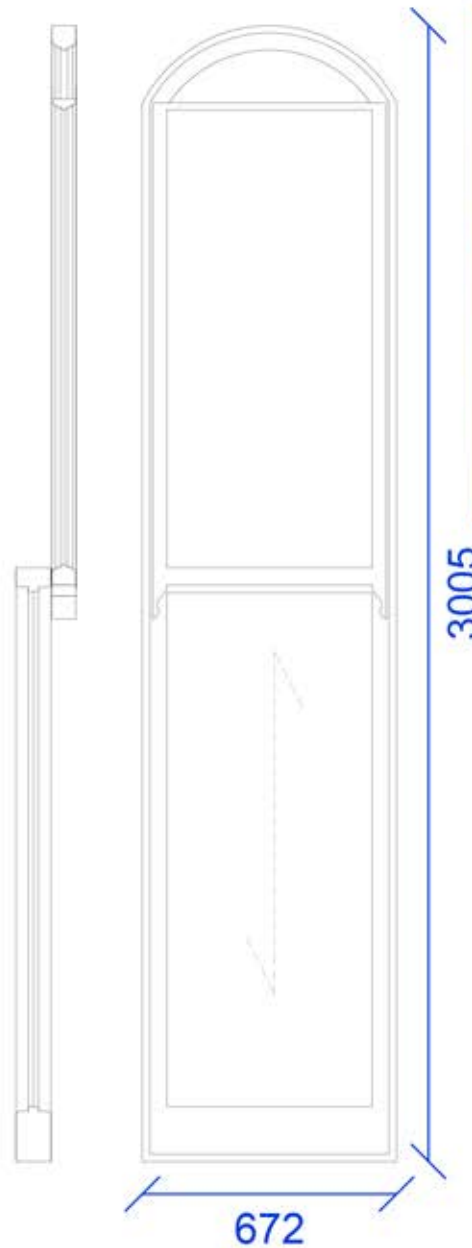
#25

Description: Non-bar floor to ceiling coupled sliding sash windows with sash horns with top arch

Defects: gaps between panes and sliding sections, build up of paint hides crack and heavy old windows do not open for ventilation, broken timber parts along sliding track and broken sliding ropes

Joinery Fixing Option: sand down paint and new sliding mechanisms replaced, removal of whole window would be necessary

Draught-Proofing Option: repairs would have to be completed before adding draught-proofing to the sliding panels

uPVC Option: quickest option and would allow double glazing to be installed, style can be imitated to look exactly like the existing

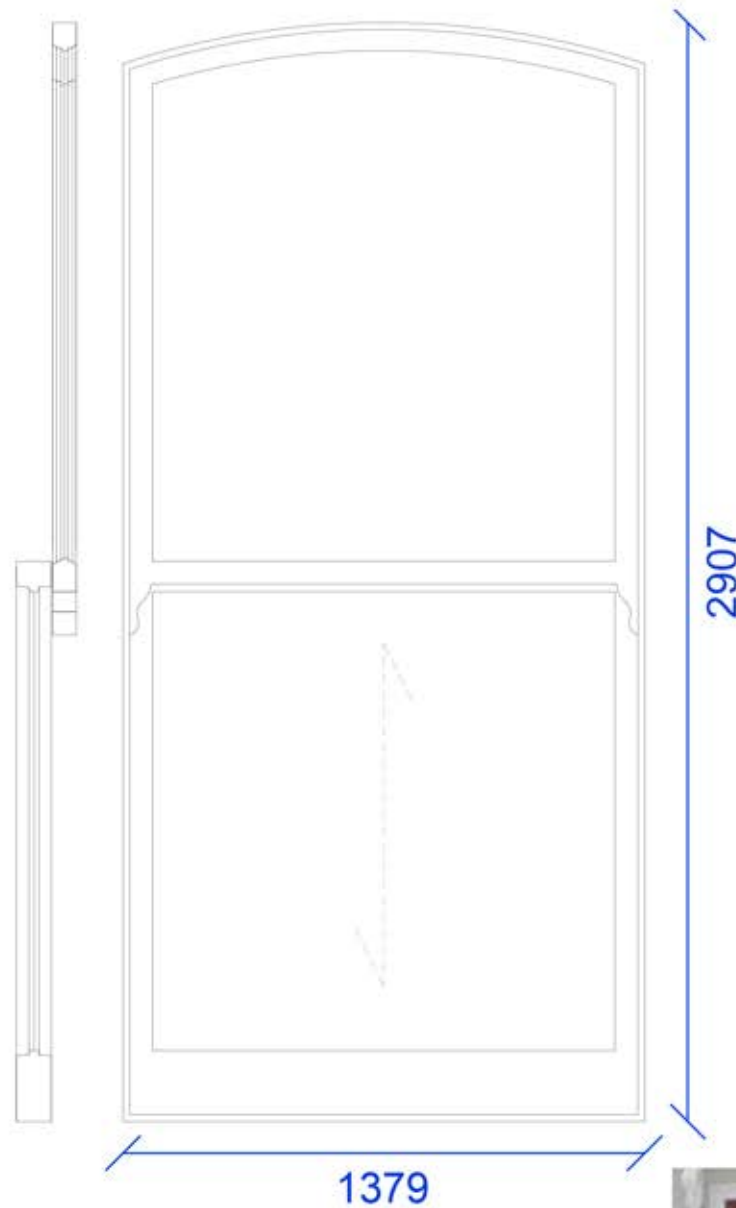
#26

Description: Non-bar floor to ceiling coupled sliding sash windows with sash horns with top arch

Defects: gaps between panes and sliding sections, build up of paint hides crack and heavy old windows do not open for ventilation, broken timber parts along sliding track and broken sliding ropes

Joinery Fixing Option: sand down paint and new sliding mechanisms replaced, removal of whole window would be necessary

Draught-Proofing Option: repairs would have to be completed before adding draught-proofing to the sliding panels

uPVC Option: quickest option and would allow double glazing to be installed, style can be imitated to look exactly like the existing
