Daisybank Villas
5-7 Anson Road
Manchester
M14 5BR

Window Replacement
Justification

May 2018

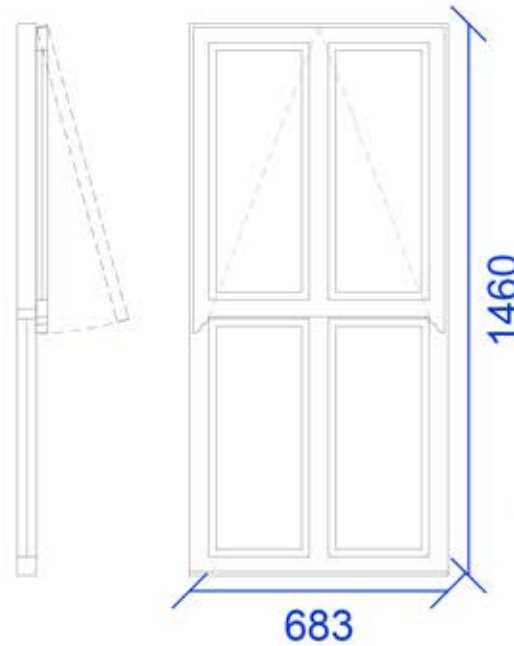
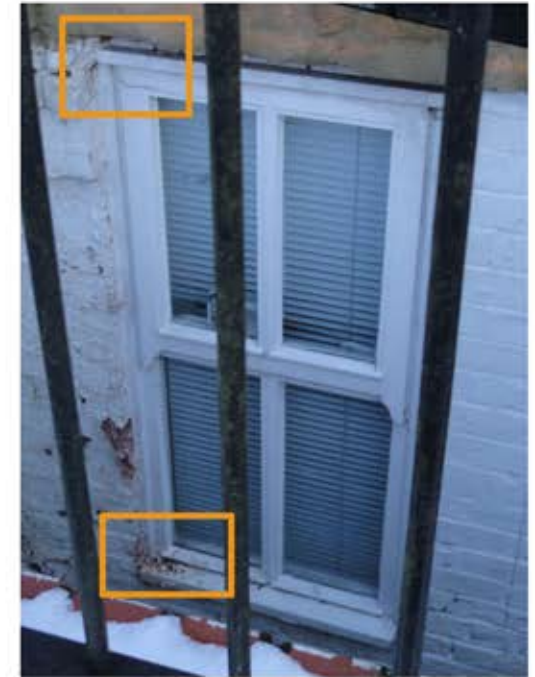
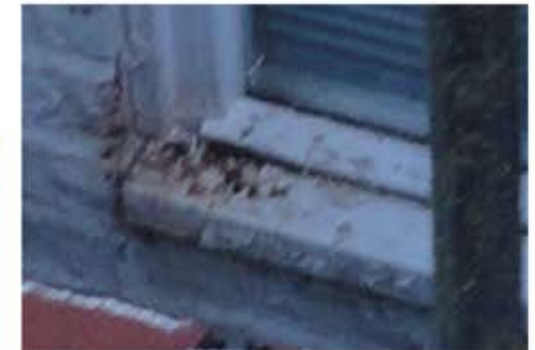
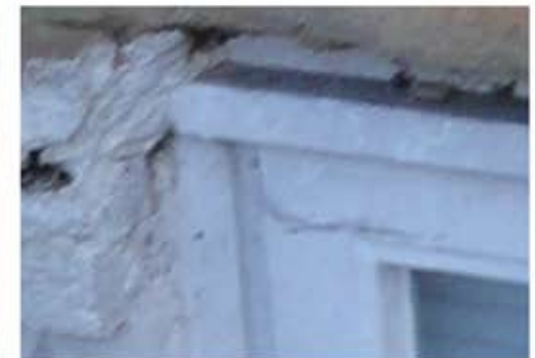
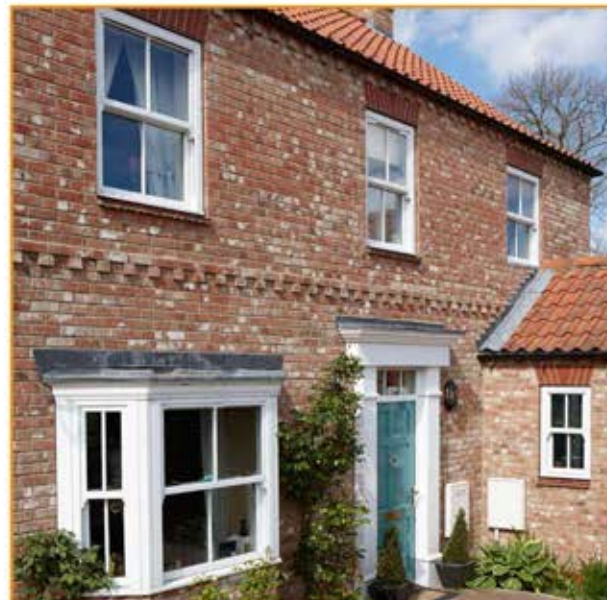
#1

Defects: damaged hinge opening, cracked timber frame, mould and fungus growing into frame, gaps around bottom panes letting in moisture

Joinery Fixing Option: all timber frame to be replaced, bottom two glass panes to be replaced

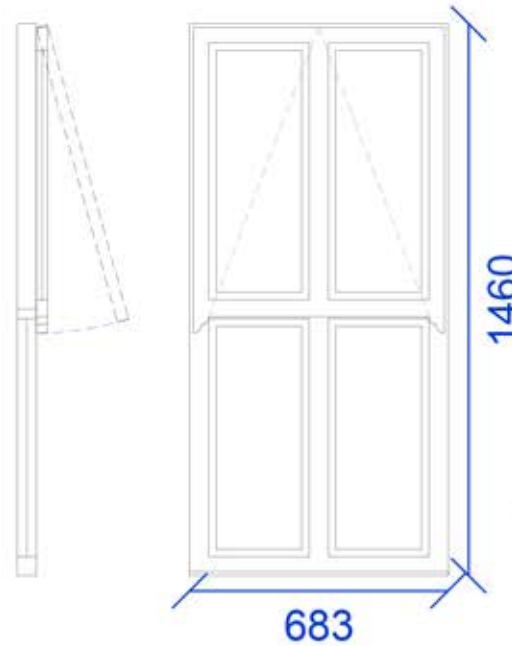
#2

Defects: damaged hinge opening, cracked timber frame, mould and fungus growing into frame, gaps around bottom panes letting in moisture

Joinery Fixing Option: all timber frame to be replaced, bottom two glass panes to be replaced

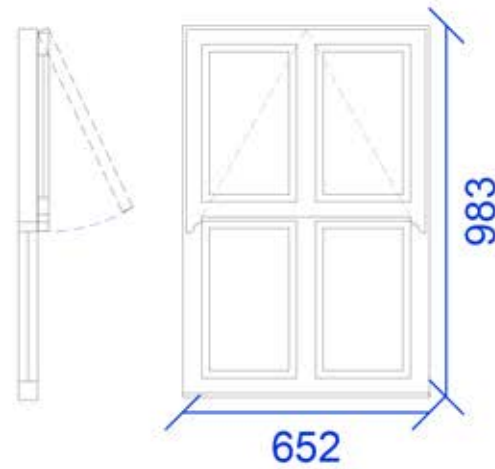
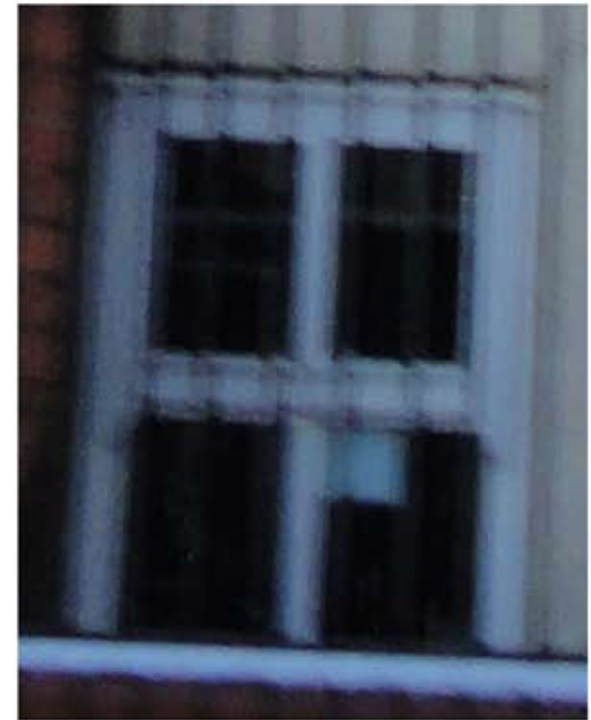
#3

Defects: damaged hinge opening, window cannot open correctly which lets in moisture due to swollen timber frame

Joinery Fixing Option: top hung panel to be completely replaced

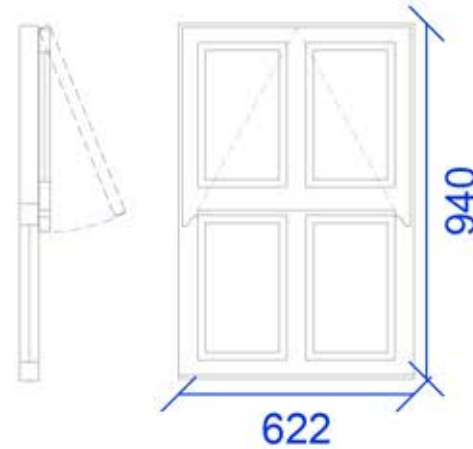
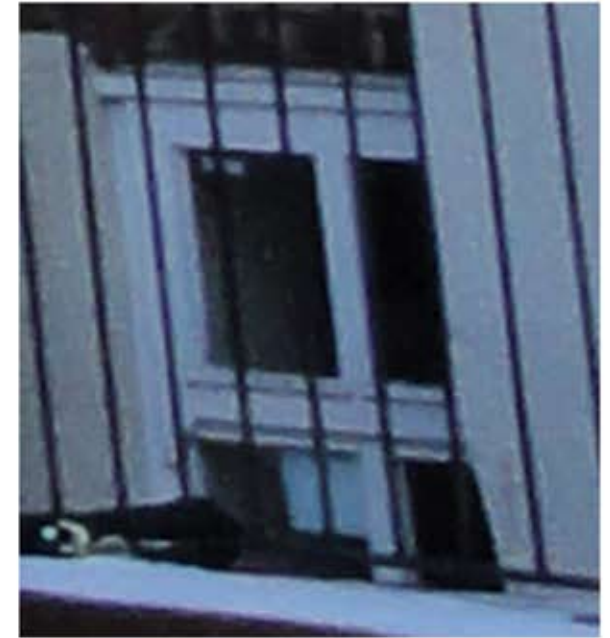
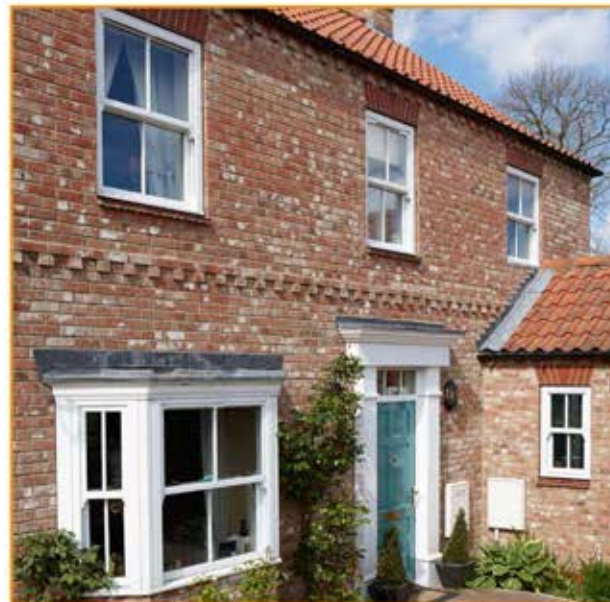
#4

Defects: damaged hinge opening, window cannot open correctly which lets in moisture due to swollen timber frame

Joinery Fixing Option: top hung panel to be completely replaced

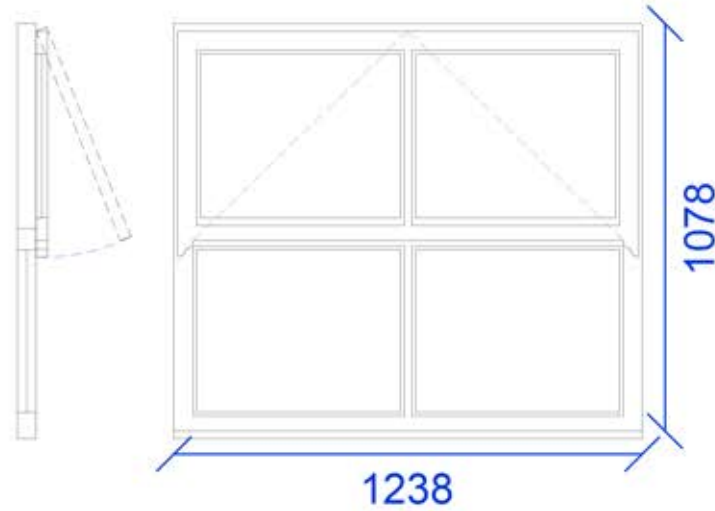
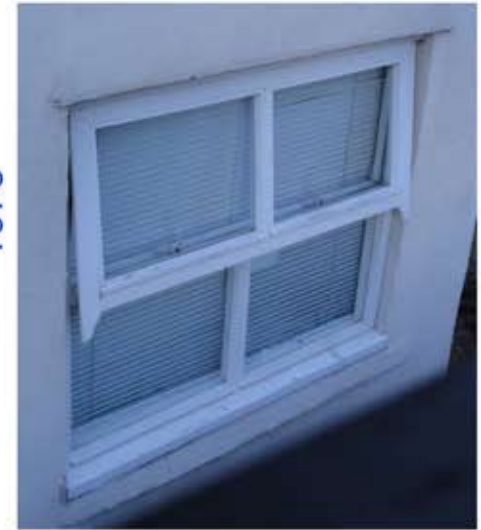
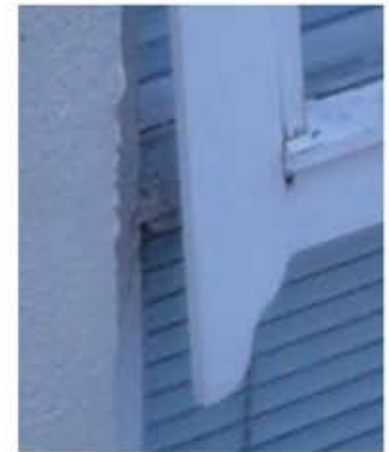
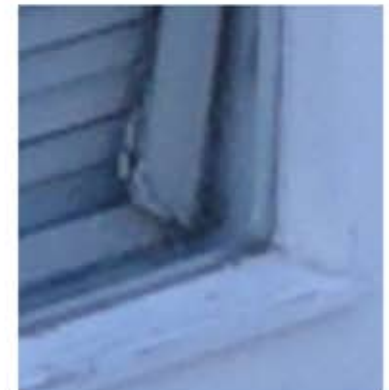
#5

Defects: damaged hinge opening, cracked and split timber joints, broken seals, difficulty closing

Joinery Fixing Option: all timber corners to be replaced inside and out- complete replacement needed with new seals and fixings

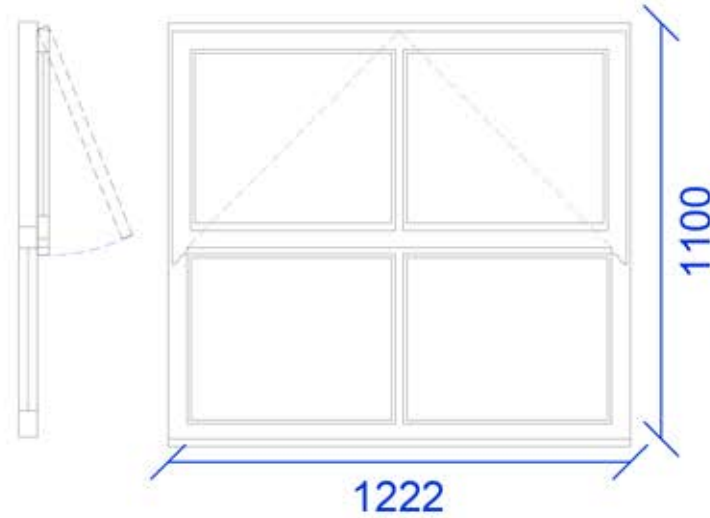
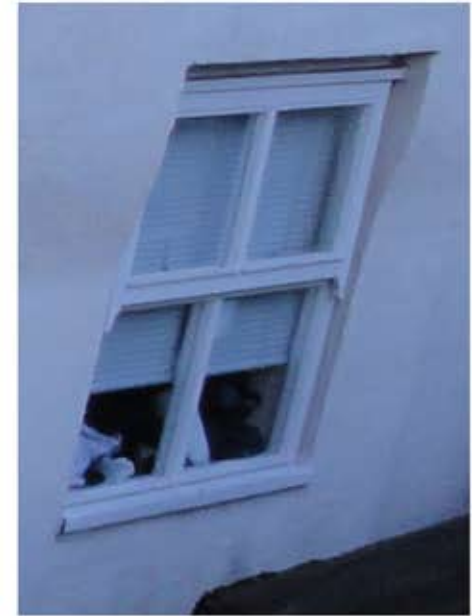
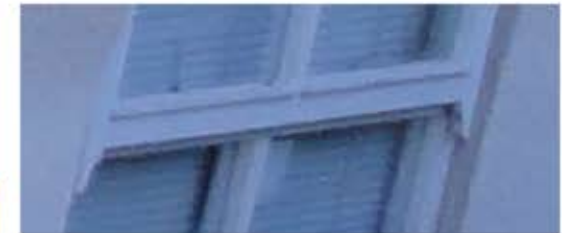
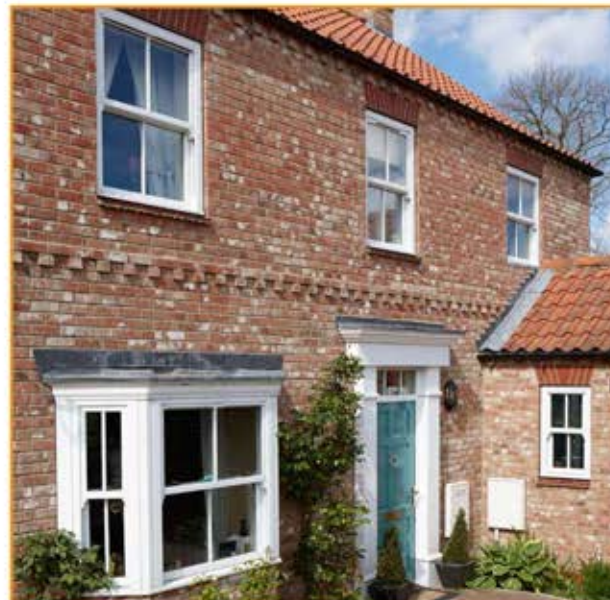
#6

Defects: damaged hinge opening, swollen top hung panel will not allow correct closing

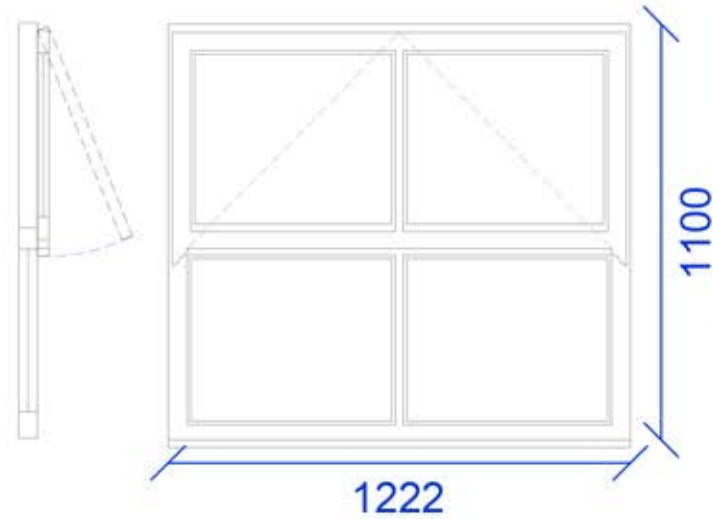
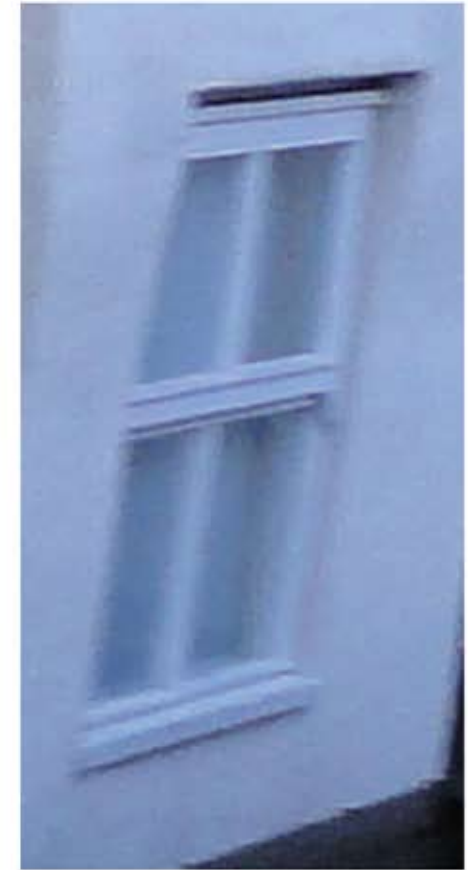
#7

Defects: damaged hinge opening, swollen top hung panel will not allow correct closing

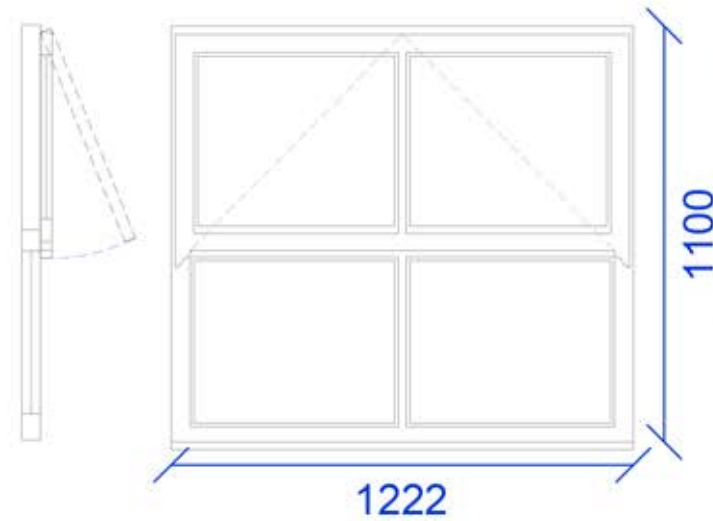
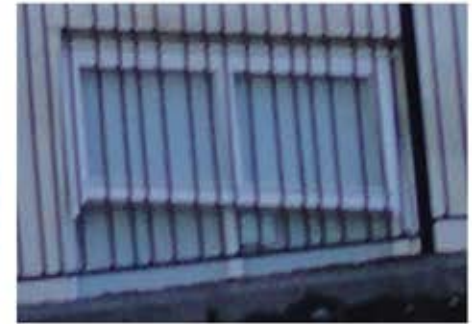
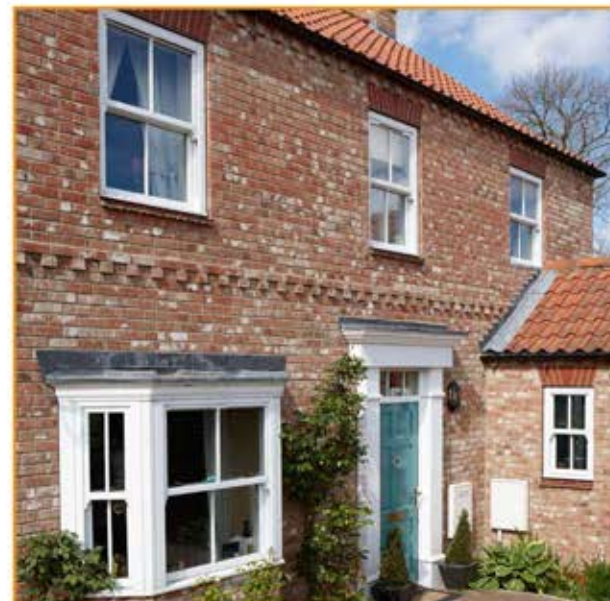
#8

Defects: damaged hinge opening, swollen top hung panel will not allow correct closing

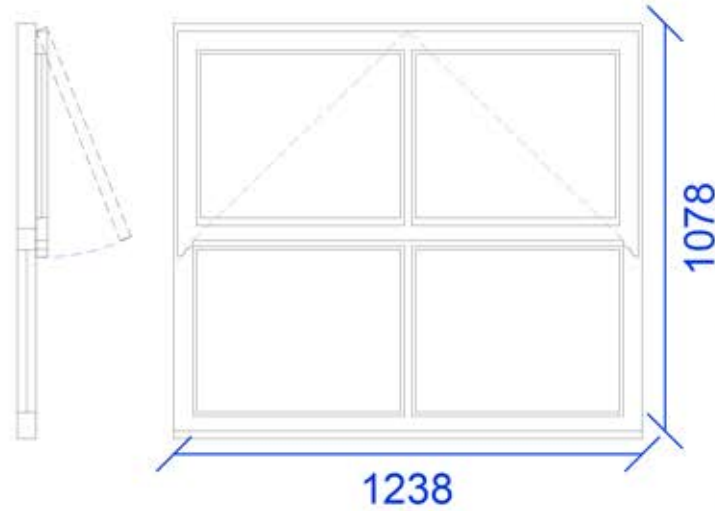
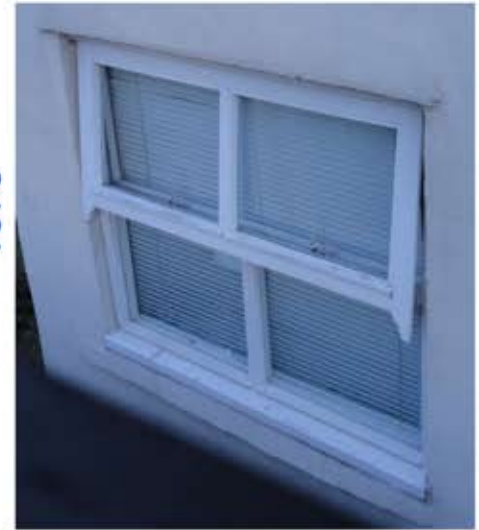
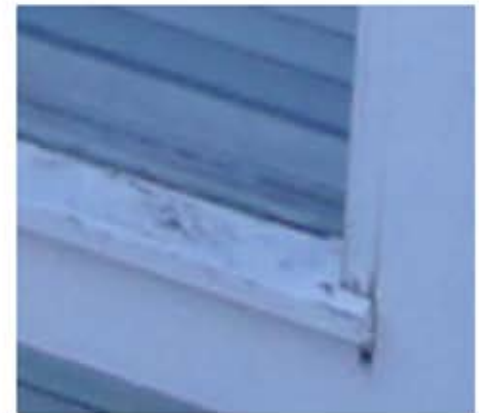
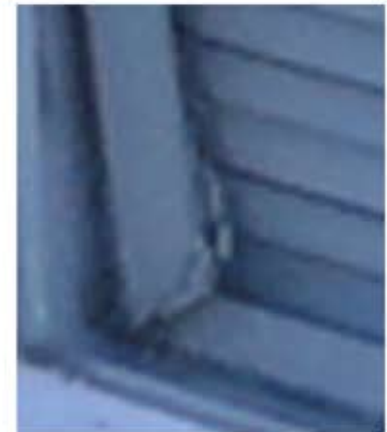
#9

Defects: damaged hinge opening, cracked and split timber joints, broken seals, difficulty closing

Joinery Fixing Option: all timber corners to be replaced inside and out- complete replacement needed with new seals and fixings

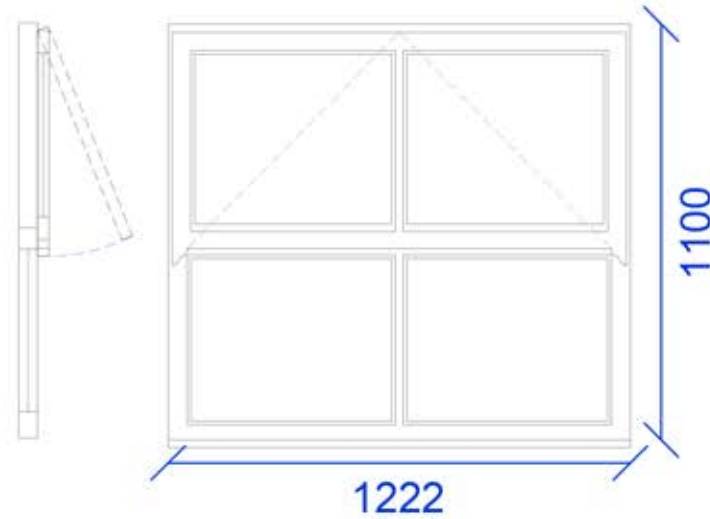
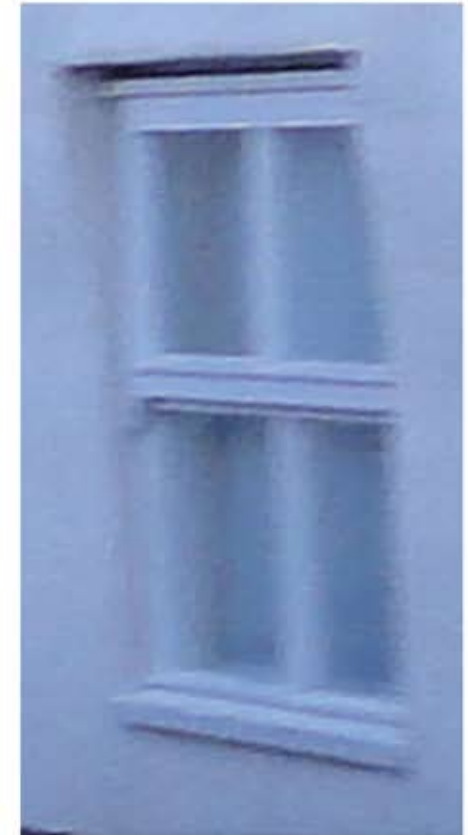
#10

Defects: damaged hinge opening, swollen top hung panel will not allow correct closing

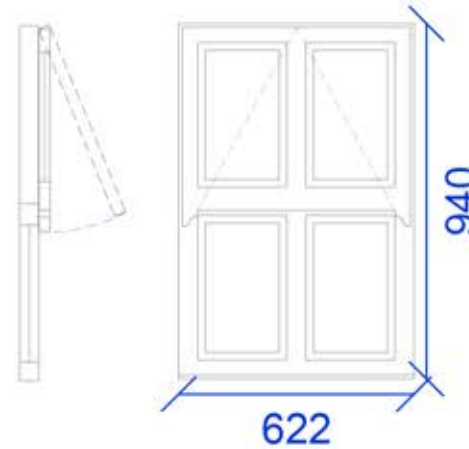
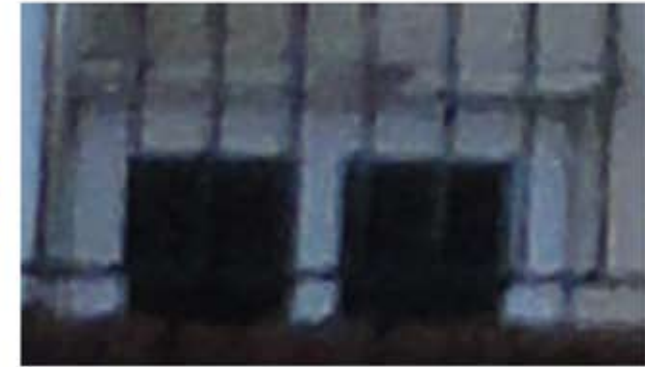
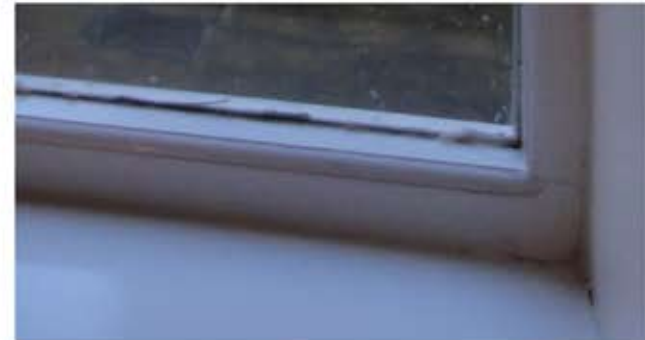
#11

Defects: damaged hinge opening, window cannot open correctly which lets in moisture due to swollen timber frame, top timber frame rotten

Joinery Fixing Option: whole window to be completely replaced

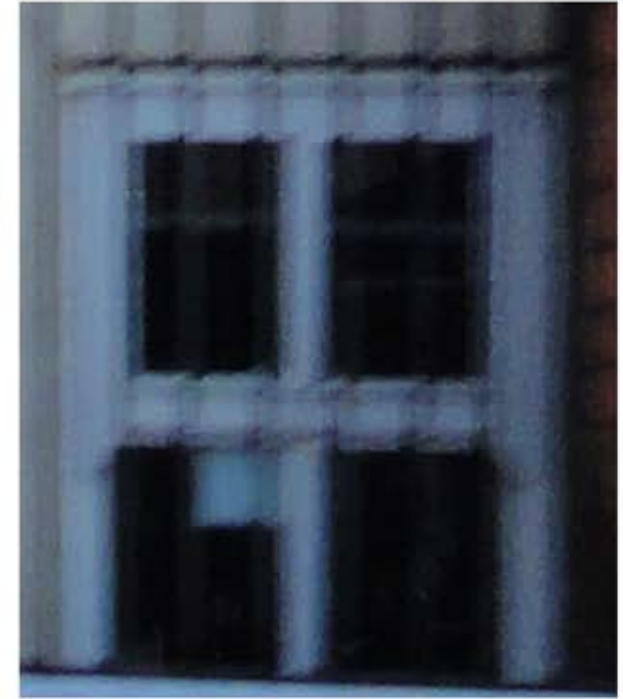
#12

Defects: damaged hinge opening, window cannot open correctly which lets in moisture due to swollen timber frame

Joinery Fixing Option: most timber pieces need to be replaced- whole window would be easier

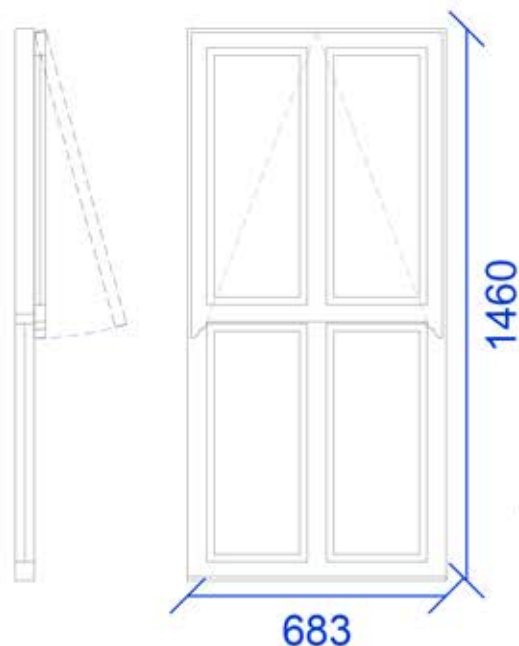
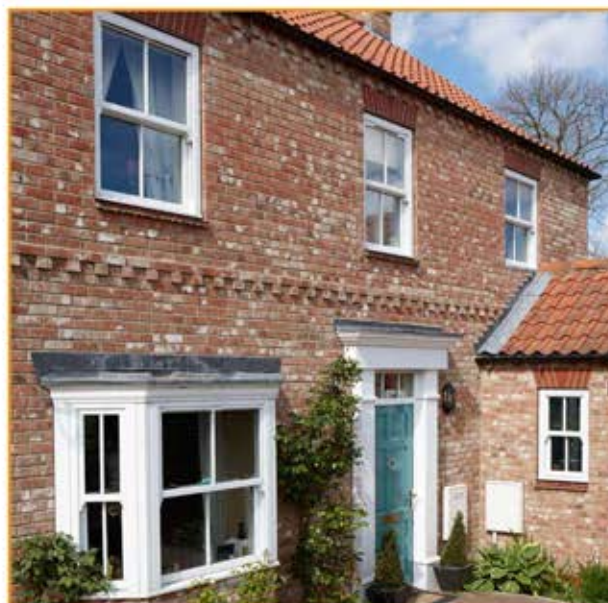
#14

Defects: damaged hinge opening, cracked timber frame, mould and fungus growing into frame, gaps around bottom panes letting in moisture

Joinery Fixing Option: all timber frame to be replaced, bottom two glass panes to be replaced

Draught-Proofing Option: repairs would have to be completed before adding draught-proofing to the openings

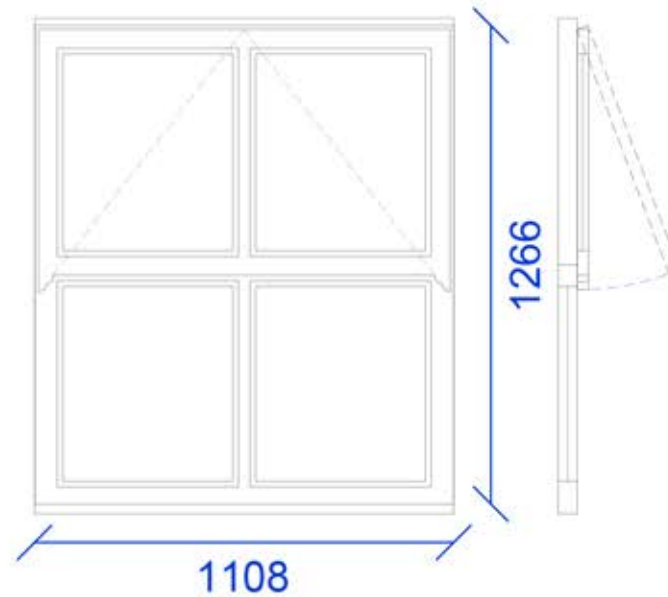
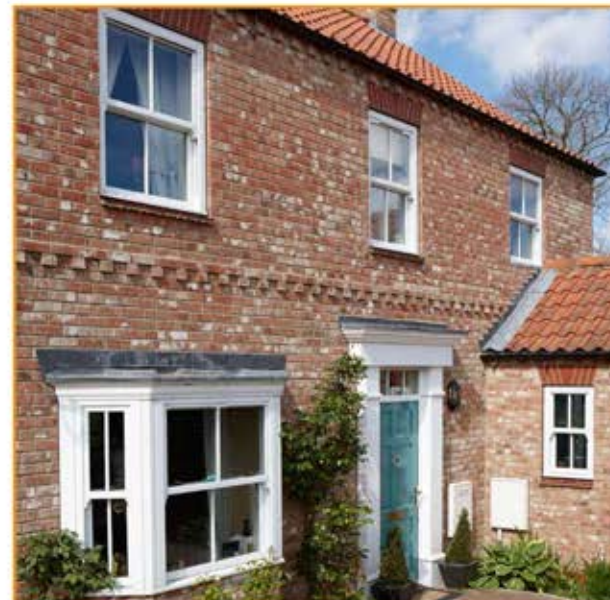
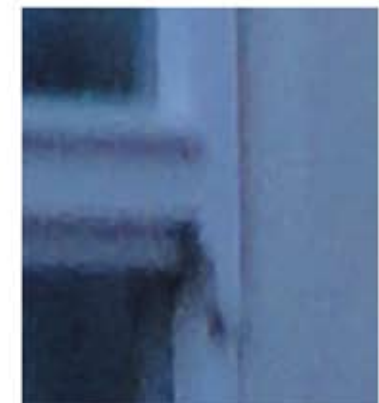
#16

Defects: gaps around top hung panel will not allow the window to close properly and lets in moisture and heat escapes

Joinery Fixing Option: top hung panel and fixings to be replaced including seals

Draught-Proofing Option: repairs would have to be completed before adding draught-proofing to the openings

uPVC Option: quickest option and would allow double glazing to be installed, style can be imitated to look exactly like the existing

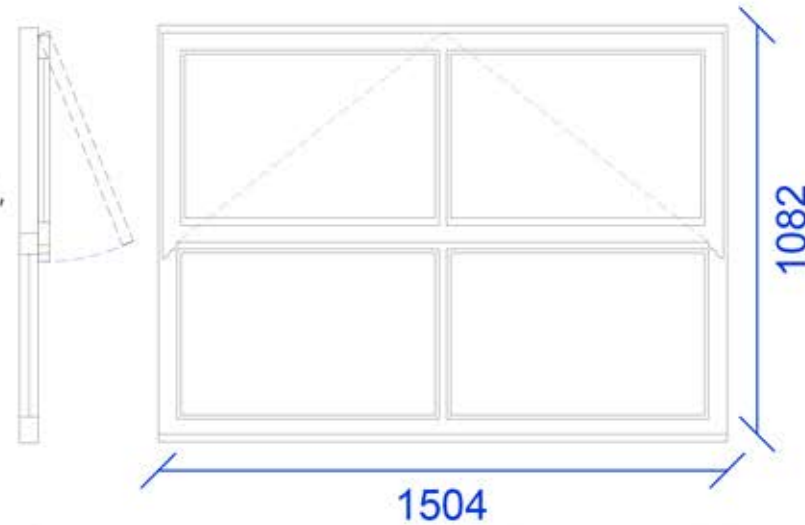
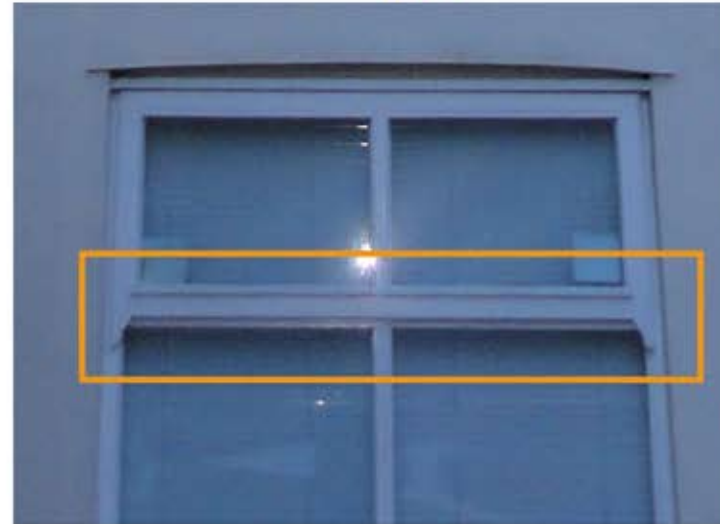
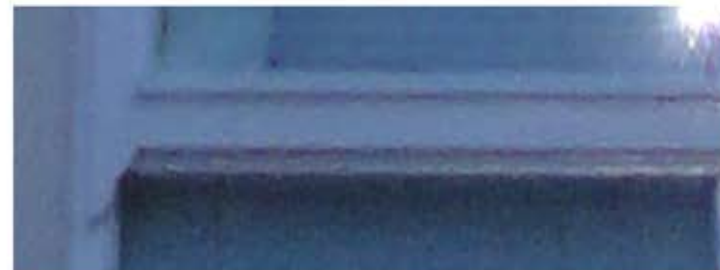
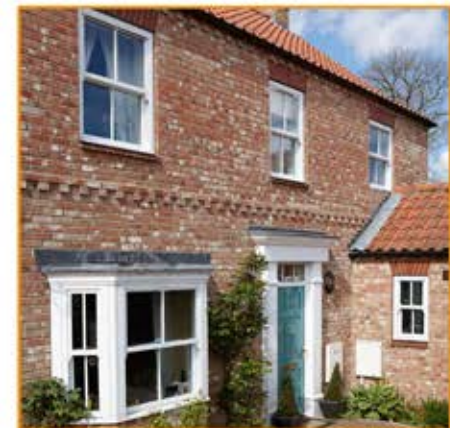
#17

Defects: bottom timber frame is rotten allowing heat to escape and moisture to enter the room

Joinery Fixing Option: bottom timber frame needs to be replaced and new sill installed- whole window needs replacing for ease

Draught-Proofing Option: repairs would have to be completed before adding draught-proofing to the openings

uPVC Option: quickest option and would allow double glazing to be installed, style can be imitated to look exactly like the existing

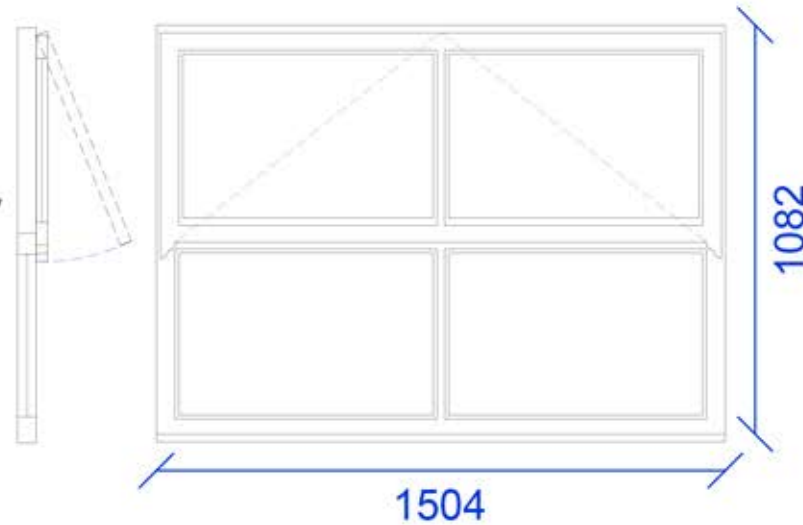
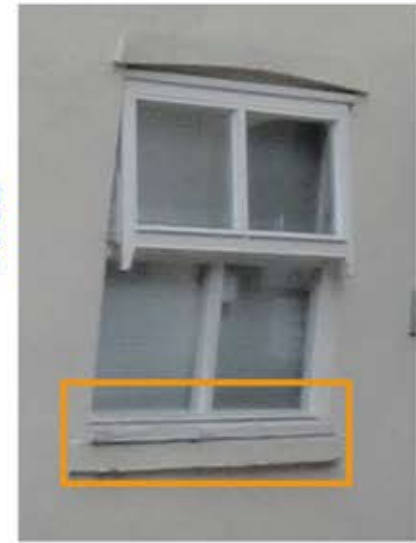
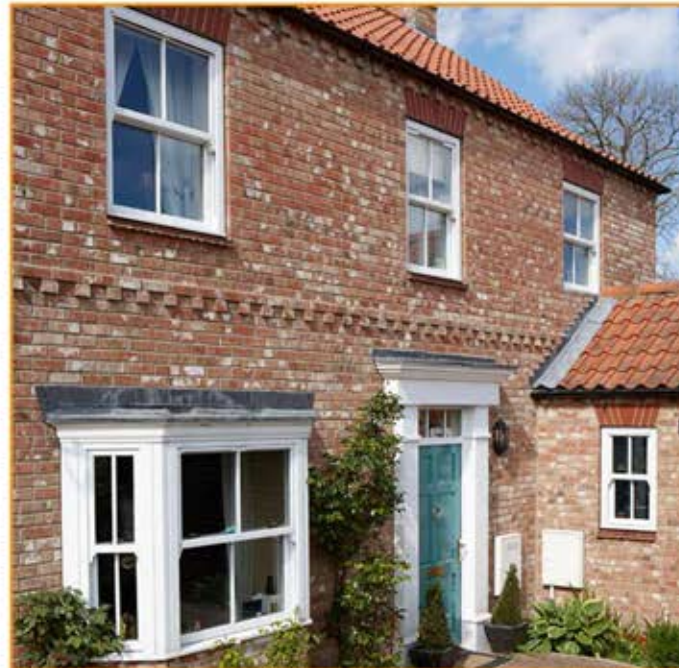
#18

Defects: cracked timber frame, mould and fungus are growing into frame, gaps around top hung panel letting out heat and letting moisture in

Joinery Fixing Option: all cracked timber frames to be replaced

Draught-Proofing Option: repairs would have to be completed before adding draught-proofing to the openings

uPVC Option: quickest option and would allow double glazing to be installed, style can be imitated to look exactly like the existing

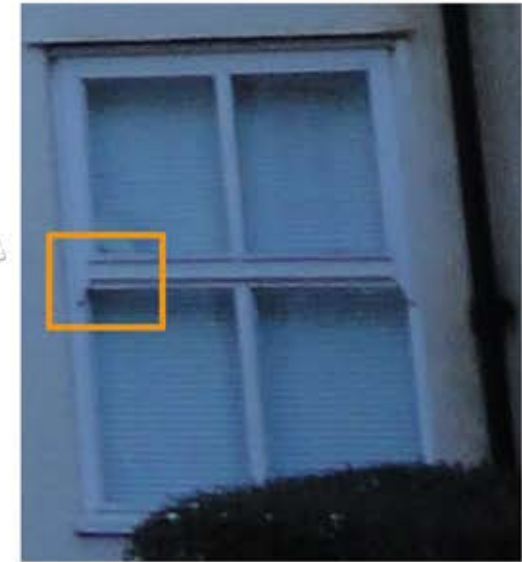
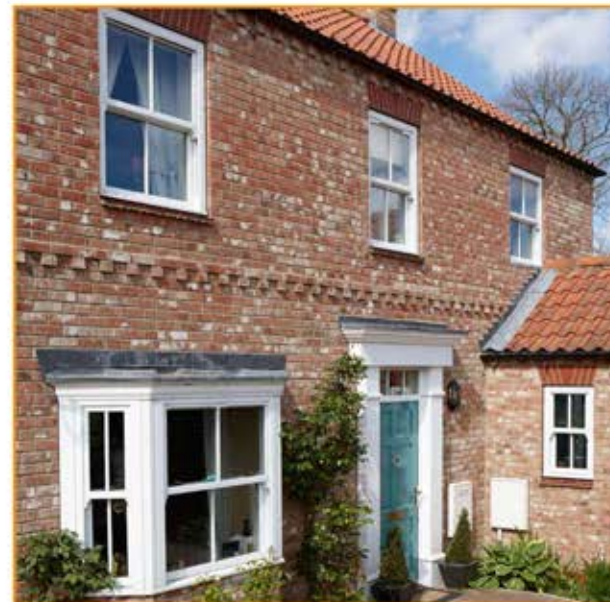
#19

Defects: gaps between panes and sliding sections, build up of paint hides crack and heavy old windows do not open for ventilation, broken timber parts along sliding track and broken sliding ropes

Joinery Fixing Option: sand down paint and new sliding mechanisms replaced, removal of whole window would be necessary

Draught-Proofing Option: repairs would have to be completed before adding draught-proofing to the sliding panels

uPVC Option: quickest option and would allow double glazing to be installed, style can be imitated to look exactly like the existing

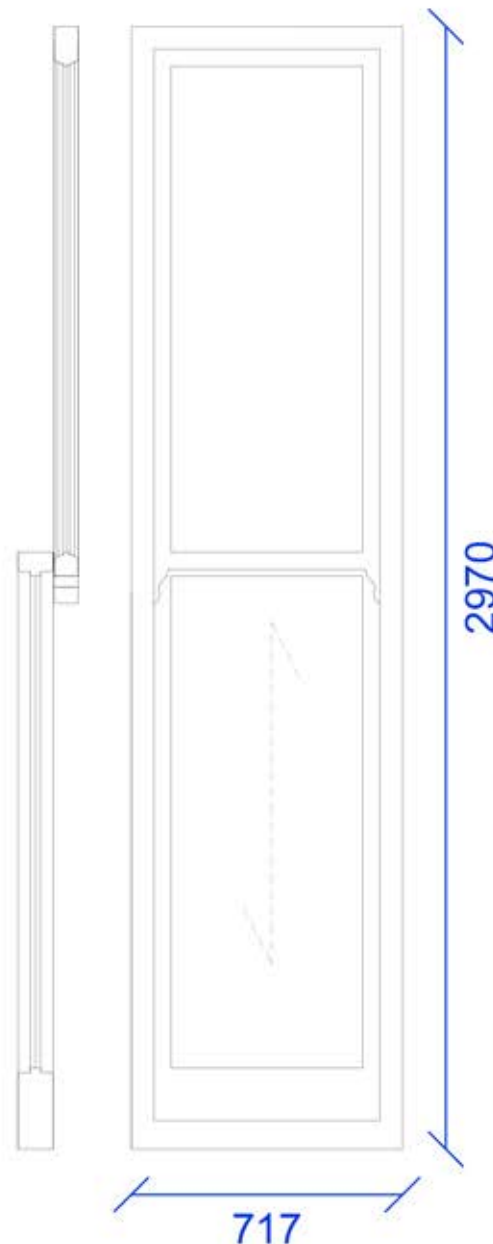
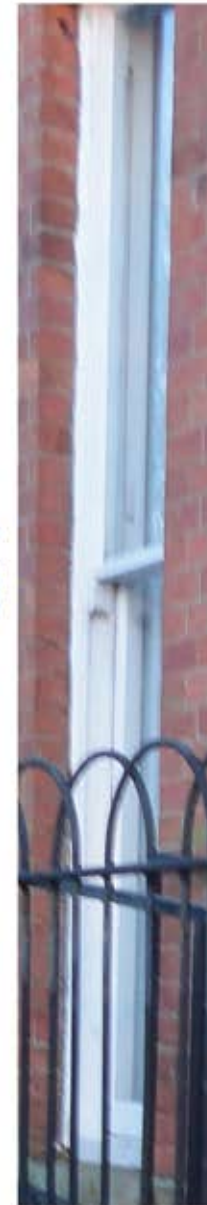
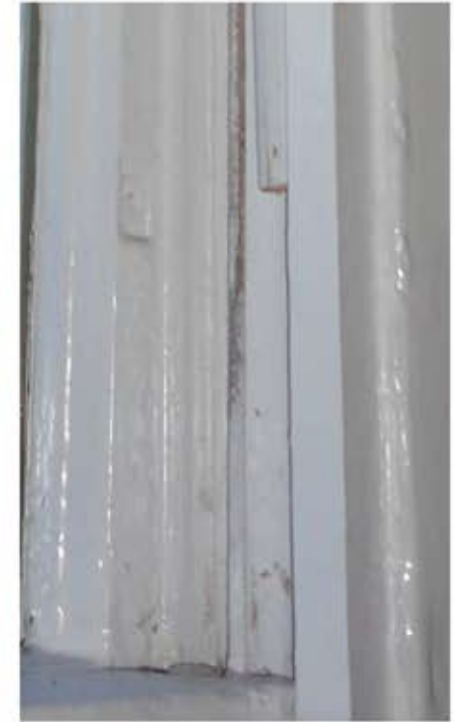
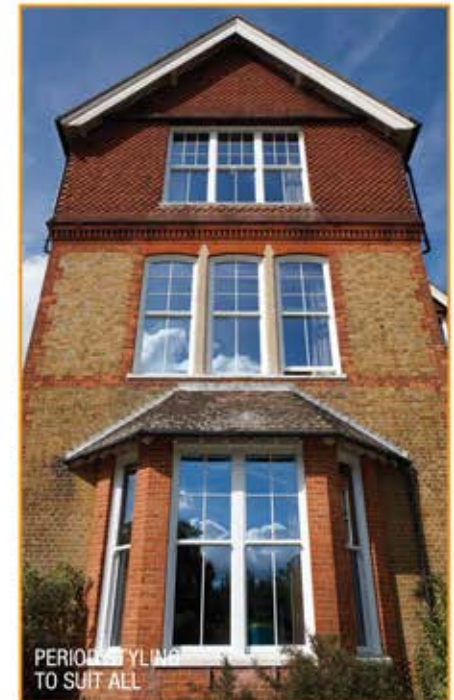
#20

Defects: gaps between panes and sliding sections, build up of paint hides crack and heavy old windows do not open for ventilation, broken timber parts along sliding track and broken sliding ropes

Joinery Fixing Option: sand down paint and new sliding mechanisms replaced, removal of whole window would be necessary

Draught-Proofing Option: repairs would have to be completed before adding draught-proofing to the sliding panels

uPVC Option: quickest option and would allow double glazing to be installed, style can be imitated to look exactly like the existing

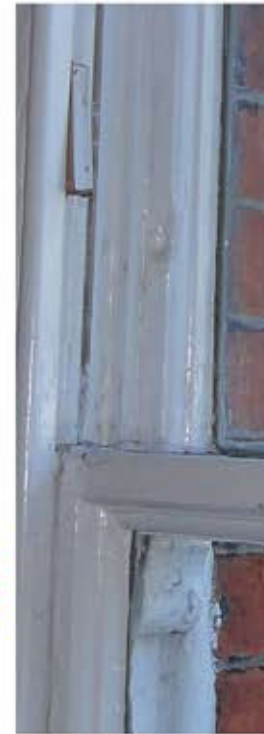
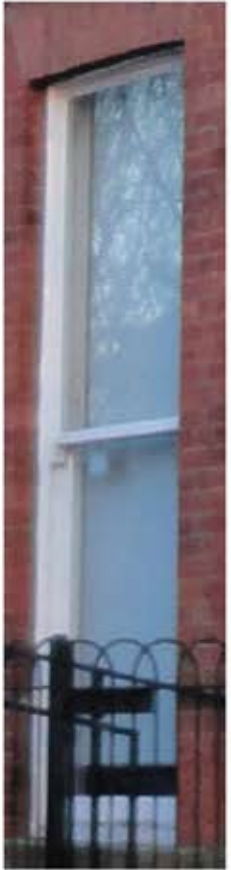
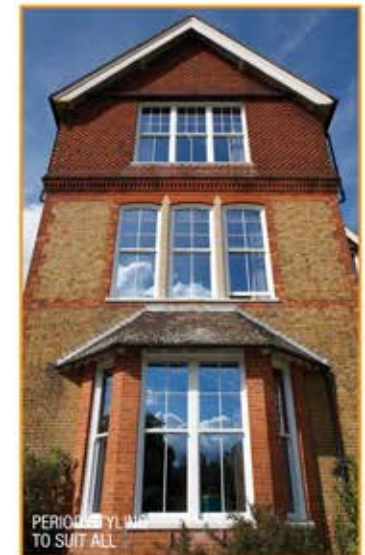
#21

Defects: gaps between panes and sliding sections, build up of paint hides crack and heavy old windows do not open for ventilation, broken timber parts along sliding track and broken sliding ropes

Joinery Fixing Option: sand down paint and new sliding mechanisms replaced, removal of whole window would be necessary

Draught-Proofing Option: repairs would have to be completed before adding draught-proofing to the sliding panels

uPVC Option: quickest option and would allow double glazing to be installed, style can be imitated to look exactly like the existing

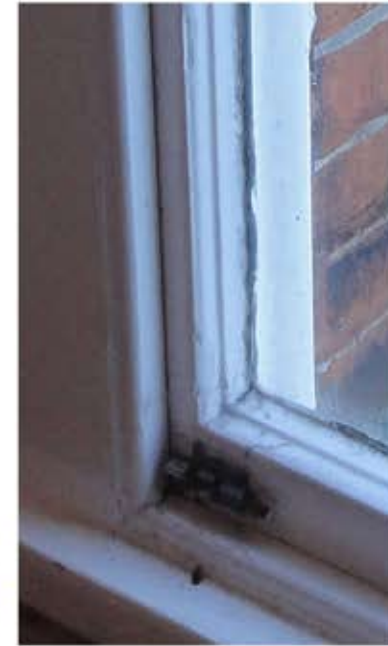
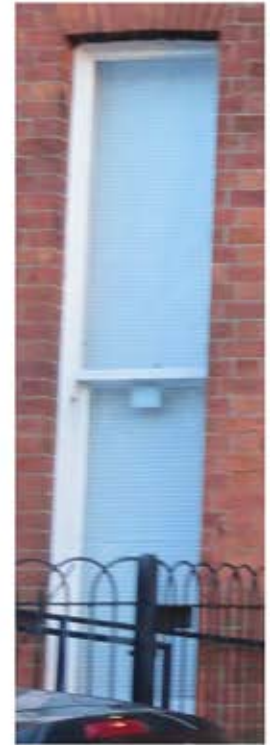
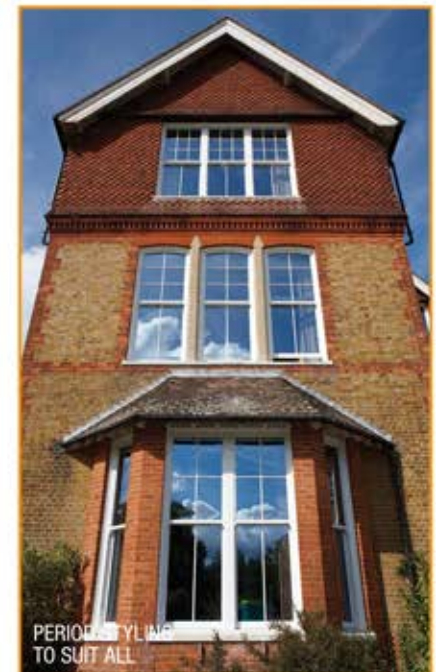
#22

Defects: gaps between panes and sliding sections, build up of paint hides crack and heavy old windows do not open for ventilation, broken timber parts along sliding track and broken sliding ropes

Joinery Fixing Option: sand down paint and new sliding mechanisms replaced, removal of whole window would be necessary

Draught-Proofing Option: repairs would have to be completed before adding draught-proofing to the sliding panels

uPVC Option: quickest option and would allow double glazing to be installed, style can be imitated to look exactly like the existing

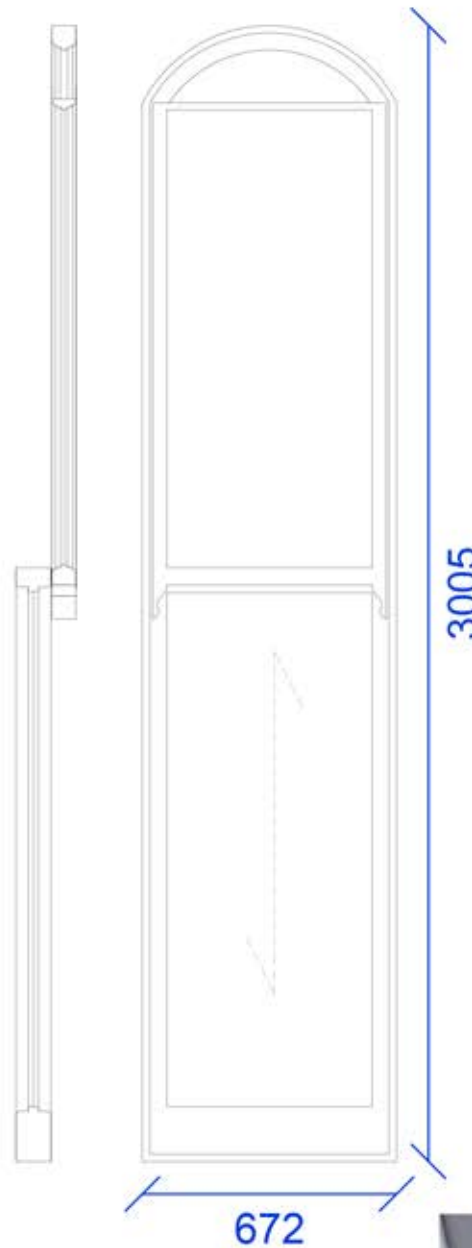
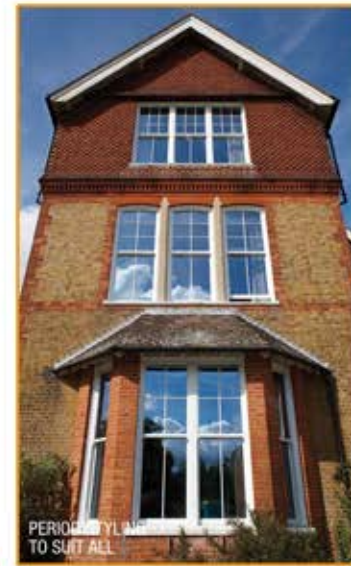
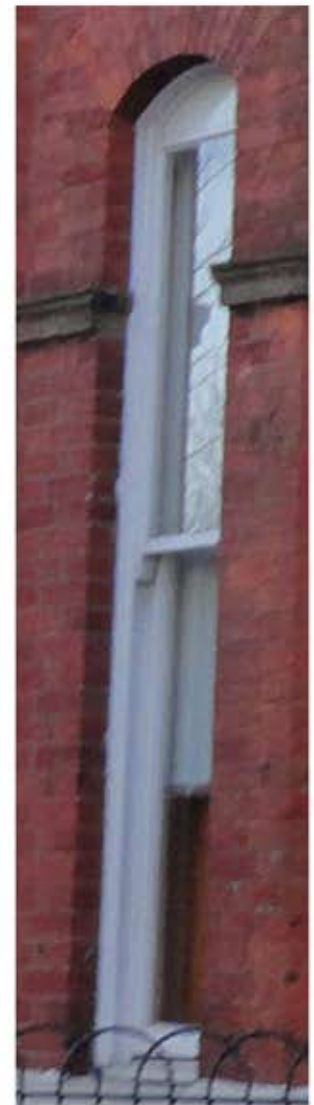
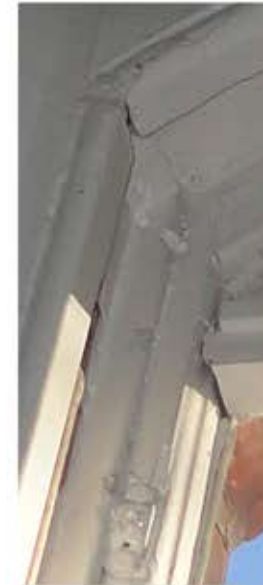
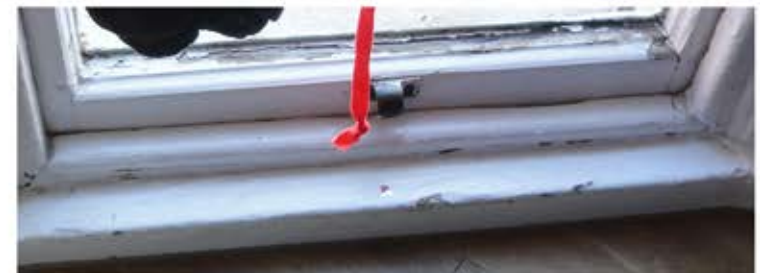
#23

Defects: gaps between panes and sliding sections, build up of paint hides crack and heavy old windows do not open for ventilation, broken timber parts along sliding track and broken sliding ropes

Joinery Fixing Option: sand down paint and new sliding mechanisms replaced, removal of whole window would be necessary

Draught-Proofing Option: repairs would have to be completed before adding draught-proofing to the sliding panels

uPVC Option: quickest option and would allow double glazing to be installed, style can be imitated to look exactly like the existing

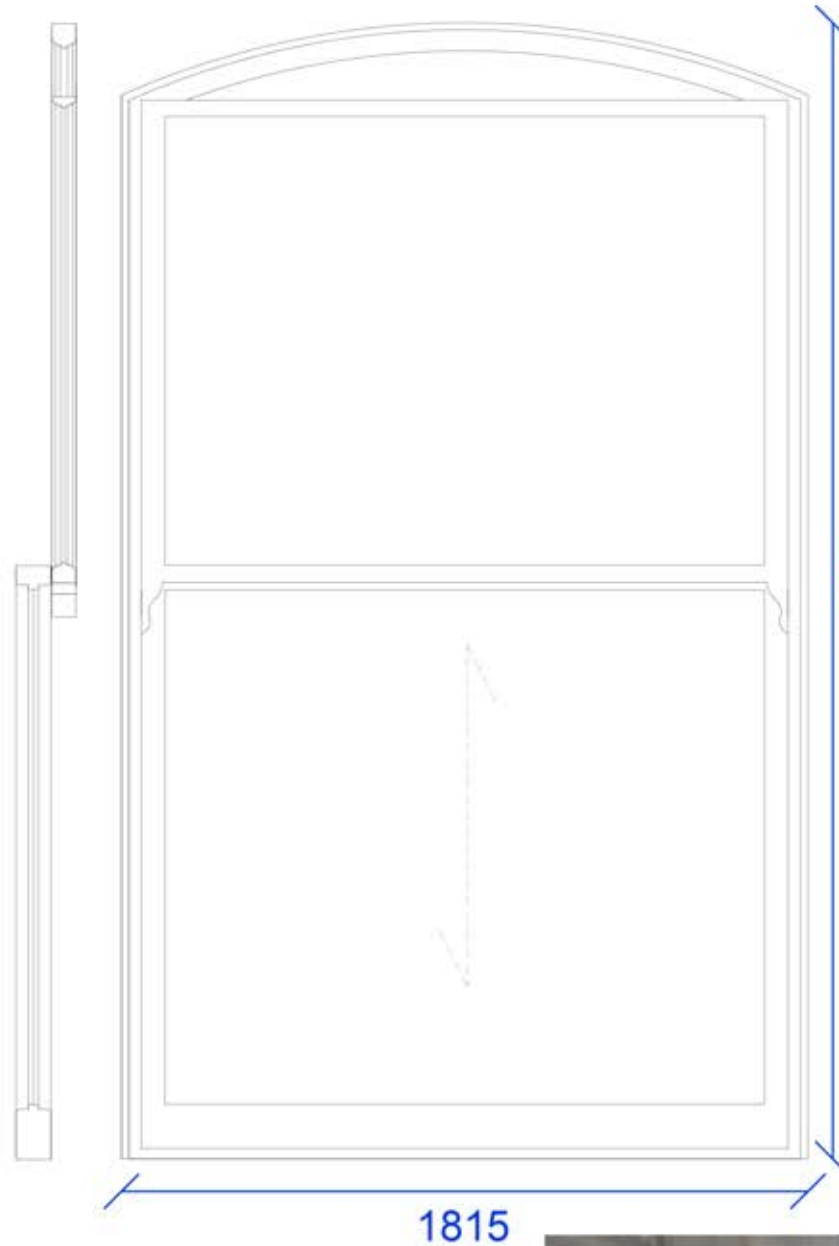
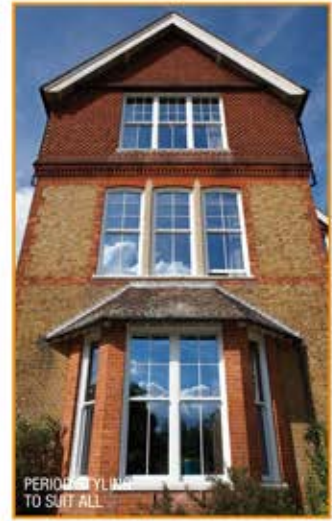
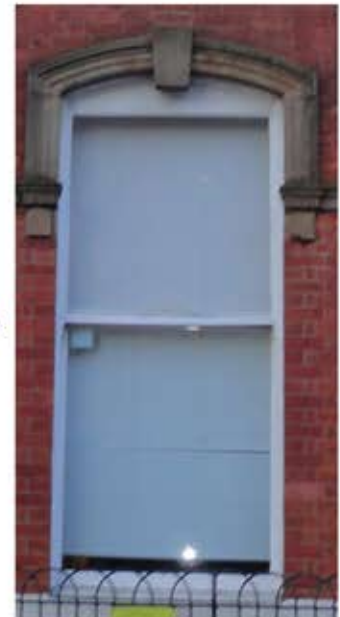
#24

Defects: gaps between panes and sliding sections, build up of paint hides crack and heavy old windows do not open for ventilation, broken timber parts along sliding track and broken sliding ropes

Joinery Fixing Option: sand down paint and new sliding mechanisms replaced, removal of whole window would be necessary

Draught-Proofing Option: repairs would have to be completed before adding draught-proofing to the sliding panels

uPVC Option: quickest option and would allow double glazing to be installed, style can be imitated to look exactly like the existing
