Daisybank Villas
5-7 Anson Road
Manchester
M14 5BR

Window Replacement
Justification

May 2018

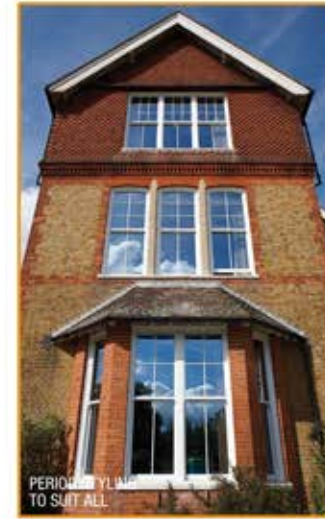
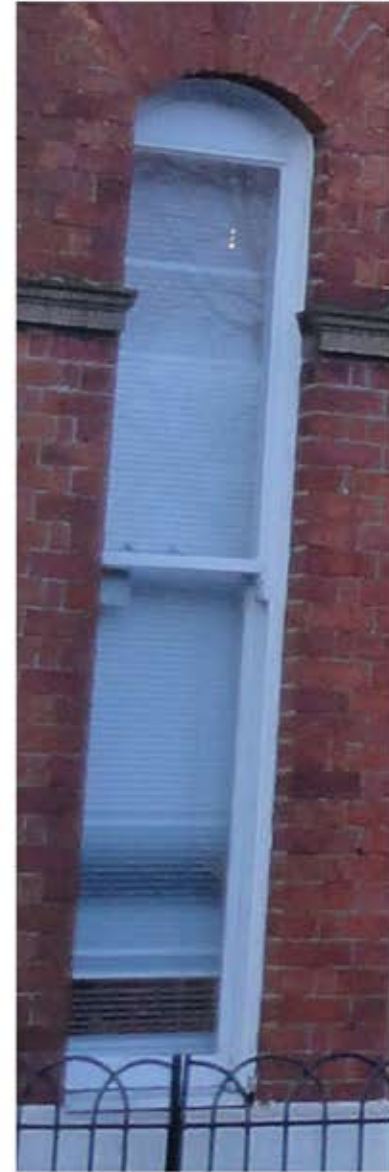
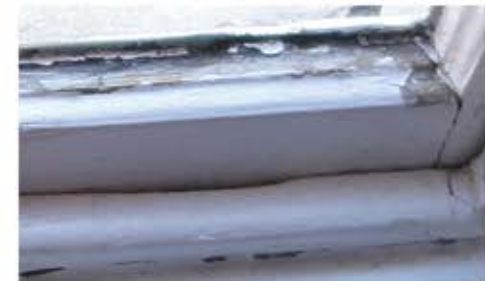
#25

Defects: gaps between panes and sliding sections, build up of paint hides crack and heavy old windows do not open for ventilation, broken timber parts along sliding track and broken sliding ropes

Joinery Fixing Option: sand down paint and new sliding mechanisms replaced, removal of whole window would be necessary

Draught-Proofing Option: repairs would have to be completed before adding draught-proofing to the sliding panels

uPVC Option: quickest option and would allow double glazing to be installed, style can be imitated to look exactly like the existing

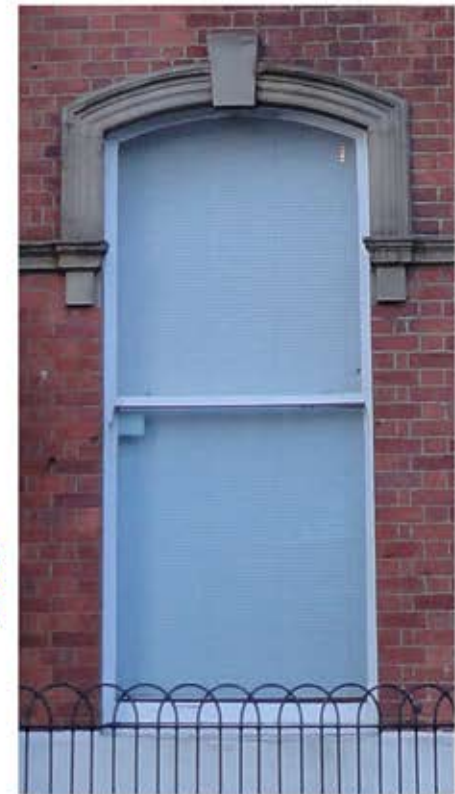
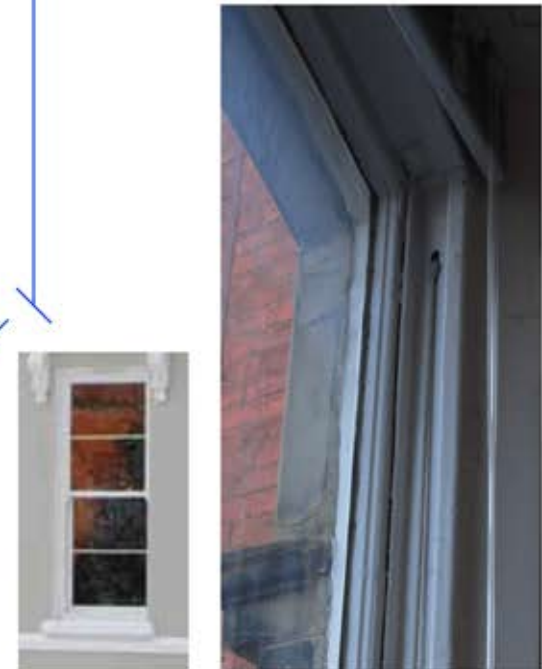
#26

Defects: gaps between panes and sliding sections, build up of paint hides crack and heavy old windows do not open for ventilation, broken timber parts along sliding track and broken sliding ropes

Joinery Fixing Option: sand down paint and new sliding mechanisms replaced, removal of whole window would be necessary

Draught-Proofing Option: repairs would have to be completed before adding draught-proofing to the sliding panels

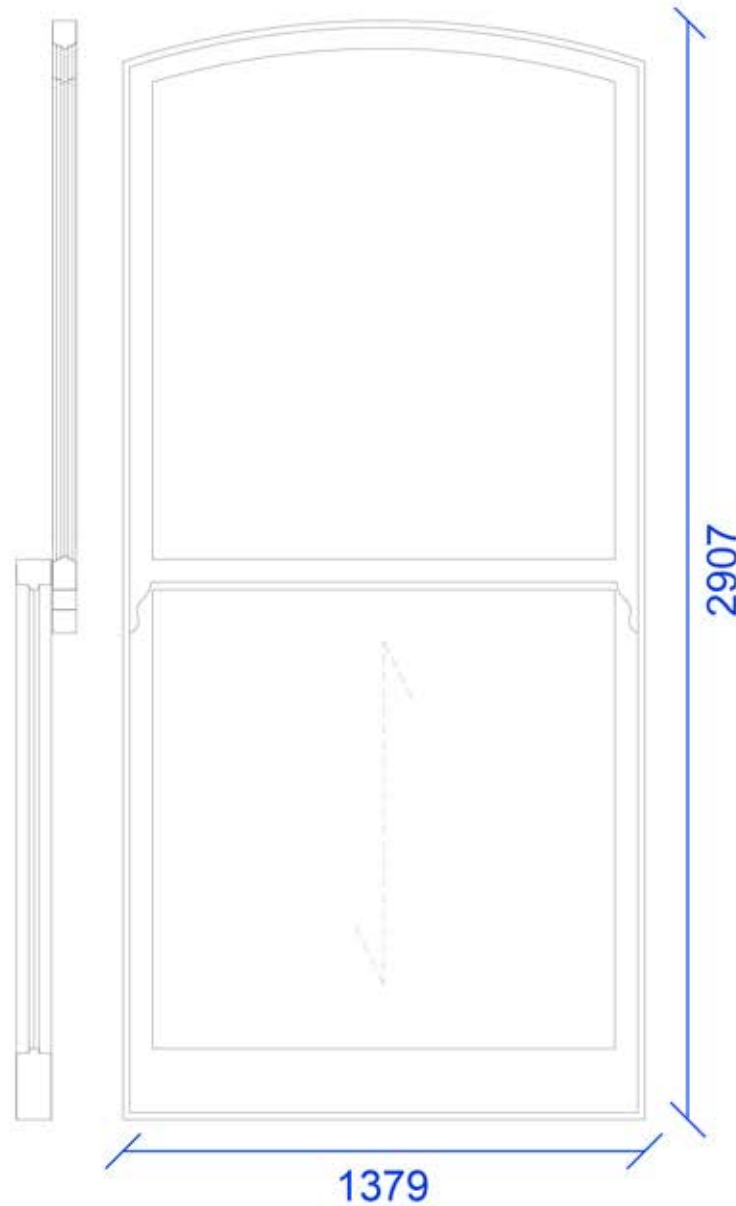
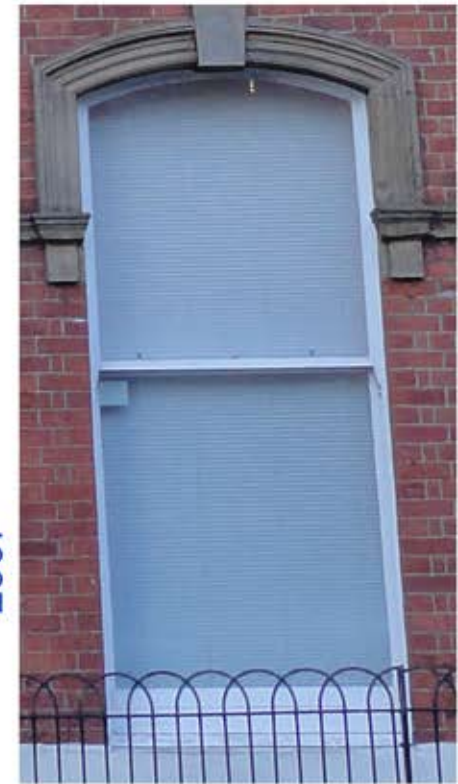
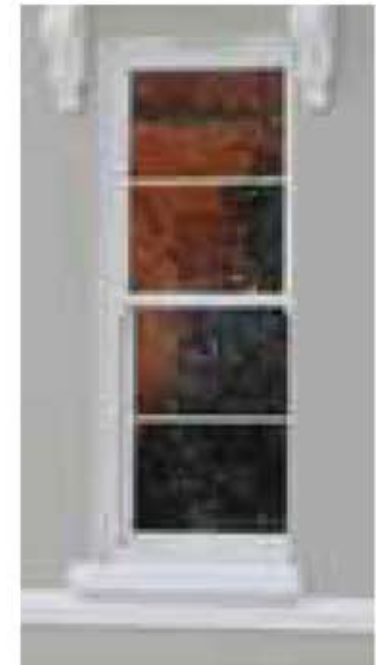
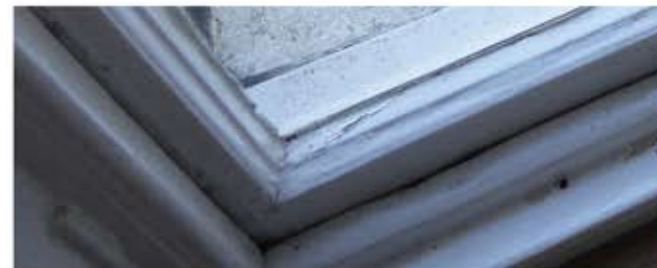
#27

Description: Non-bar floor to ceiling coupled sliding sash windows with sash horns with top arch

Defects: gaps between panes and sliding sections, build up of paint hides crack and heavy old windows do not open for ventilation, broken timber parts along sliding track and broken sliding ropes

Joinery Fixing Option: sand down paint and new sliding mechanisms replaced, removal of whole window would be necessary

Draught-Proofing Option: repairs would have to be completed before adding draught-proofing to the sliding panels

uPVC Option: quickest option and would allow double glazing to be installed, style can be imitated to look exactly like the existing

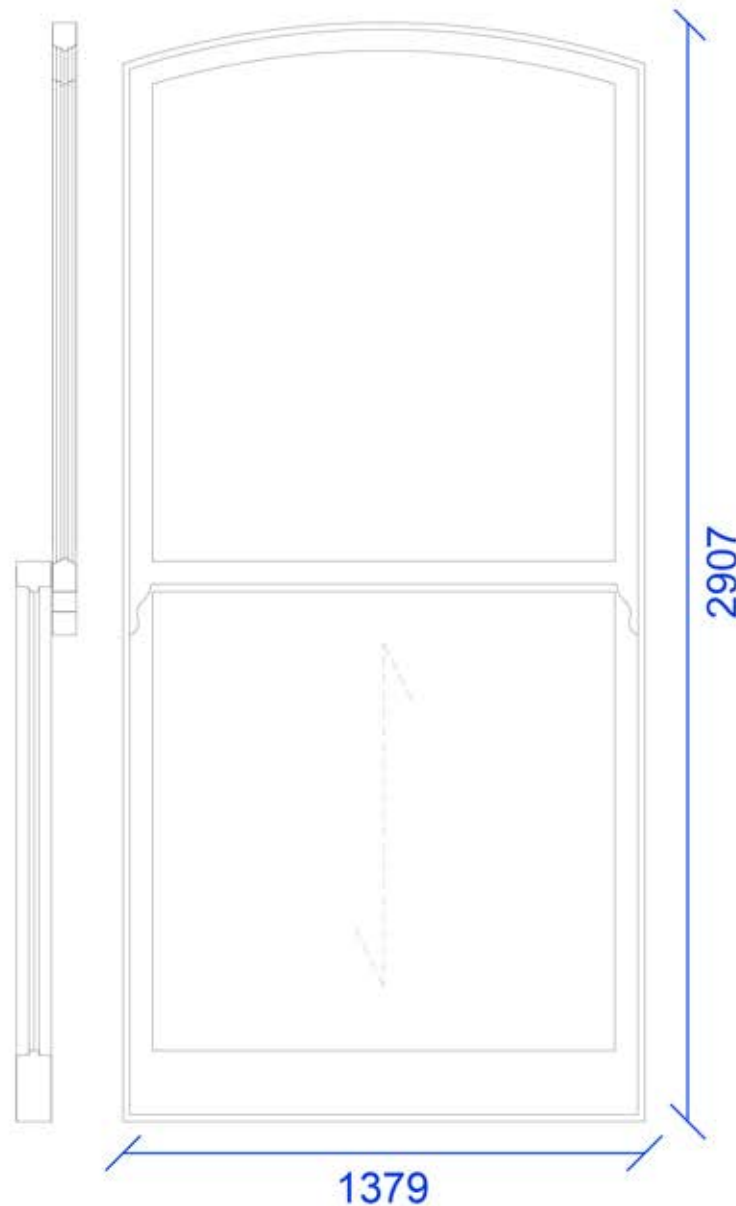
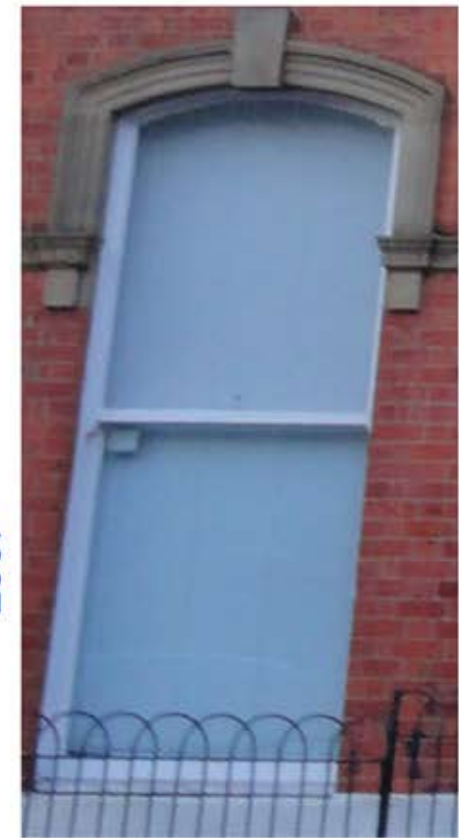
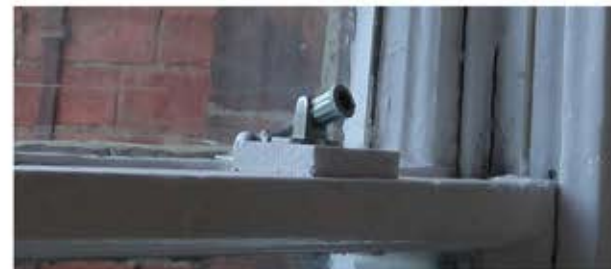
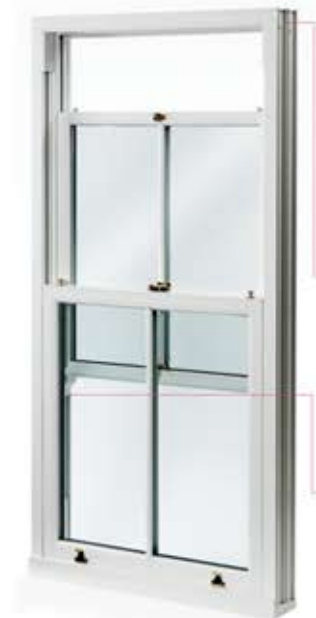
#28

Description: Non-bar floor to ceiling coupled sliding sash windows with sash horns with top arch

Defects: gaps between panes and sliding sections, build up of paint hides crack and heavy old windows do not open for ventilation, broken timber parts along sliding track and broken sliding ropes

Joinery Fixing Option: sand down paint and new sliding mechanisms replaced, removal of whole window would be necessary

Draught-Proofing Option: repairs would have to be completed before adding draught-proofing to the sliding panels

uPVC Option: quickest option and would allow double glazing to be installed, style can be imitated to look exactly like the existing

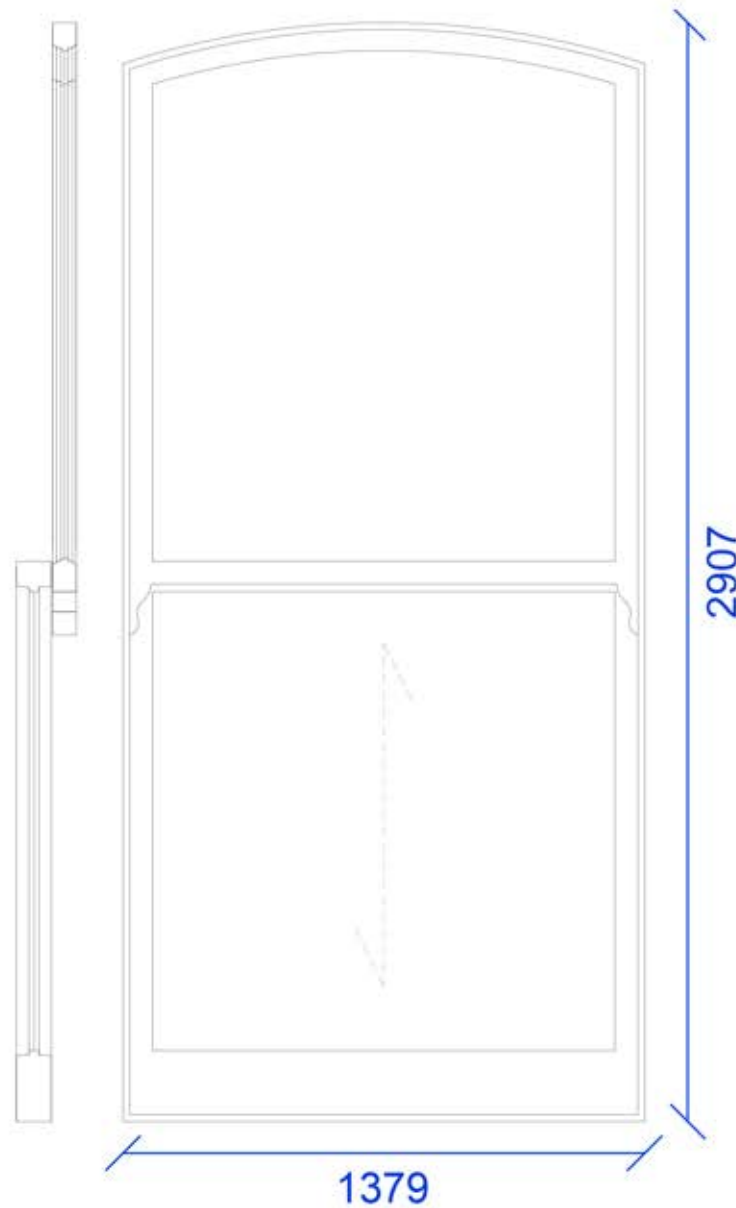
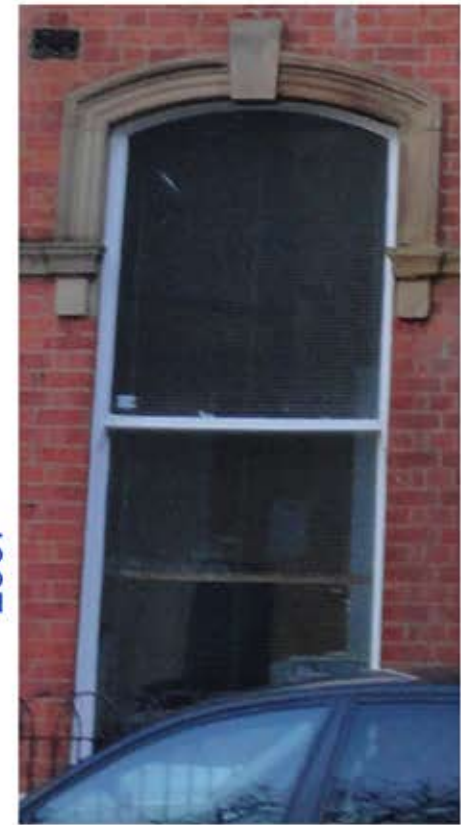
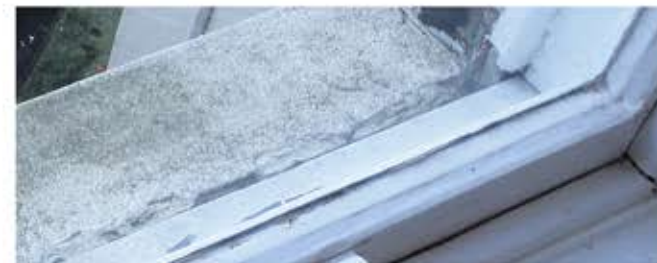
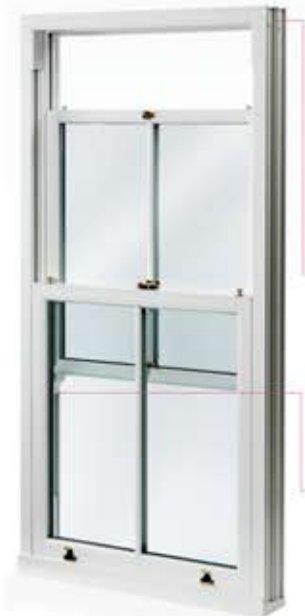
#29

Description: Non-bar floor to ceiling coupled sliding sash windows with sash horns with top arch

Defects: gaps between panes and sliding sections, build up of paint hides crack and heavy old windows do not open for ventilation, broken timber parts along sliding track and broken sliding ropes

Joinery Fixing Option: sand down paint and new sliding mechanisms replaced, removal of whole window would be necessary

Draught-Proofing Option: repairs would have to be completed before adding draught-proofing to the sliding panels

uPVC Option: quickest option and would allow double glazing to be installed, style can be imitated to look exactly like the existing

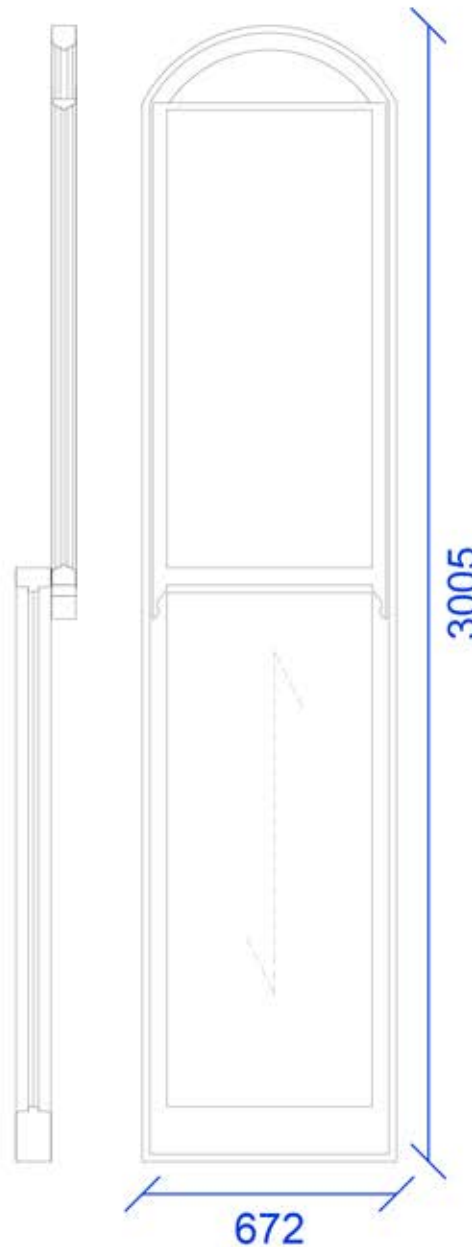
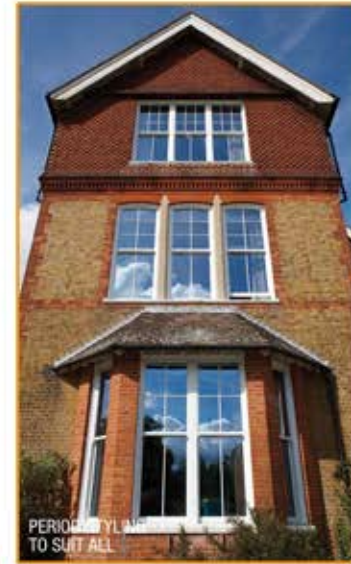
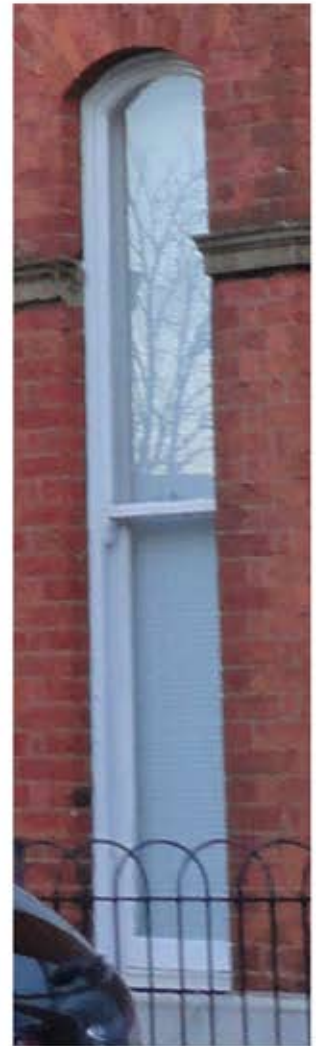
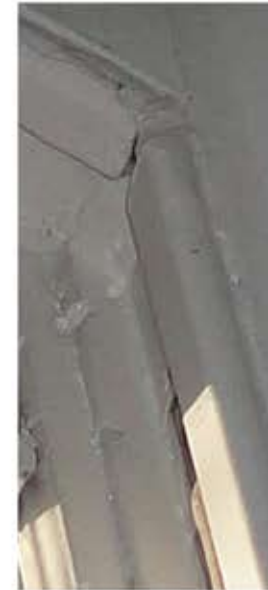
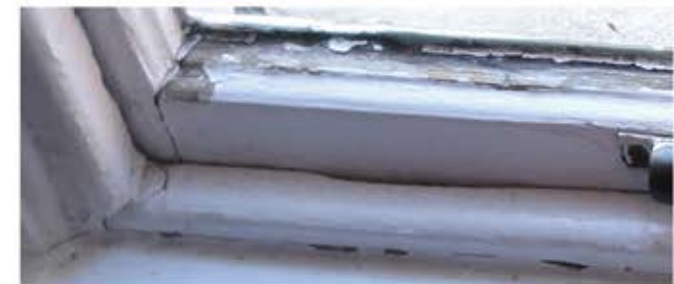
#30

Description: Non-bar floor to ceiling coupled sliding sash windows with sash horns with top arch

Defects: gaps between panes and sliding sections, build up of paint hides crack and heavy old windows do not open for ventilation, broken timber parts along sliding track and broken sliding ropes

Joinery Fixing Option: sand down paint and new sliding mechanisms replaced, removal of whole window would be necessary

Draught-Proofing Option: repairs would have to be completed before adding draught-proofing to the sliding panels

uPVC Option: quickest option and would allow double glazing to be installed, style can be imitated to look exactly like the existing

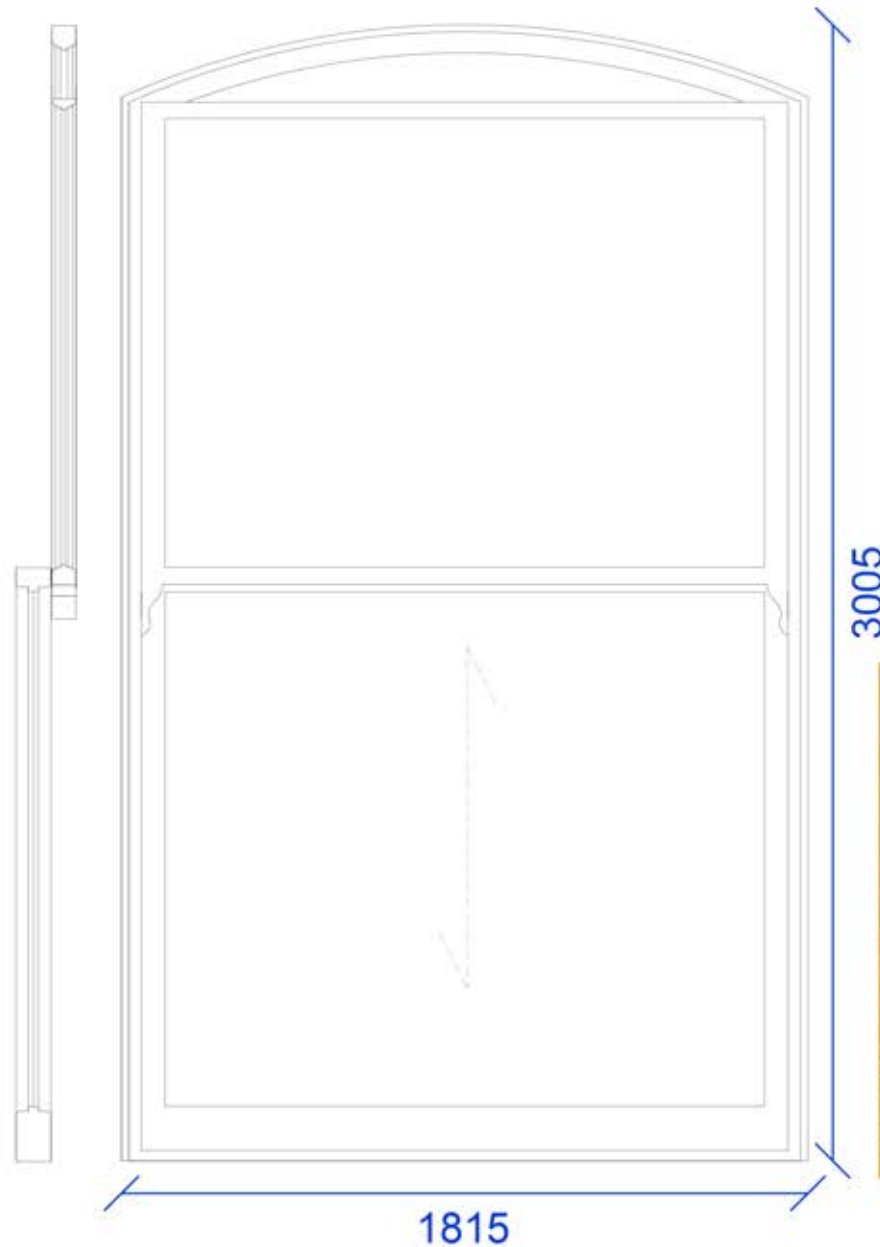
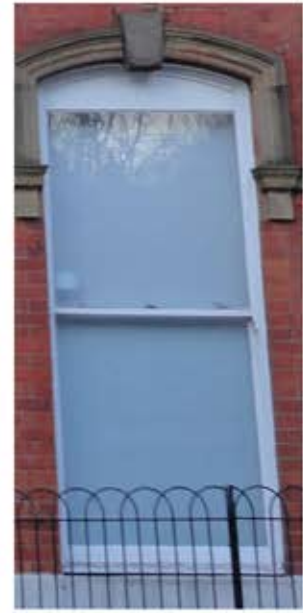
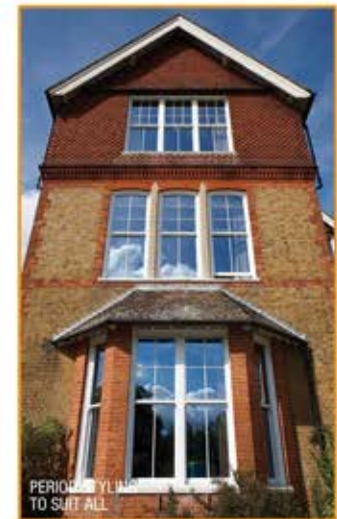
#31

Description: Non-bar floor to ceiling coupled sliding sash windows with sash horns with top arch

Defects: gaps between panes and sliding sections, build up of paint hides crack and heavy old windows do not open for ventilation, broken timber parts along sliding track and broken sliding ropes

Joinery Fixing Option: sand down paint and new sliding mechanisms replaced, removal of whole window would be necessary

Draught-Proofing Option: repairs would have to be completed before adding draught-proofing to the sliding panels

uPVC Option: quickest option and would allow double glazing to be installed, style can be imitated to look exactly like the existing

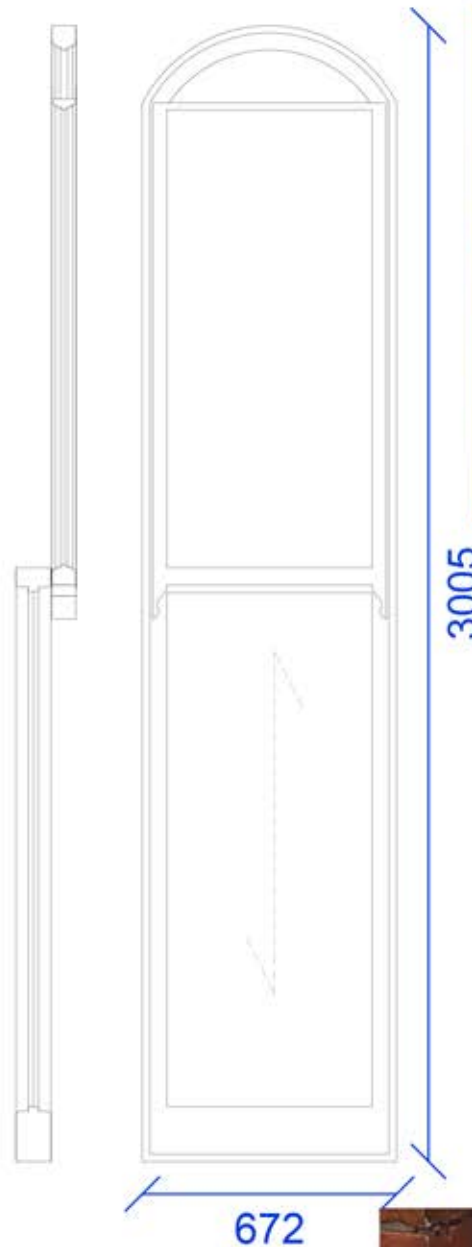
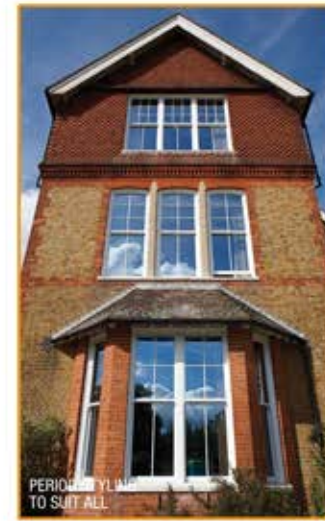
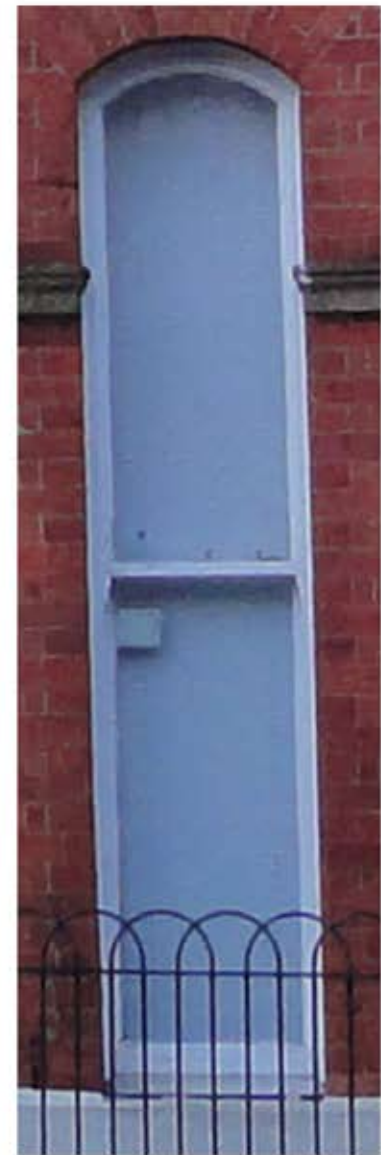
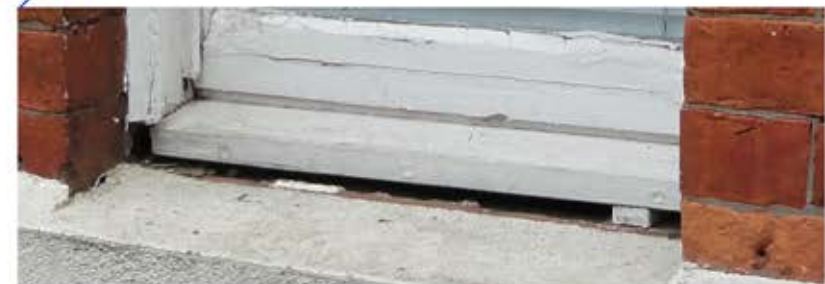
#32

Description: Non-bar floor to ceiling coupled sliding sash windows with sash horns

Defects: gaps between panes and sliding sections, build up of paint hides crack and heavy old windows do not open for ventilation, broken timber parts along sliding track and broken sliding ropes

Joinery Fixing Option: sand down paint and new sliding mechanisms replaced, removal of whole window would be necessary

Draught-Proofing Option: repairs would have to be completed before adding draught-proofing to the sliding panels

uPVC Option: quickest option and would allow double glazing to be installed, style can be imitated to look exactly like the existing

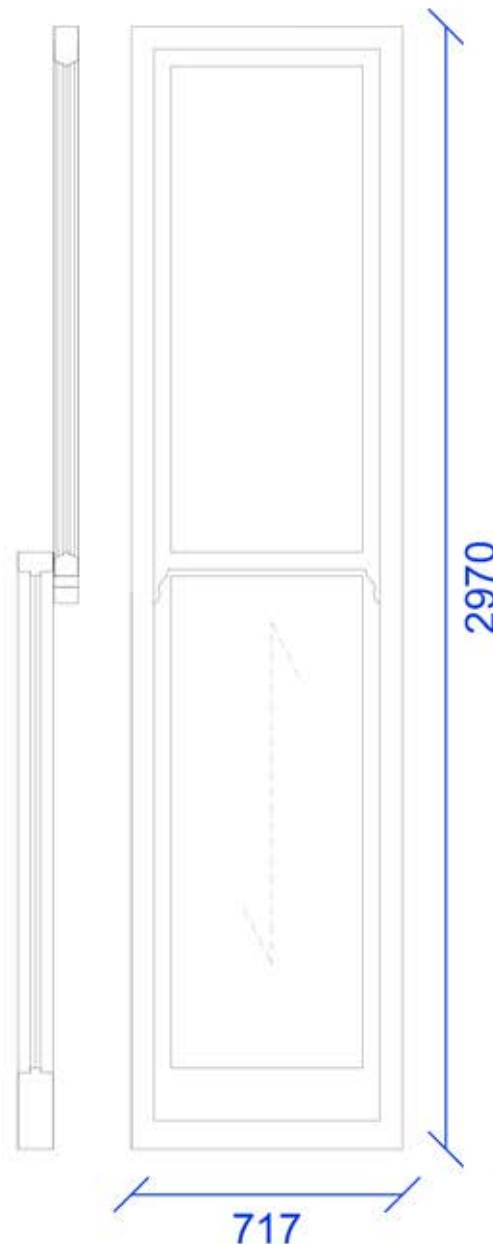
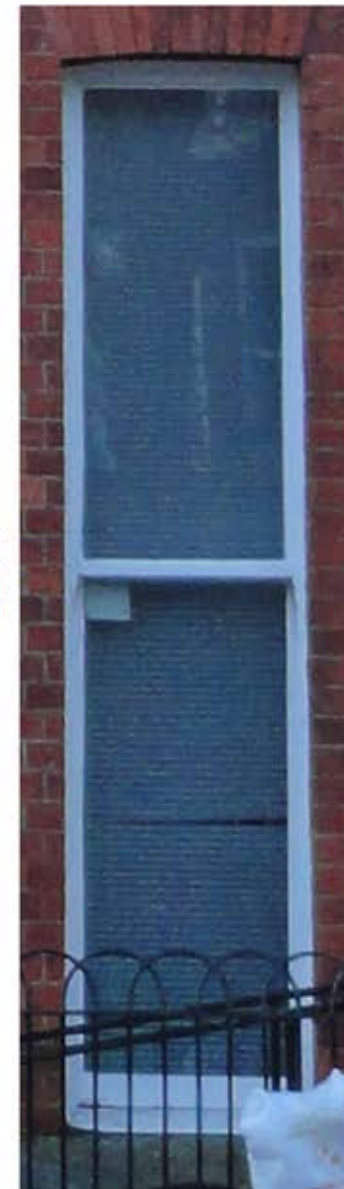
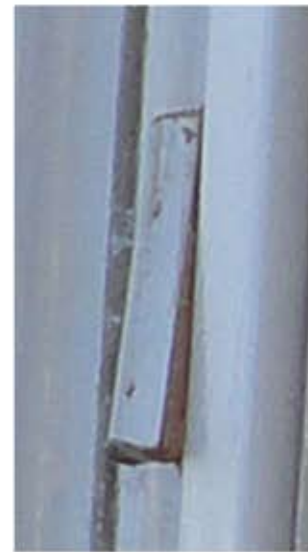
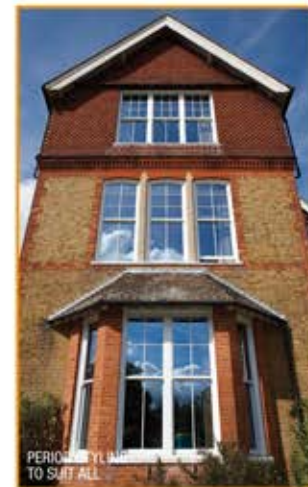
#33

Description: Non-bar floor to ceiling coupled sliding sash windows with sash horns

Defects: gaps between panes and sliding sections, build up of paint hides crack and heavy old windows do not open for ventilation, broken timber parts along sliding track and broken sliding ropes

Joinery Fixing Option: sand down paint and new sliding mechanisms replaced, removal of whole window would be necessary

Draught-Proofing Option: repairs would have to be completed before adding draught-proofing to the sliding panels

uPVC Option: quickest option and would allow double glazing to be installed, style can be imitated to look exactly like the existing

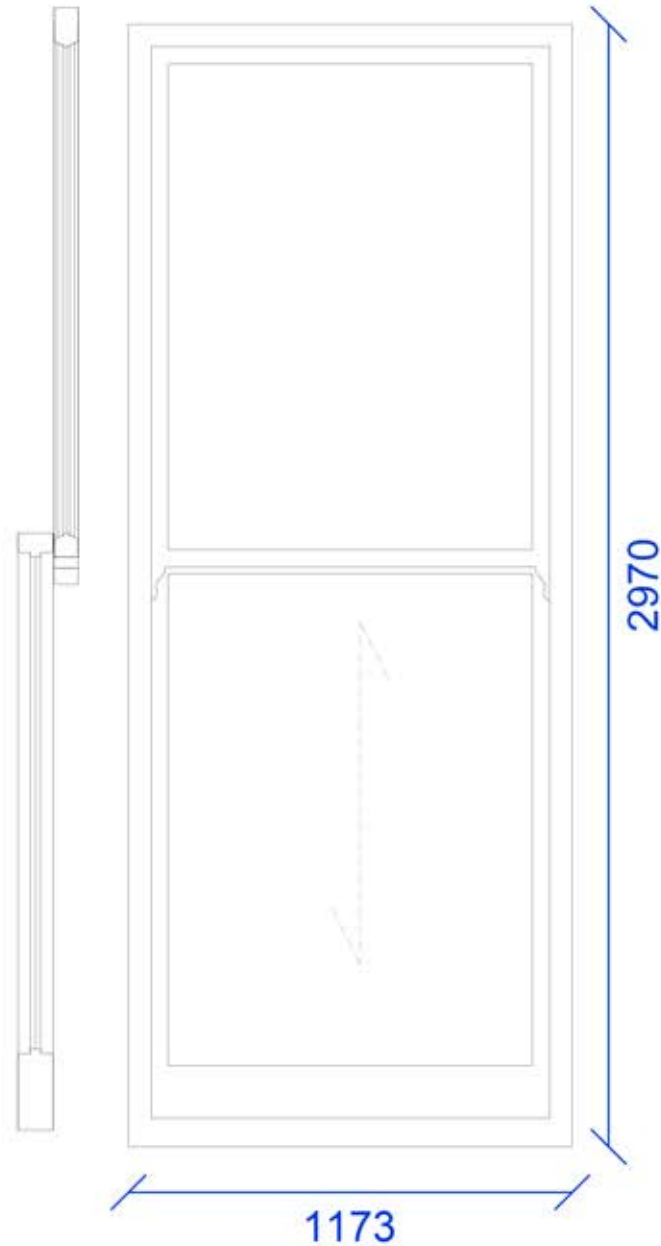
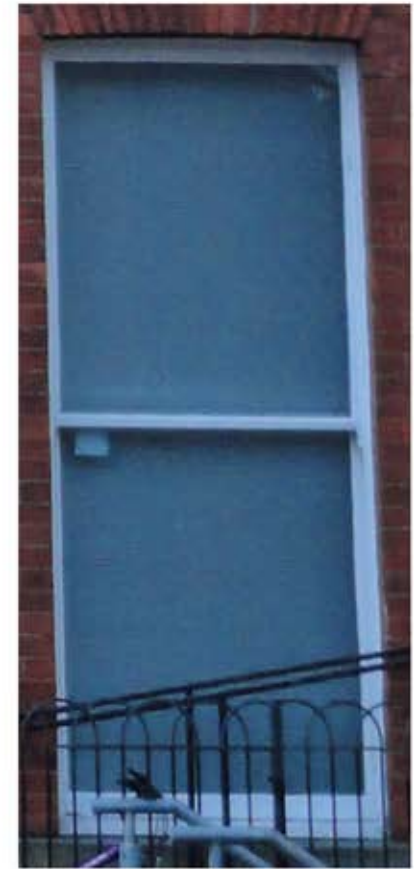
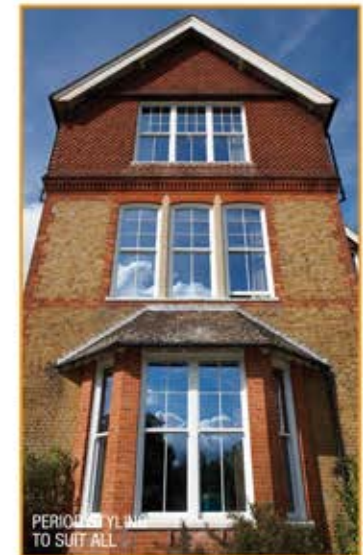
#34

Description: Non-bar floor to ceiling coupled sliding sash windows with sash horns

Defects: gaps between panes and sliding sections, build up of paint hides crack and heavy old windows do not open for ventilation, broken timber parts along sliding track and broken sliding ropes

Joinery Fixing Option: sand down paint and new sliding mechanisms replaced, removal of whole window would be necessary

Draught-Proofing Option: repairs would have to be completed before adding draught-proofing to the sliding panels

uPVC Option: quickest option and would allow double glazing to be installed, style can be imitated to look exactly like the existing

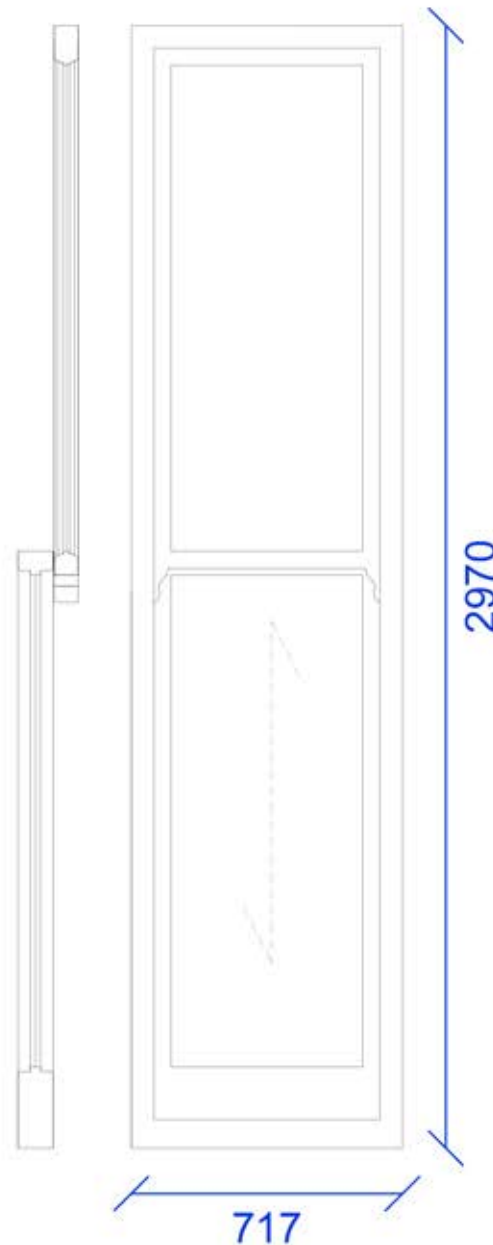
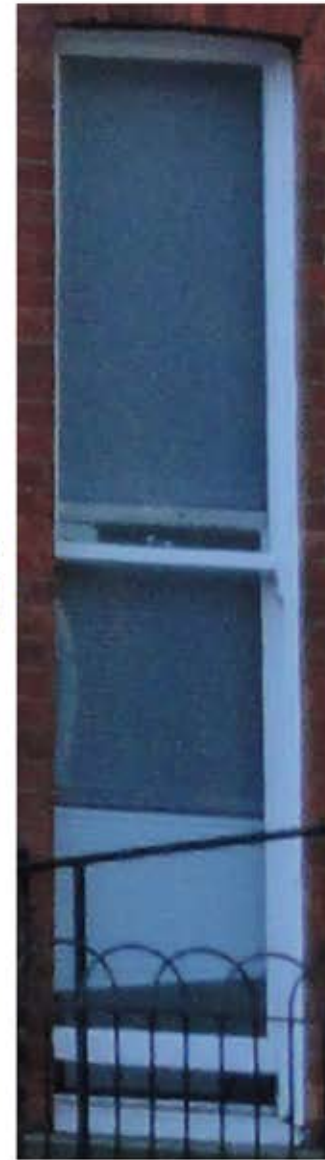
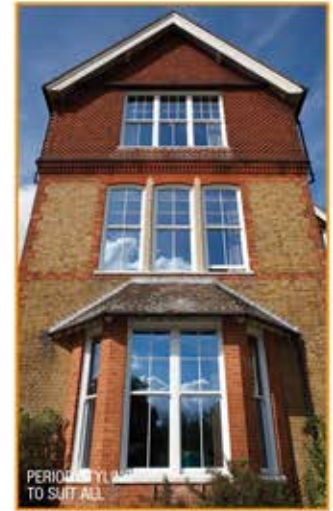
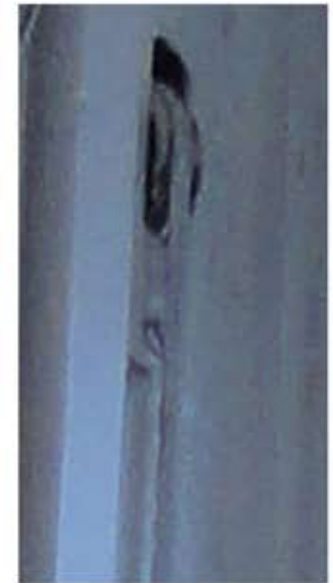
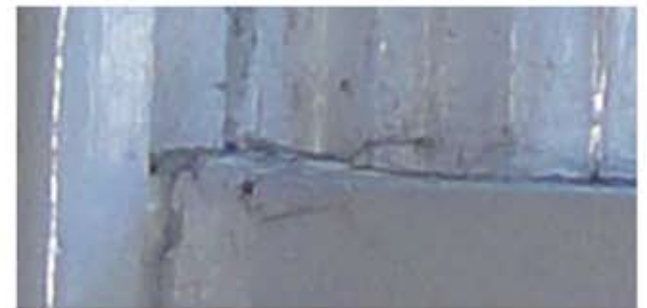
#35

Description: Non-bar floor to ceiling coupled sliding sash windows with sash horns

Defects: gaps between panes and sliding sections, build up of paint hides crack and heavy old windows do not open for ventilation, broken timber parts along sliding track and broken sliding ropes

Joinery Fixing Option: sand down paint and new sliding mechanisms replaced, removal of whole window would be necessary

Draught-Proofing Option: repairs would have to be completed before adding draught-proofing to the sliding panels

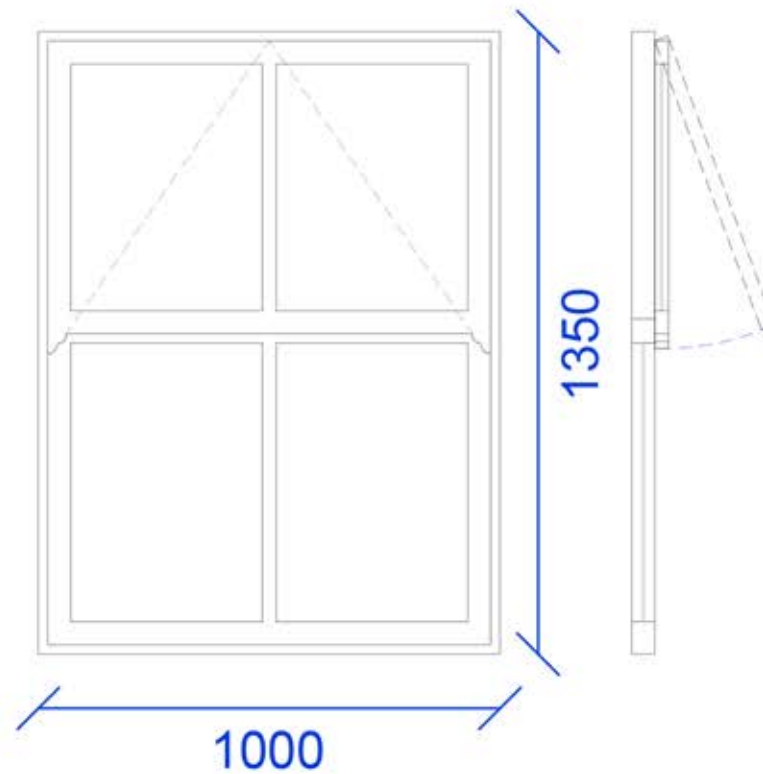
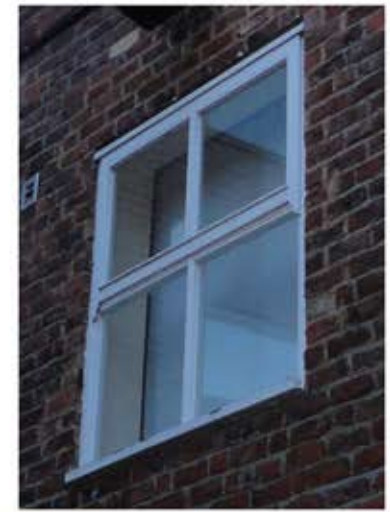
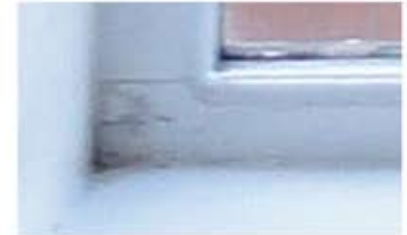
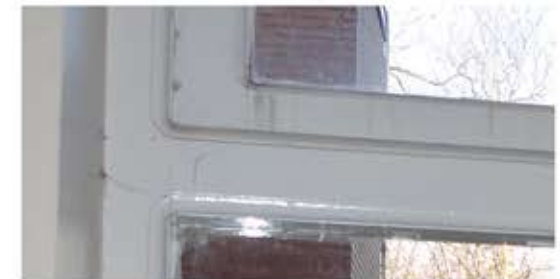
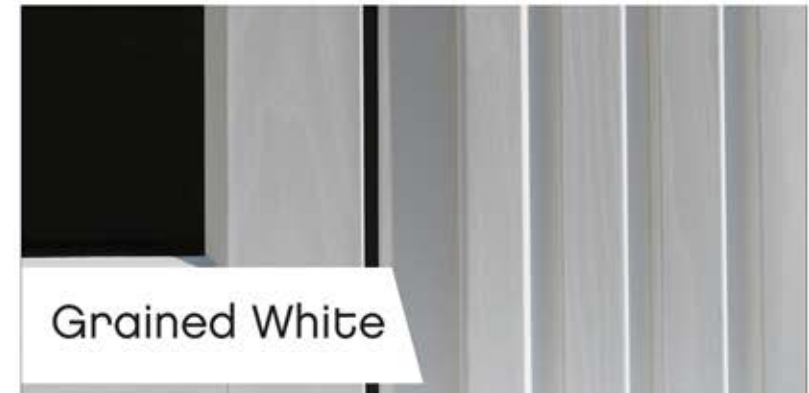
#36

Defects: cracked timber frame, mould and fungus are growing into frame, gaps around top hung panel letting out heat and letting moisture in

Joinery Fixing Option: all cracked timber frames to be replaced

Draught-Proofing Option: repairs would have to be completed before adding draught-proofing to the openings

uPVC Option: quickest option and would allow double glazing to be installed, style can be imitated to look exactly like the existing

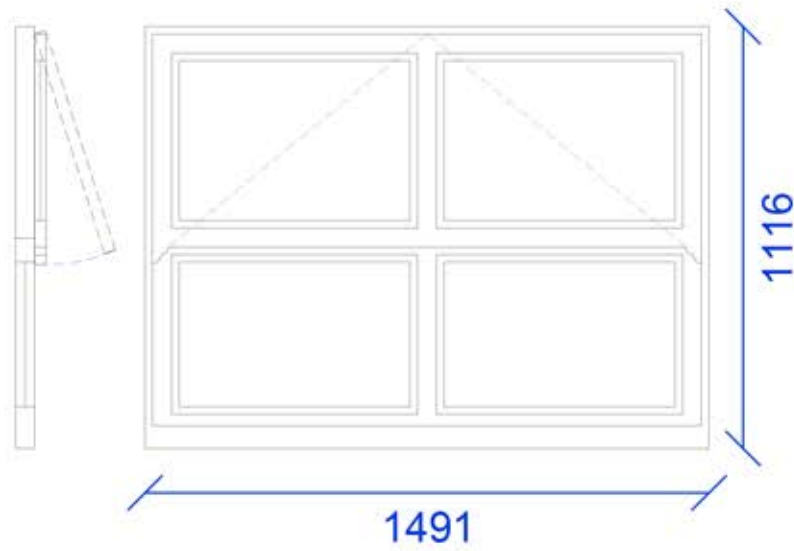
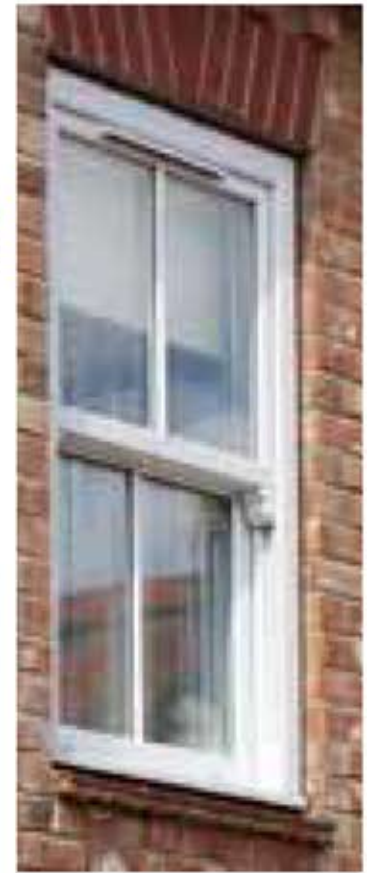
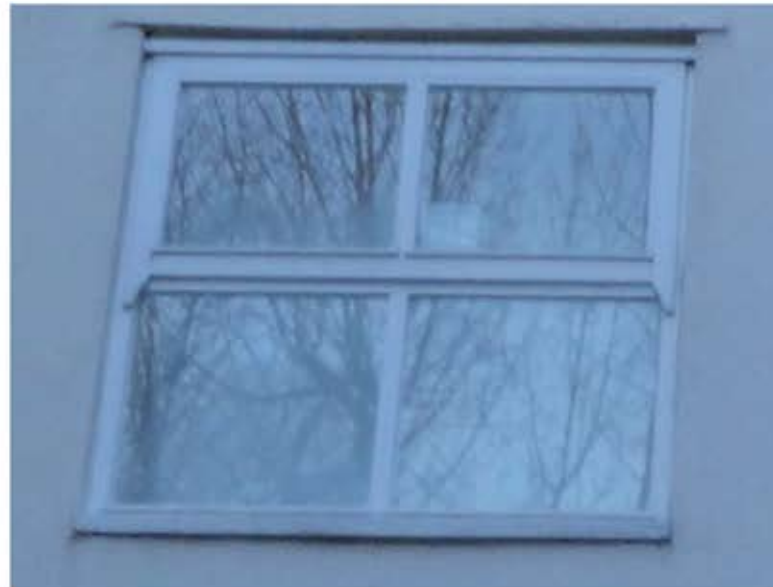
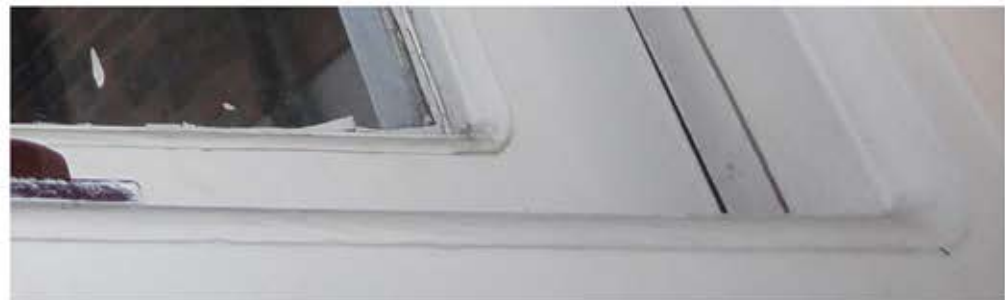
#37

Description: Top hung casement window, top half opening, styled to match sash windows with central bars and sash horns.

Defects: cracked timber frame, mould and fungus are growing into frame, gaps around top hung panel letting out heat and letting moisture in

Joinery Fixing Option: all cracked timber frames to be replaced

Draught-Proofing Option: repairs would have to be completed before adding draught-proofing to the openings

uPVC Option: quickest option and would allow double glazing to be installed, style can be imitated to look exactly like the existing

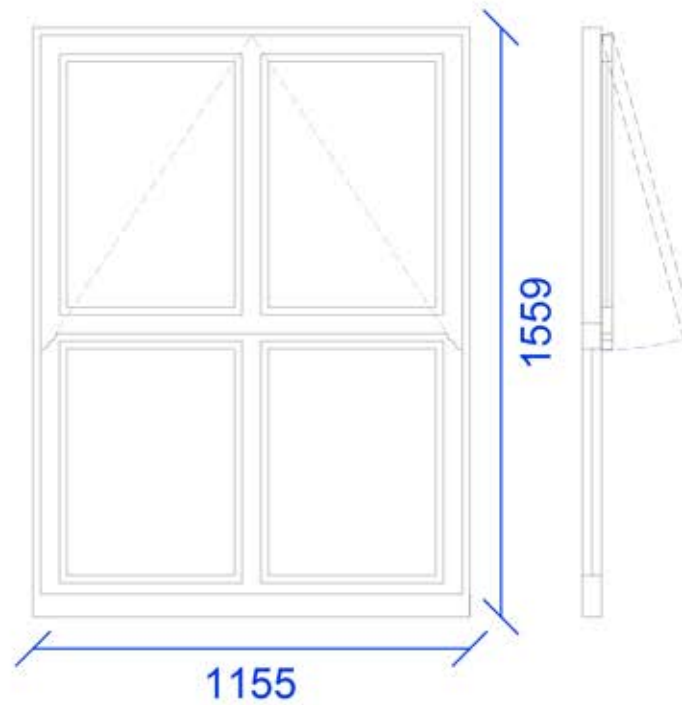
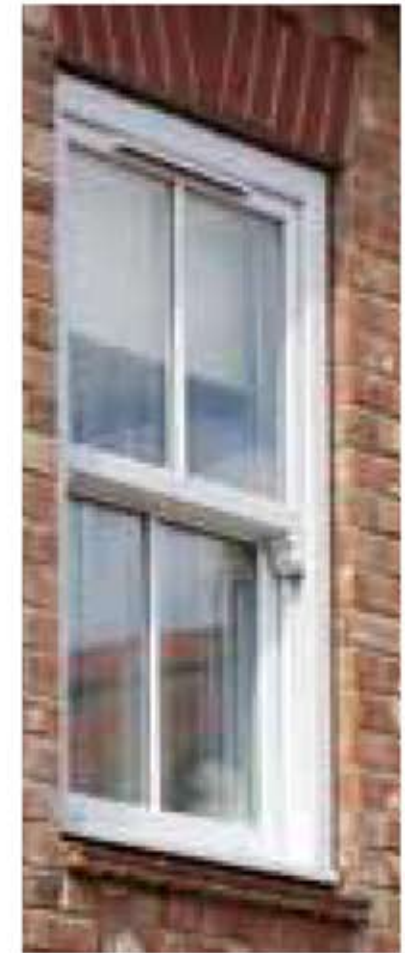
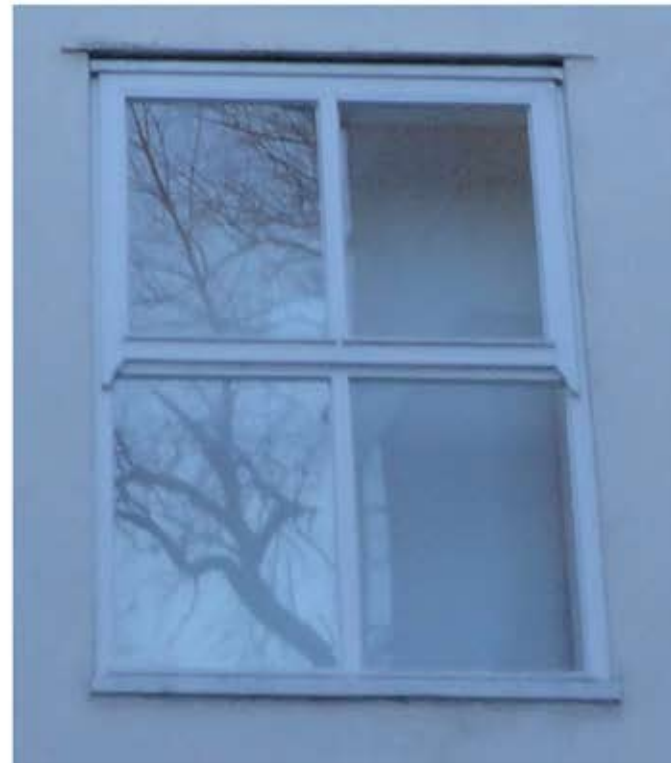
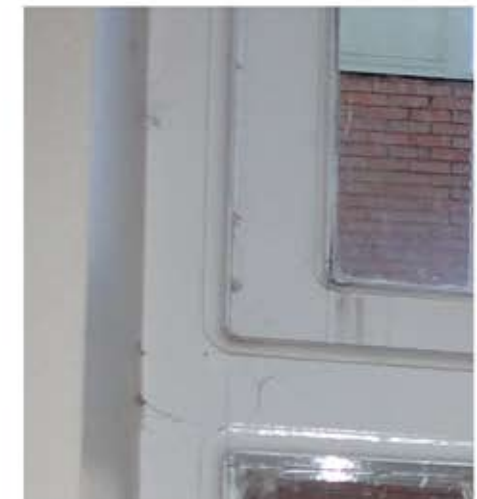
#38

Description: Top hung casement window, top half opening, styled to match sash windows with central bars and sash horns.

Defects: mould and fungus growing in and around frame, gaps around top hung panel letting out heat and letting moisture in

Joinery Fixing Option: all rotten timber frames to be replaced

Draught-Proofing Option: repairs would have to be completed before adding draught-proofing to the openings

uPVC Option: quickest option and would allow double glazing to be installed, style can be imitated to look exactly like the existing
