Daisybank Villas
5-7 Anson Road
Manchester
M14 5BR

Window Replacement
Justification

May 2018

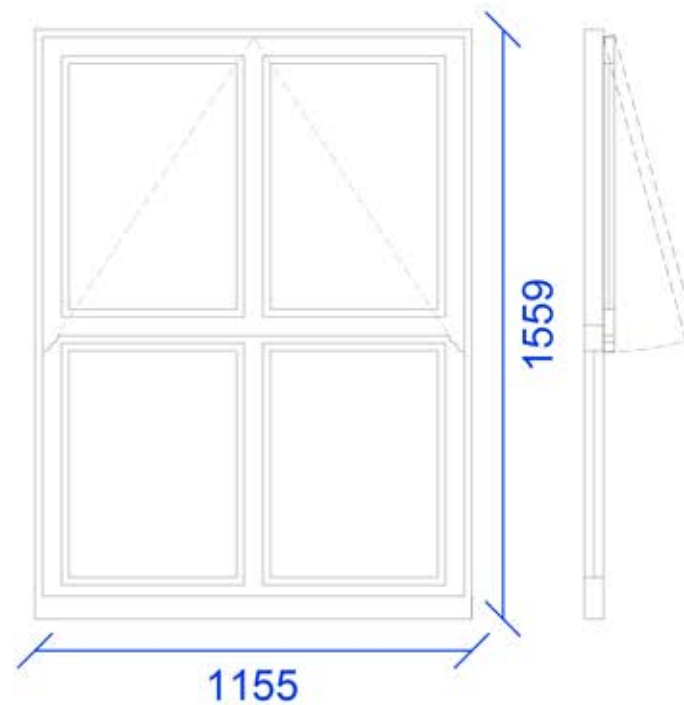
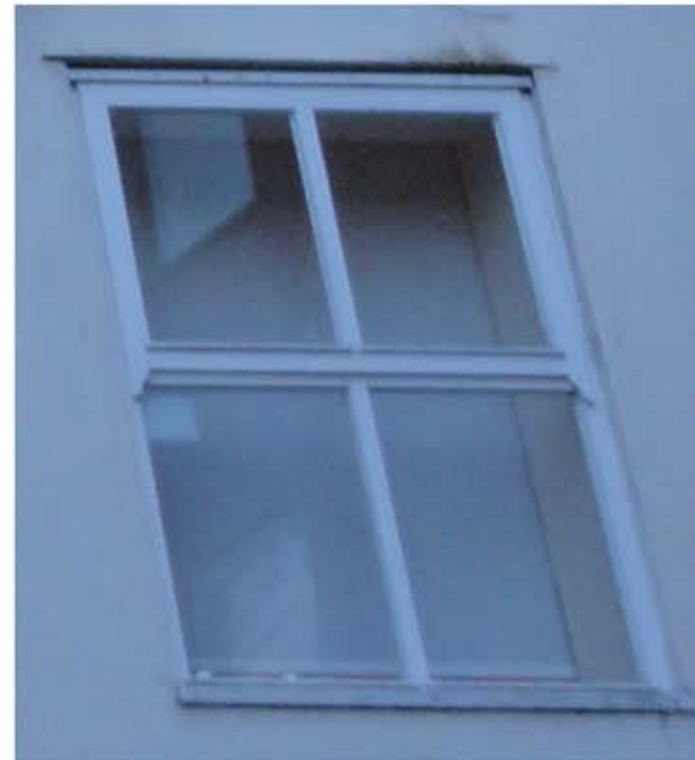
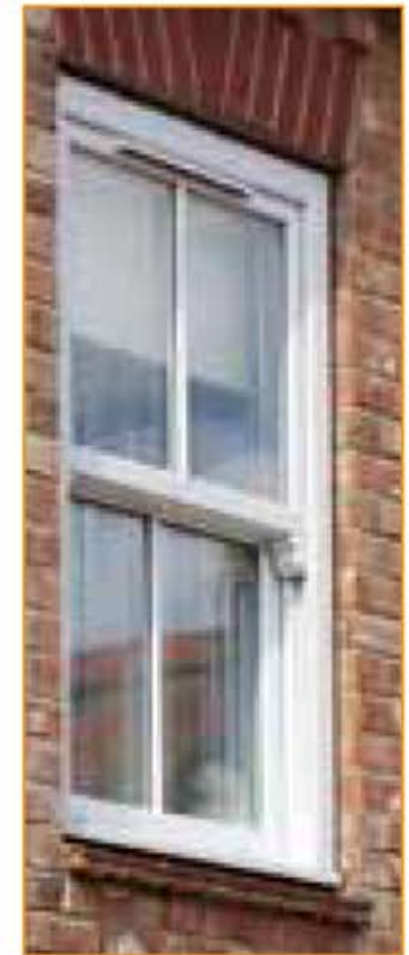
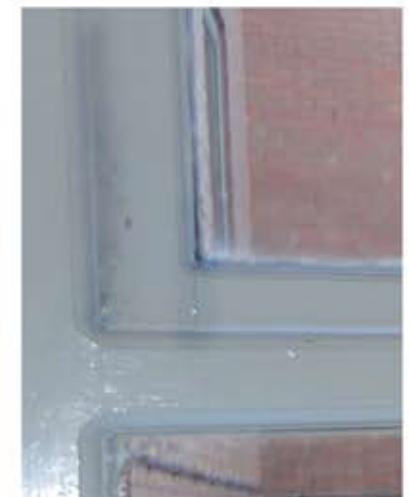
#39

Description: Top hung casement window, top half opening, styled to match sash windows with central bars and sash horns.

Defects: no seals present, no vent fitted allowing heat to escape, gaps around window and wall

Draught-Proofing Option: repairs would have to be completed before adding draught-proofing to the openings

uPVC Option: quickest option and would allow double glazing to be installed, style can be imitated to look exactly like the existing

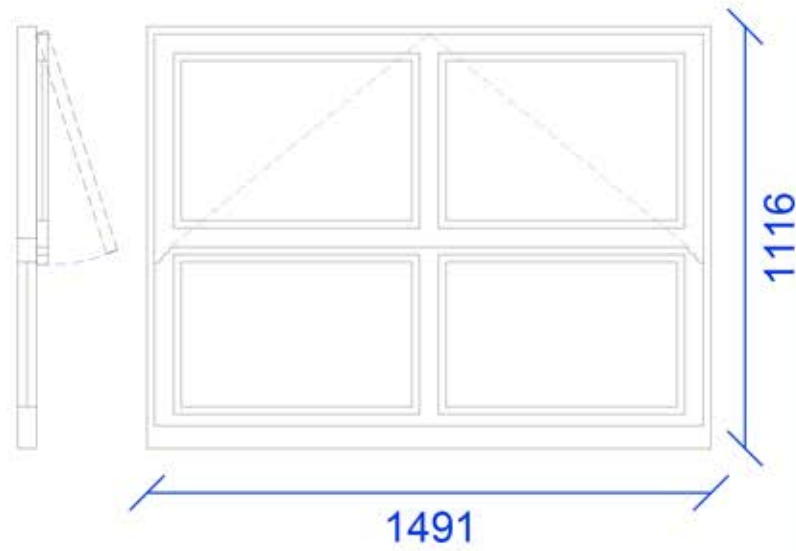
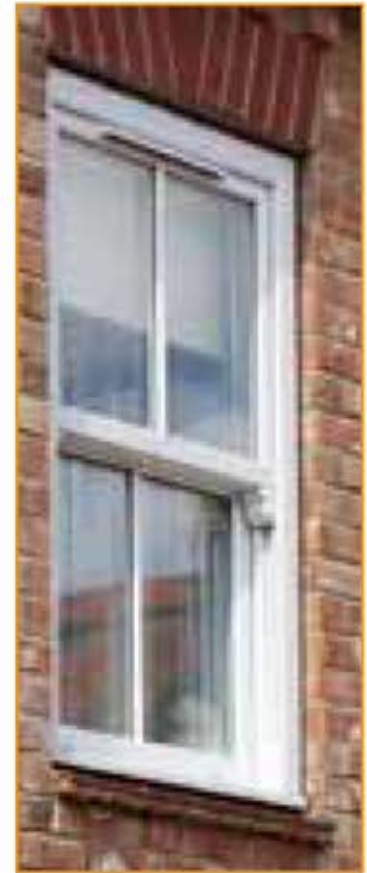
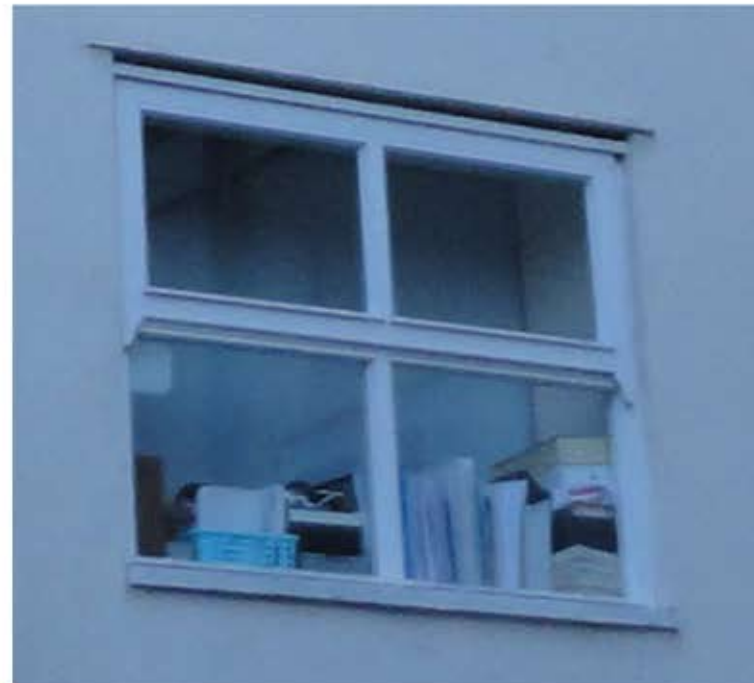
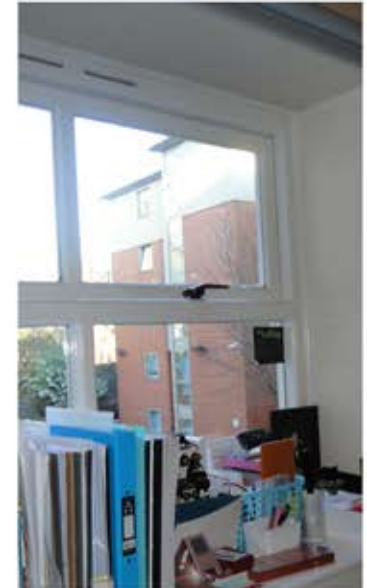
#40

Description: Top hung casement window, top half opening, styled to match sash windows with central bars and sash horns.

Defects: difficulty shutting top hung panel due to damage to hinges, mould growing into the frame around the single glazing

Draught-Proofing Option: repairs would have to be completed before adding draught-proofing to the openings

uPVC Option: quickest option and would allow double glazing to be installed, style can be imitated to look exactly like the existing

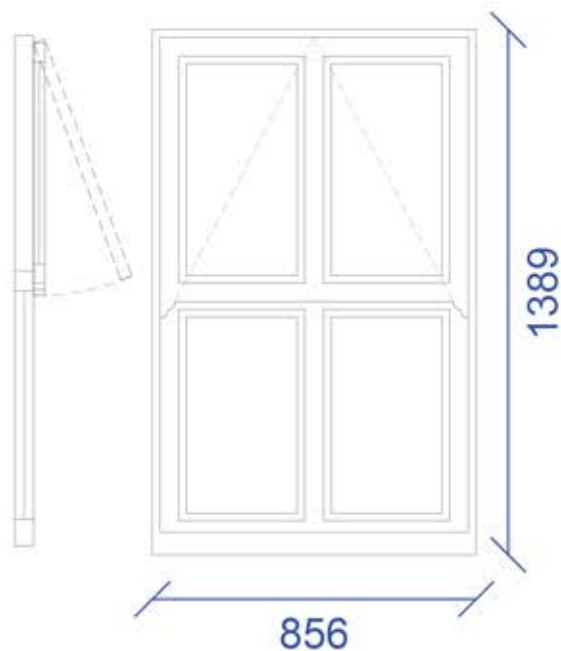
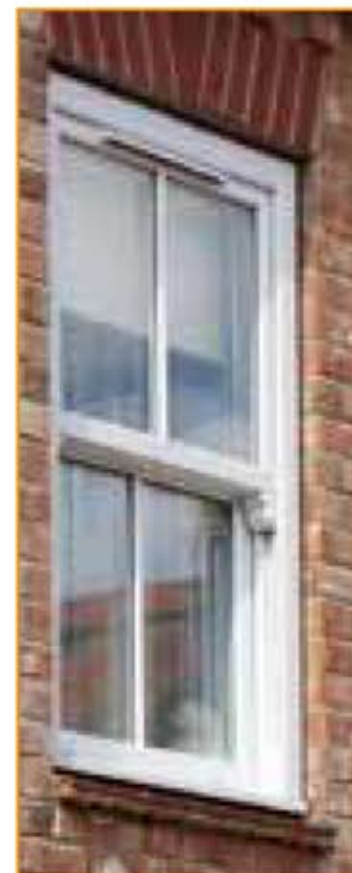
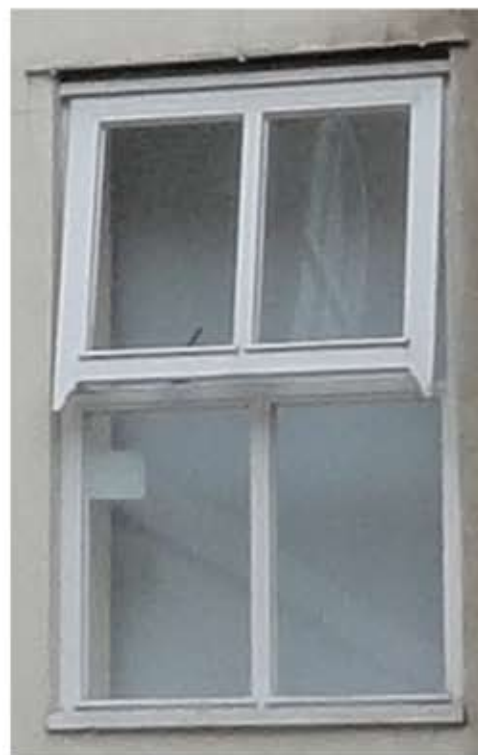
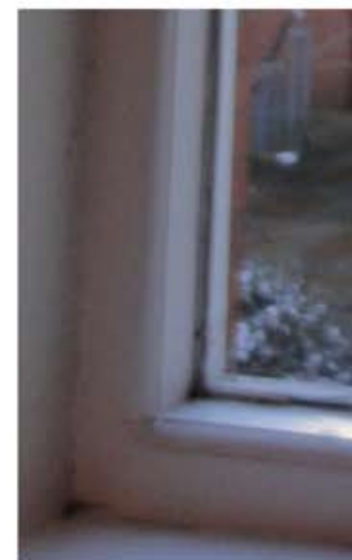
#41

Defects: difficulty shutting top hung panel due to damage to hinges, mould growing into the frame around the single glazing

Joinery Fixing Option: fill in gaps around the outside, replace rotten timber pieces

Draught-Proofing Option: repairs would have to be completed before adding draught-proofing to the openings

uPVC Option: quickest option and would allow double glazing to be installed, style can be imitated to look exactly like the existing

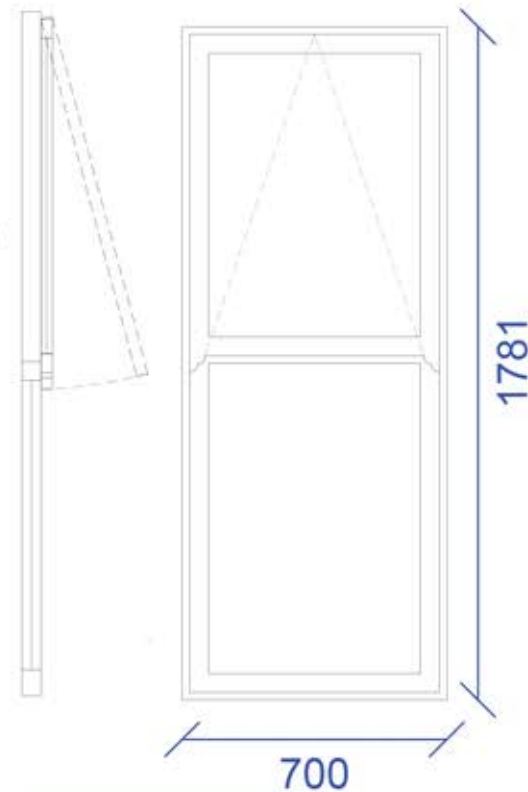
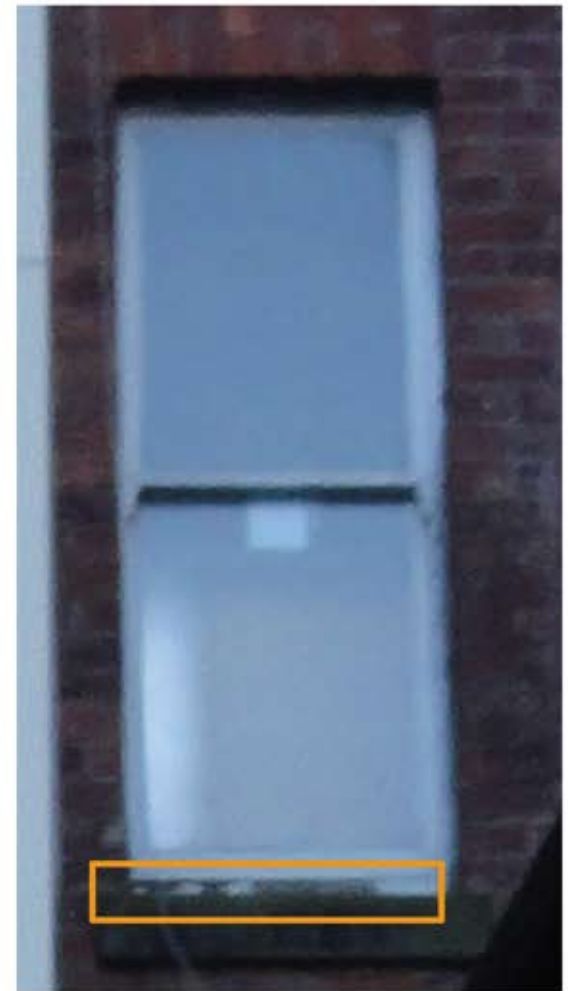
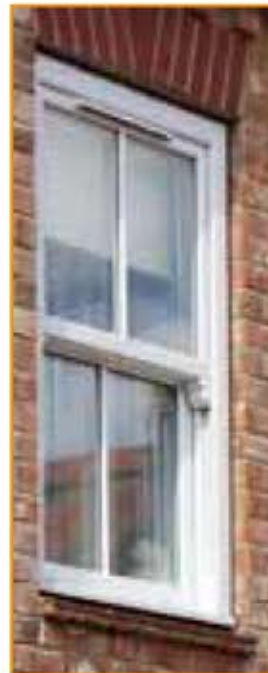
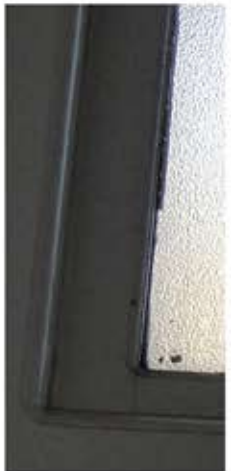
#42

Description: Centre-bar sliding sash windows with sash horns and swept arch

Defects: gaps between panes and sliding sections, build up of paint hides crack and heavy old windows do not open for ventilation, broken timber parts along sliding track and broken sliding ropes

Joinery Fixing Option: sand down paint and new sliding mechanisms replaced, removal of whole window would be necessary

Draught-Proofing Option: repairs would have to be completed before adding draught-proofing to the sliding panels

uPVC Option: quickest option and would allow double glazing to be installed, style can be imitated to look exactly like the existing

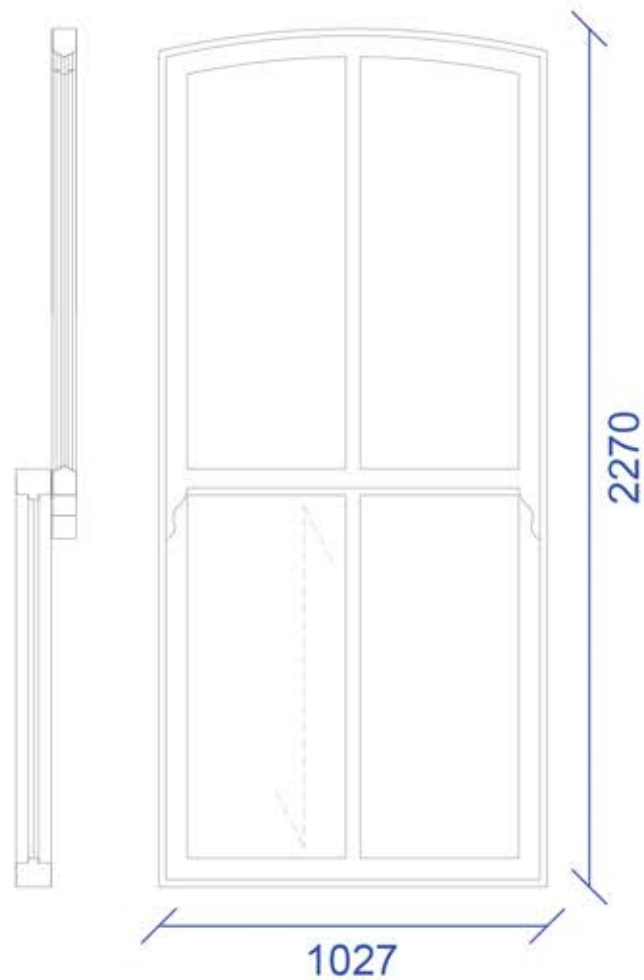
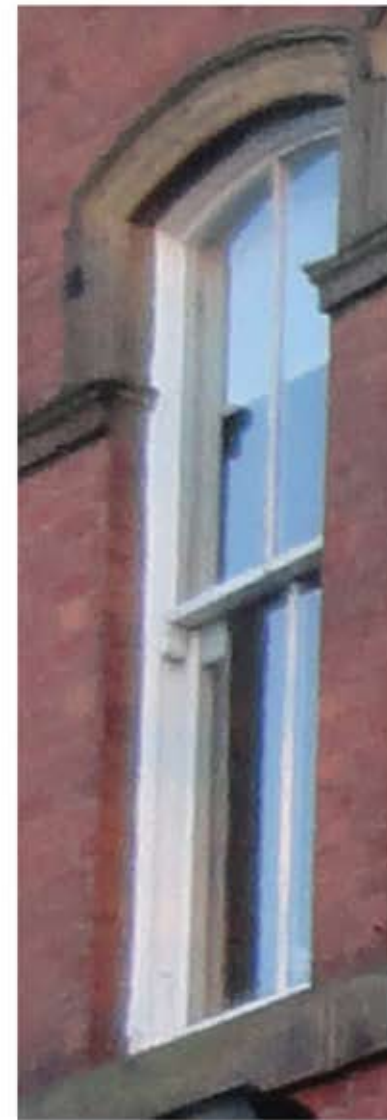
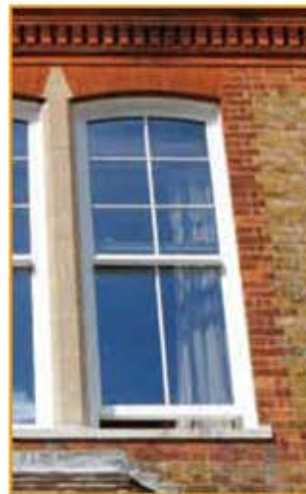
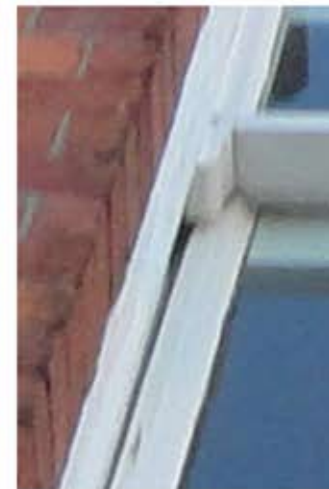
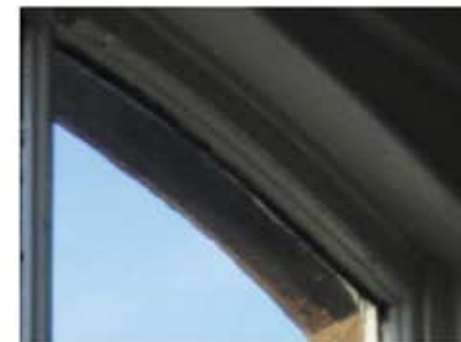
#43

Description: Centre-bar sliding sash windows with sash horns and swept arch

Defects: gaps between panes and sliding sections, build up of paint hides crack and heavy old windows do not open for ventilation, broken timber parts along sliding track and broken sliding ropes

Joinery Fixing Option: sand down paint and new sliding mechanisms replaced, removal of whole window would be necessary

Draught-Proofing Option: repairs would have to be completed before adding draught-proofing to the sliding panels

uPVC Option: quickest option and would allow double glazing to be installed, style can be imitated to look exactly like the existing

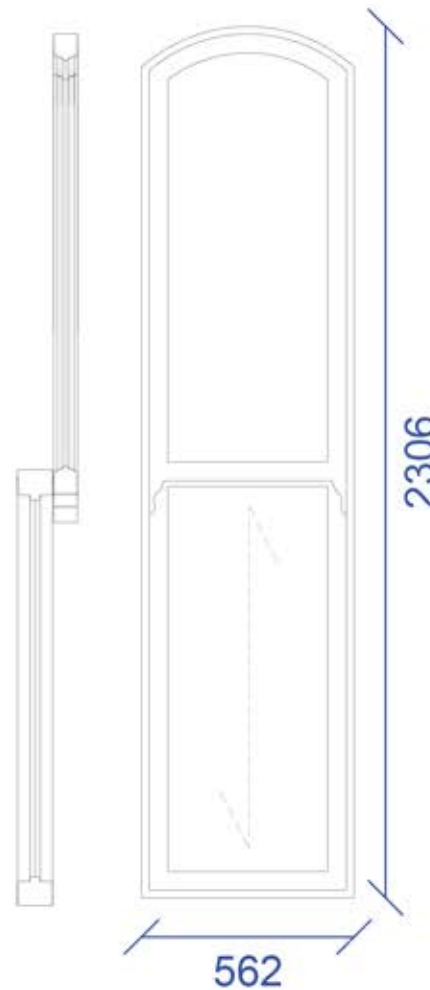
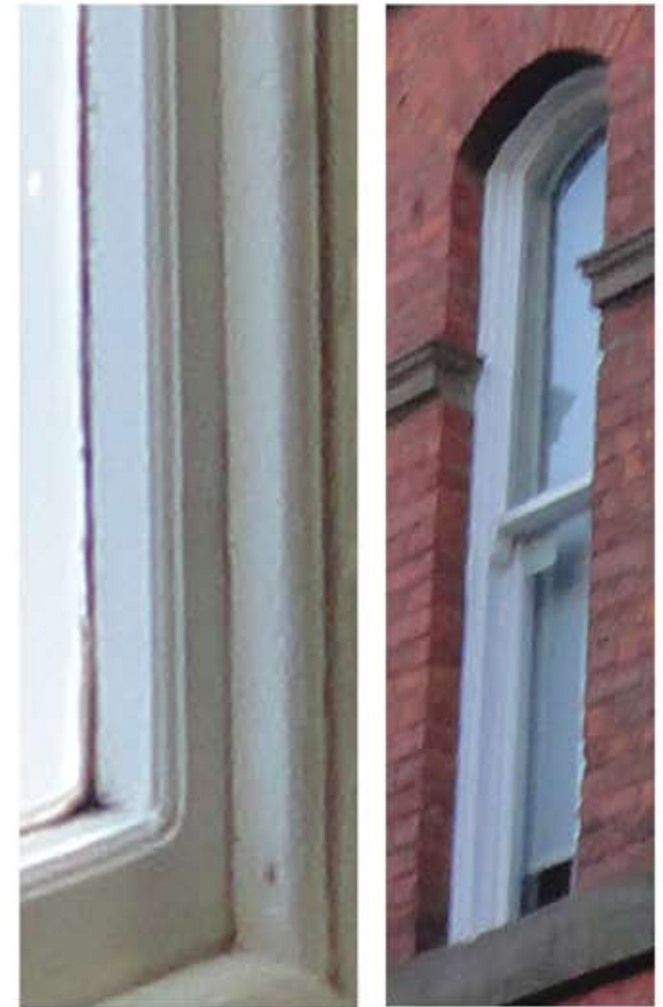
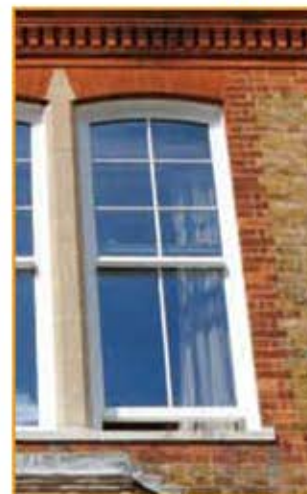
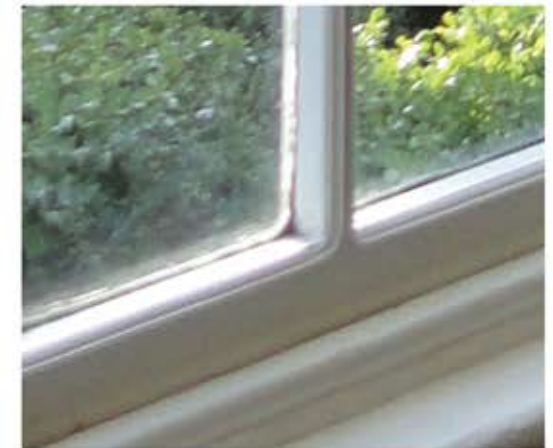
#46

Description: Center-bar sliding sash windows with sash horns and swept arch

Defects: gaps between panes and sliding sections, build up of paint hides crack and heavy old windows difficult to open for ventilation, broken timber parts along sliding track

Joinery Fixing Option: sand down paint and new sliding mechanisms replaced, removal of whole window would be necessary

Draught-Proofing Option: repairs would have to be completed before adding draught-proofing to the sliding panels

uPVC Option: quickest option and would allow double glazing to be installed, style can be imitated to look exactly like the existing

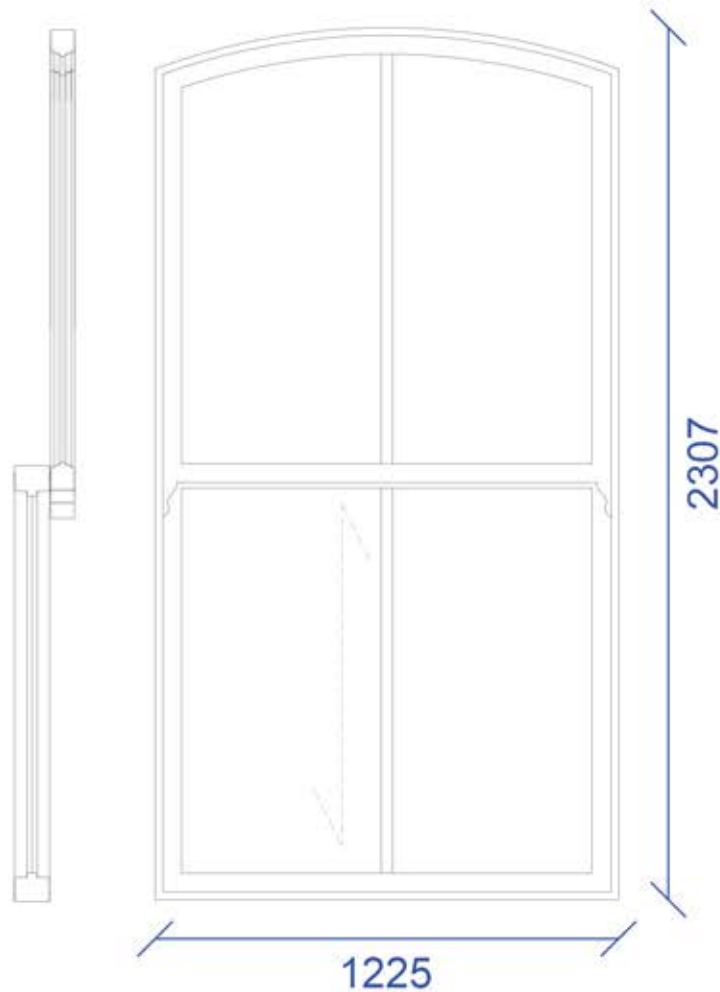
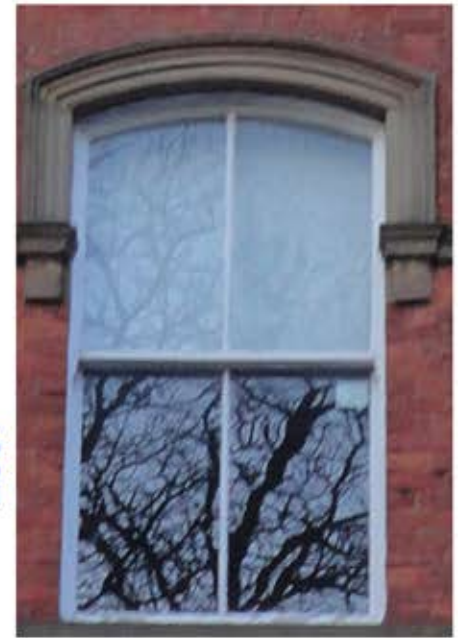
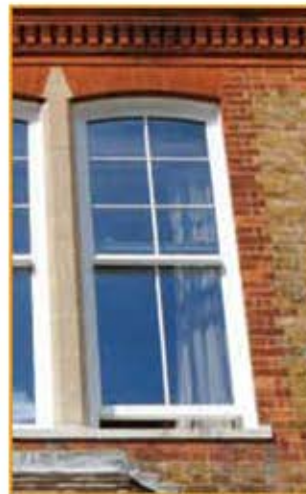
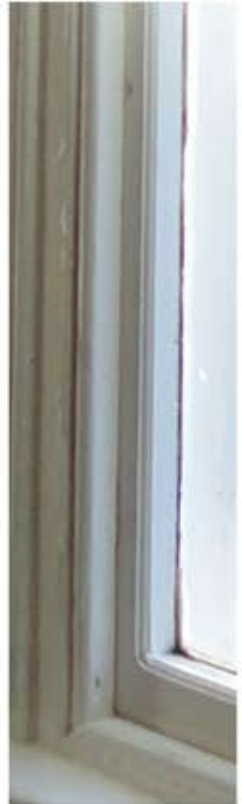
#47

Description: Non-bar sliding sash windows with sash horns and swept arch

Defects: gaps between panes and sliding sections, build up of paint hides crack and heavy old windows difficult to open for ventilation, broken timber parts along sliding track

Joinery Fixing Option: sand down paint and new sliding mechanisms replaced, removal of whole window would be necessary

Draught-Proofing Option: repairs would have to be completed before adding draught-proofing to the sliding panels

uPVC Option: quickest option and would allow double glazing to be installed, style can be imitated to look exactly like the existing

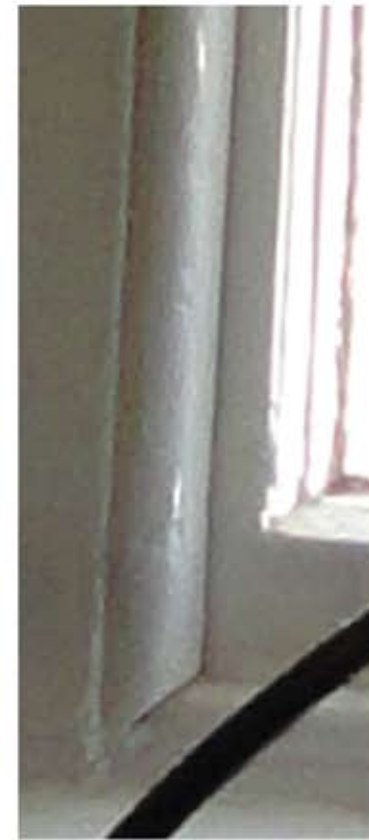
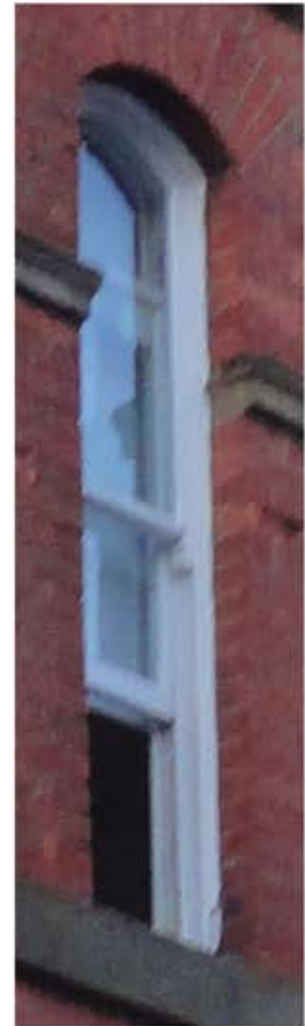
#48

Description: Center-bar sliding sash windows with sash horns and swept arch

Defects: gaps between panes and sliding sections, build up of paint hides crack and heavy old windows difficult to open for ventilation, broken timber parts along sliding track

Joinery Fixing Option: sand down paint and new sliding mechanisms replaced, removal of whole window would be necessary

Draught-Proofing Option: repairs would have to be completed before adding draught-proofing to the sliding panels

uPVC Option: quickest option and would allow double glazing to be installed, style can be imitated to look exactly like the existing

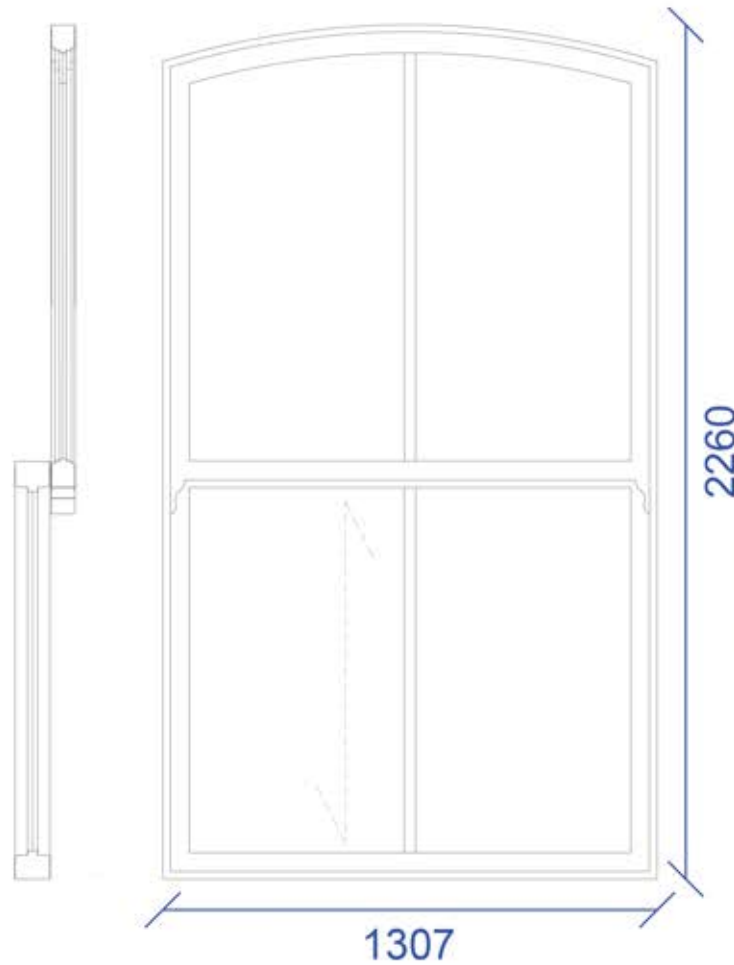
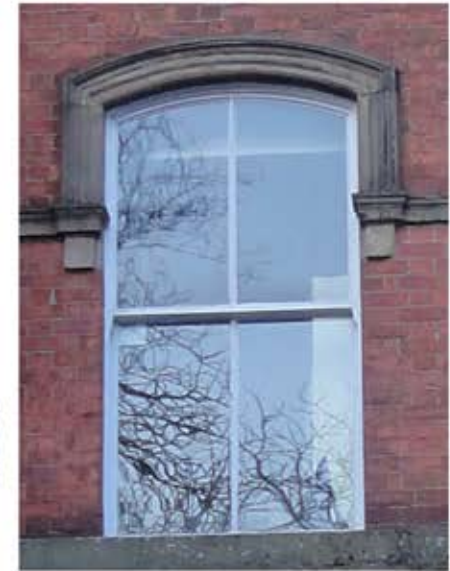
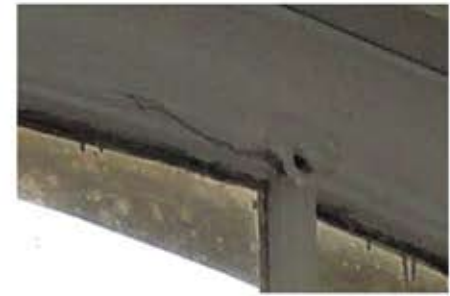
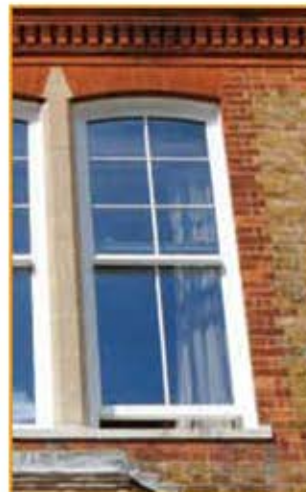
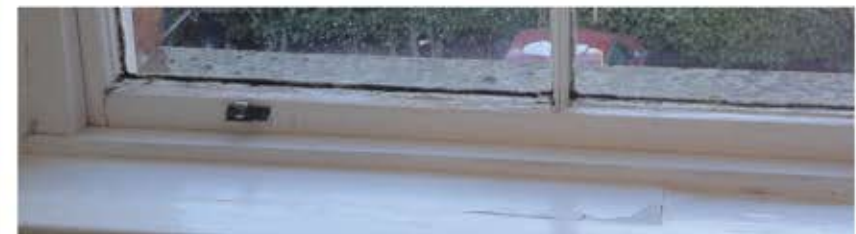
#49

Description: Center-bar sliding sash windows with sash horns and swept arch

Defects: gaps between panes and sliding sections, build up of paint hides crack and heavy old windows difficult to open for ventilation, broken timber parts along sliding track

Joinery Fixing Option: sand down paint and new sliding mechanisms replaced, removal of whole window would be necessary

Draught-Proofing Option: repairs would have to be completed before adding draught-proofing to the sliding panels

uPVC Option: quickest option and would allow double glazing to be installed, style can be imitated to look exactly like the existing

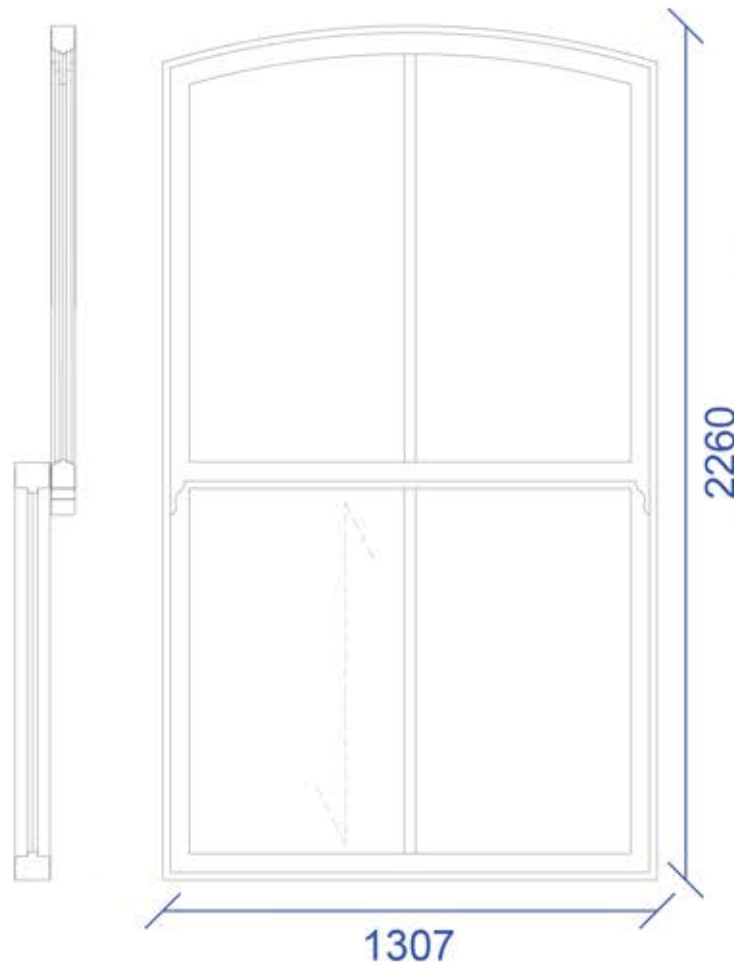
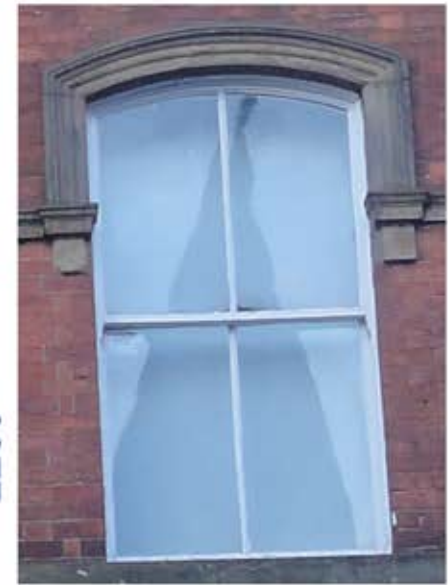
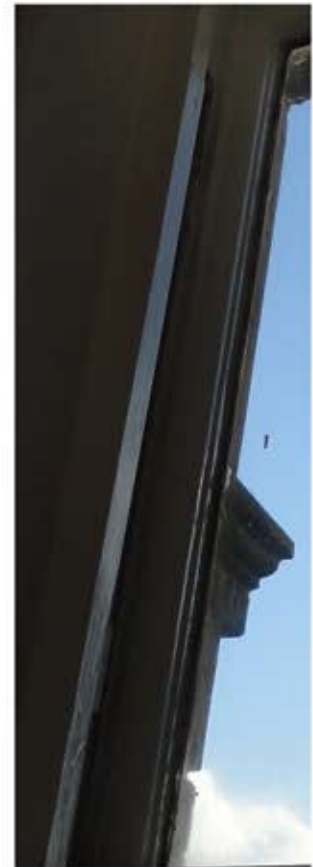
#50

Description: Center-bar sliding sash windows with sash horns and swept arch

Defects: gaps between panes and sliding sections, build up of paint hides crack and heavy old windows difficult to open for ventilation, broken timber parts along sliding track

Joinery Fixing Option: sand down paint and new sliding mechanisms replaced, removal of whole window would be necessary

Draught-Proofing Option: repairs would have to be completed before adding draught-proofing to the sliding panels

uPVC Option: quickest option and would allow double glazing to be installed, style can be imitated to look exactly like the existing

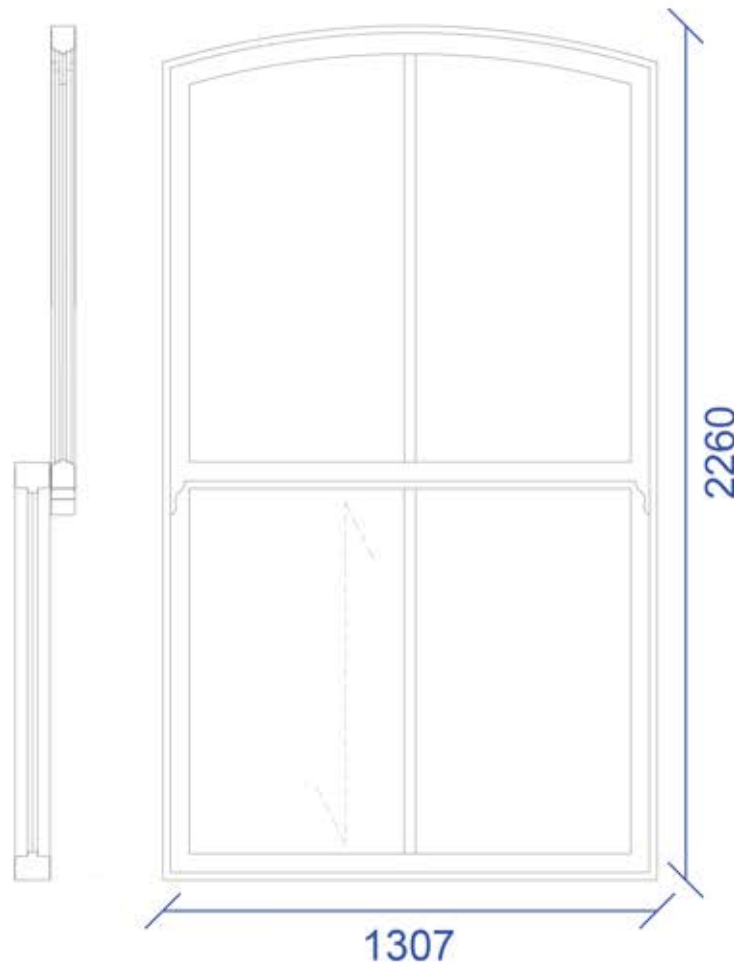
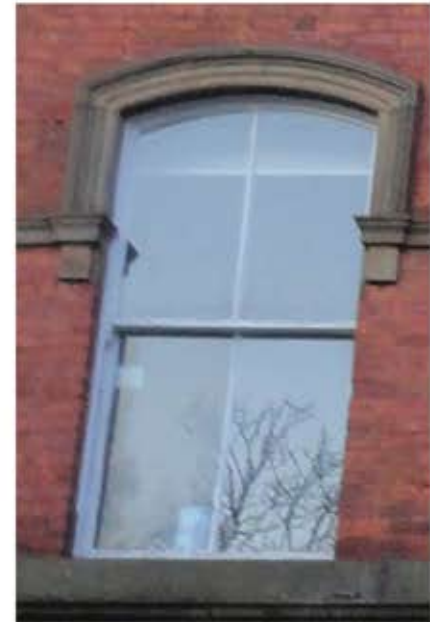
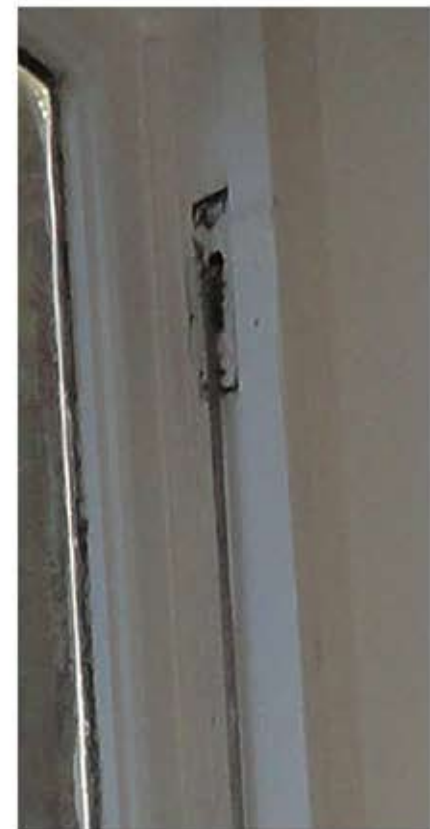
#51

Description: Center-bar sliding sash windows with sash horns and swept arch

Defects: gaps between panes and sliding sections, build up of paint hides crack and heavy old windows difficult to open for ventilation, broken timber parts along sliding track

Joinery Fixing Option: sand down paint and new sliding mechanisms replaced, removal of whole window would be necessary

Draught-Proofing Option: repairs would have to be completed before adding draught-proofing to the sliding panels

uPVC Option: quickest option and would allow double glazing to be installed, style can be imitated to look exactly like the existing

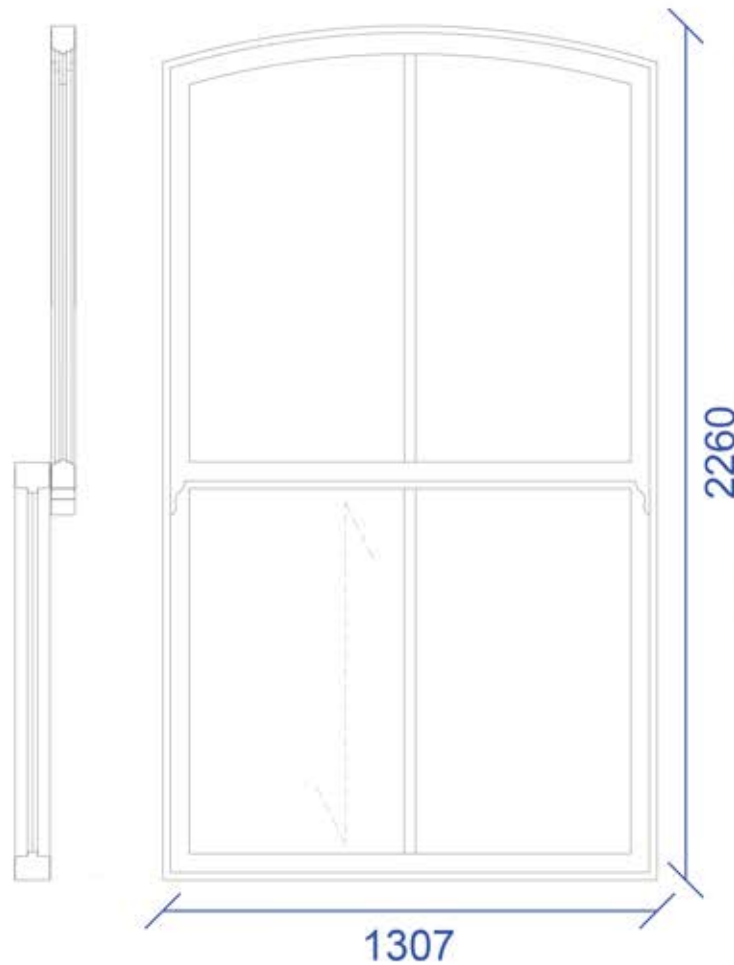
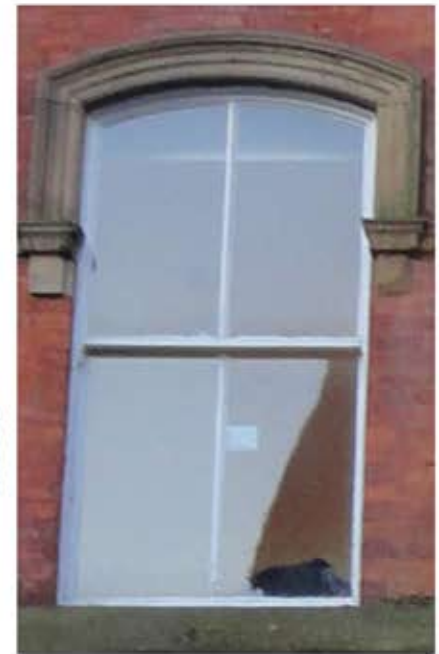
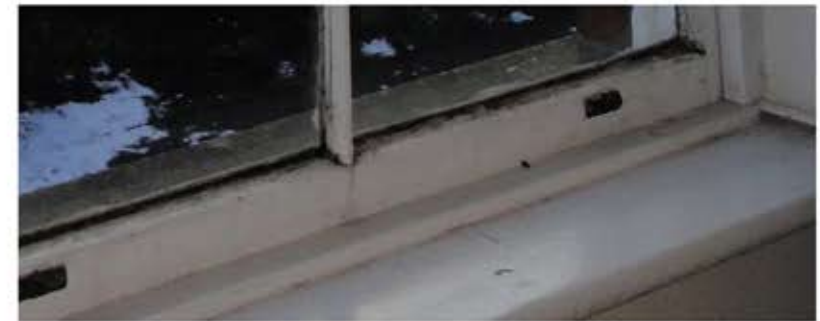
#52

Description: Non-bar sliding sash windows with sash horns and swept arch

Defects: gaps between panes and sliding sections, build up of paint hides crack and heavy old windows difficult to open for ventilation, broken timber parts along sliding track

Joinery Fixing Option: sand down paint and new sliding mechanisms replaced, removal of whole window would be necessary

Draught-Proofing Option: repairs would have to be completed before adding draught-proofing to the sliding panels

uPVC Option: quickest option and would allow double glazing to be installed, style can be imitated to look exactly like the existing

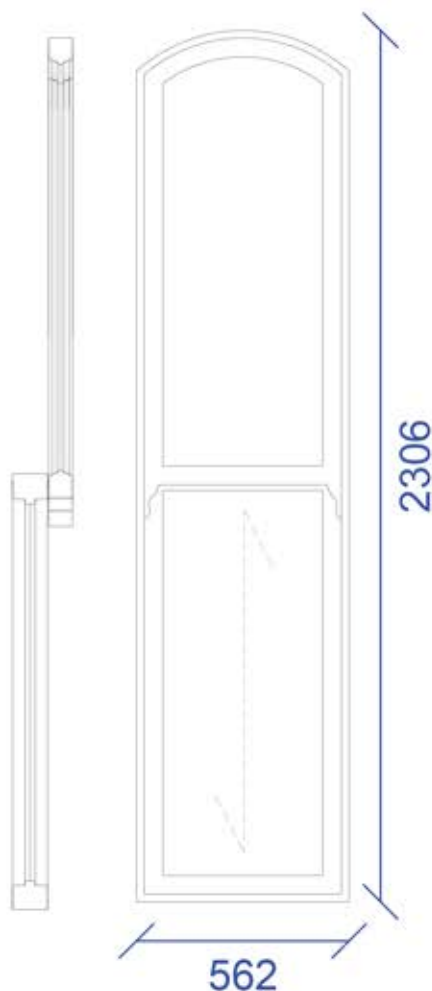
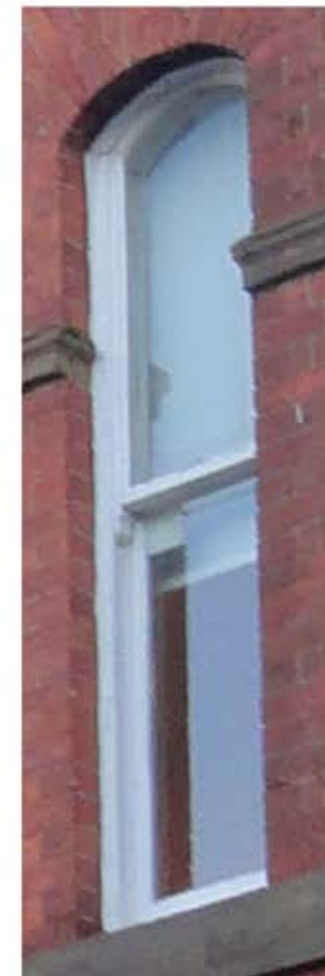
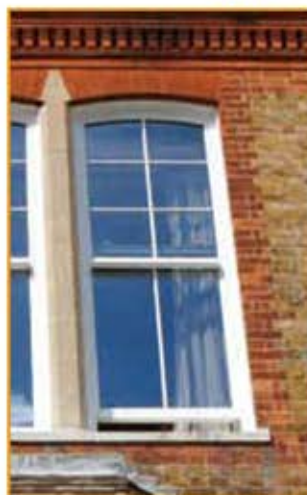
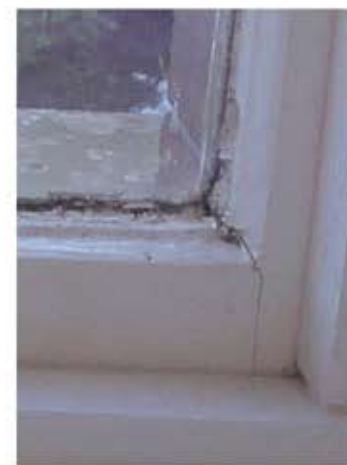
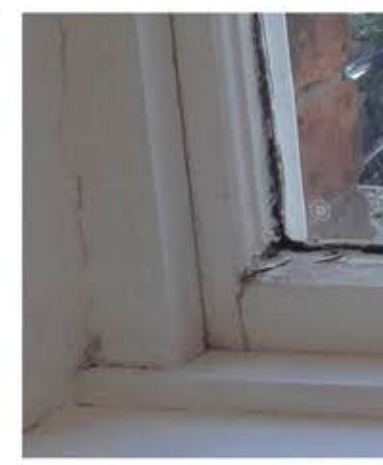
#53

Description: Center-bar sliding sash windows with sash horns and swept arch

Defects: gaps between panes and sliding sections, build up of paint hides crack and heavy old windows difficult to open for ventilation, broken timber parts along sliding track

Joinery Fixing Option: sand down paint and new sliding mechanisms replaced, removal of whole window would be necessary

Draught-Proofing Option: repairs would have to be completed before adding draught-proofing to the sliding panels

uPVC Option: quickest option and would allow double glazing to be installed, style can be imitated to look exactly like the existing

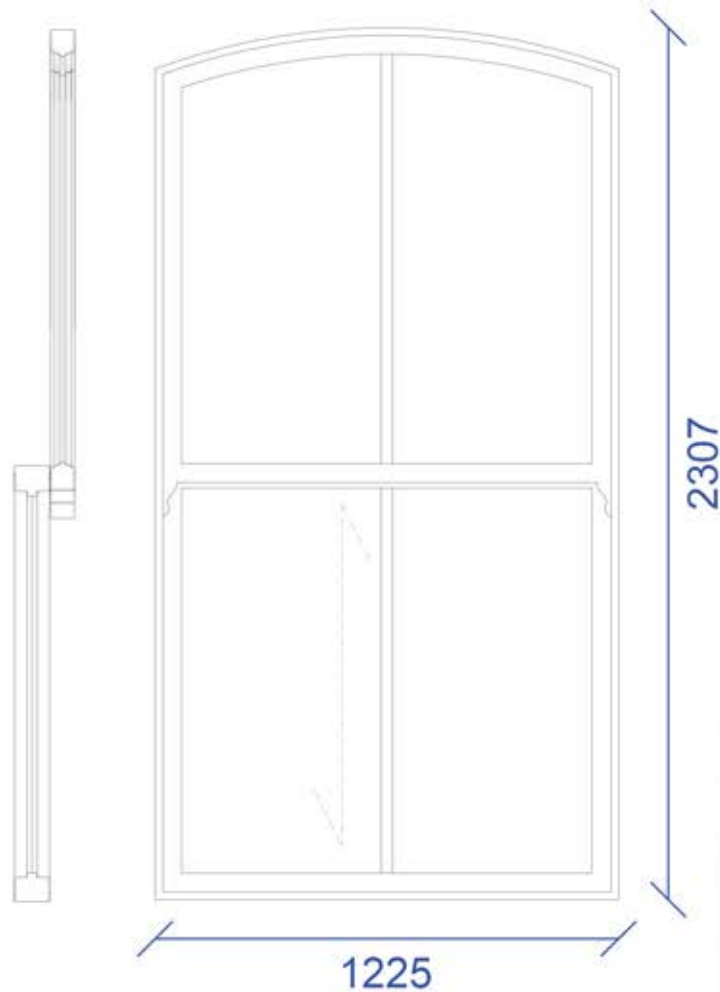
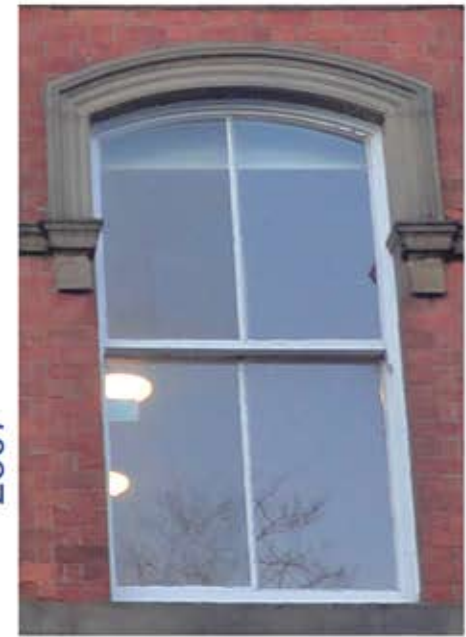
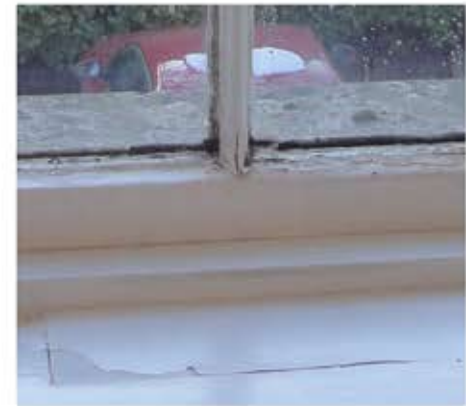
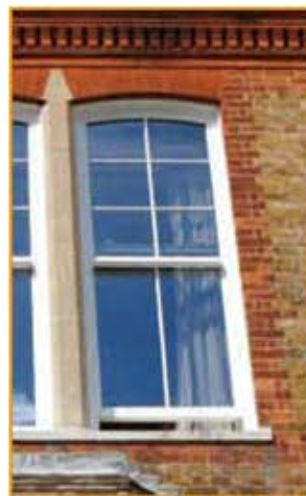
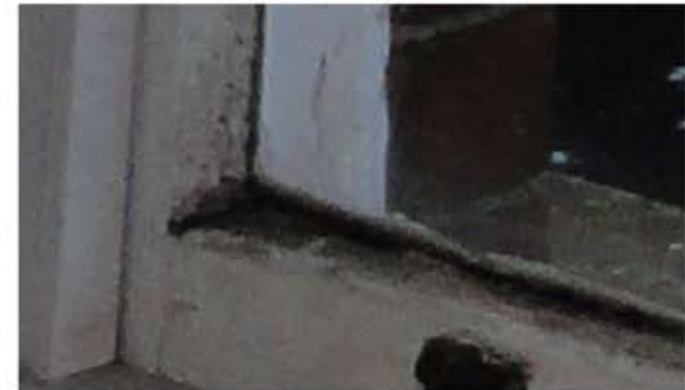
#54

Description: Non-bar sliding sash windows with sash horns and swept arch

Defects: gaps between panes and sliding sections, build up of paint hides crack and heavy old windows difficult to open for ventilation, broken timber parts along sliding track

Joinery Fixing Option: sand down paint and new sliding mechanisms replaced, removal of whole window would be necessary

Draught-Proofing Option: repairs would have to be completed before adding draught-proofing to the sliding panels

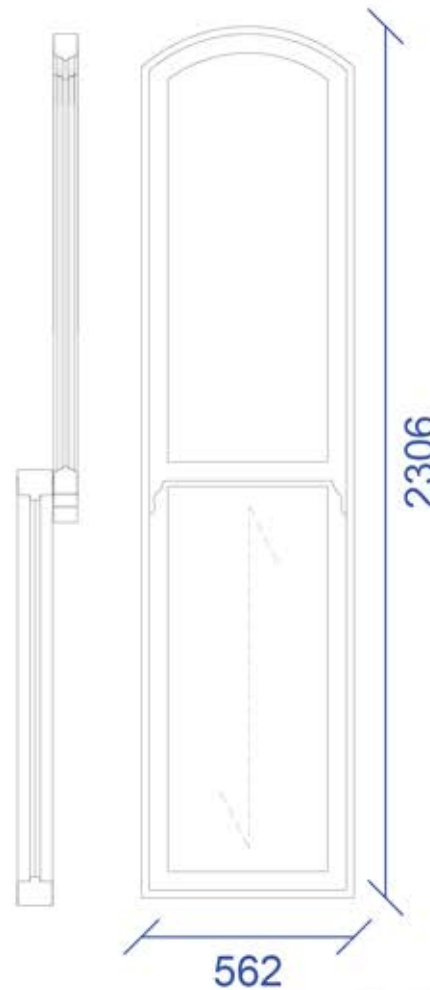
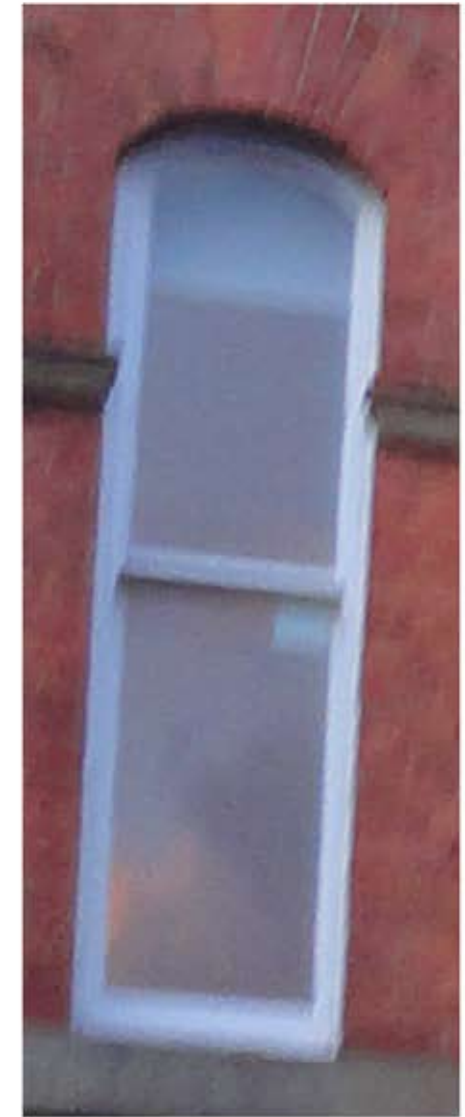
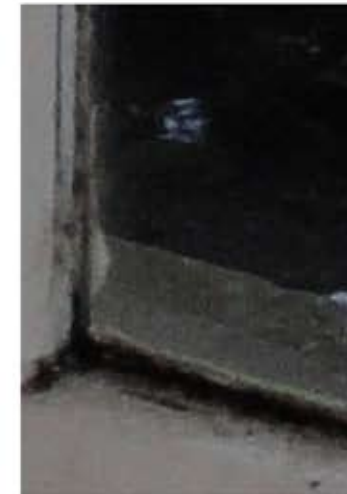
#55

Description: Non-bar sliding sash windows with sash horns and true arch

Defects: gaps between panes and sliding sections, build up of paint hides crack and heavy old windows difficult to open for ventilation, broken timber parts along sliding track doesn't close properly

Joinery Fixing Option: sand down paint and new sliding mechanisms replaced, removal of whole window would be necessary

Draught-Proofing Option: repairs would have to be completed before adding draught-proofing to the sliding panels

uPVC Option: quickest option and would allow double glazing to be installed, style can be imitated to look exactly like the existing
