Daisybank Villas
5-7 Anson Road
Manchester
M14 5BR

Window Replacement
Justification

May 2018

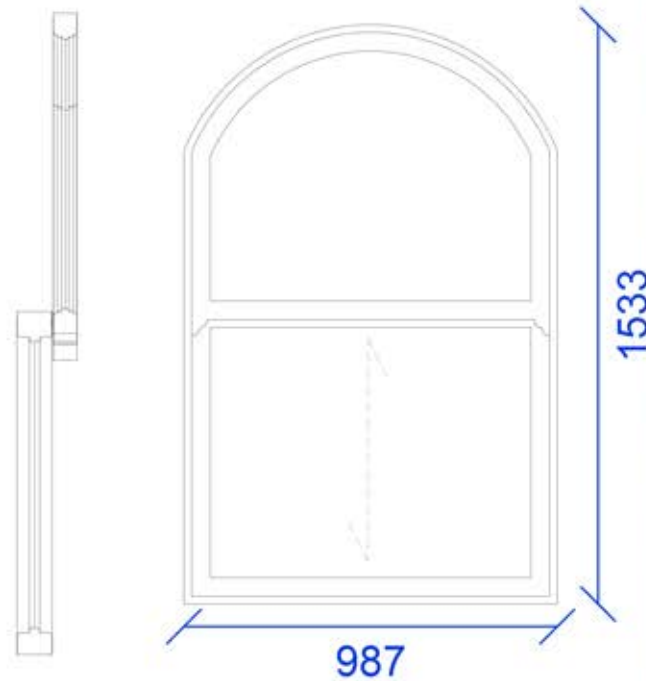
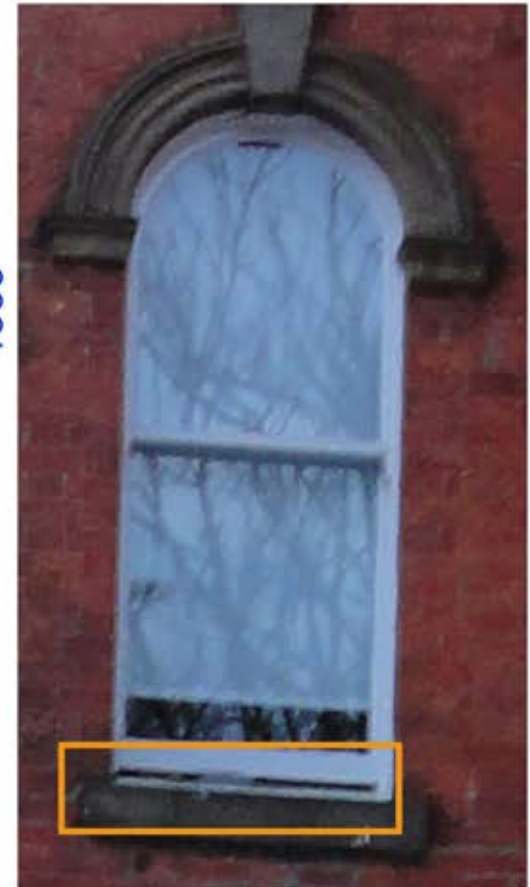
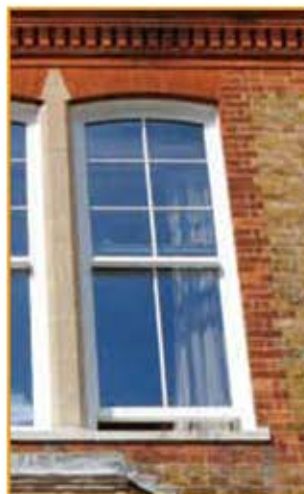
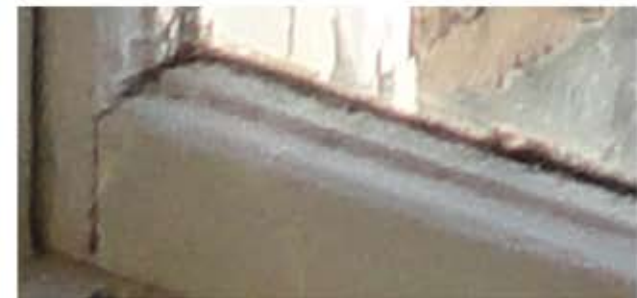
#56

Description: Centre-bar sliding sash windows with sash horns and swept arch

Defects: gaps between panes and sliding sections, build up of paint hides crack and heavy old windows do not open for ventilation, broken timber parts along sliding track and difficult to close

Joinery Fixing Option: sand down paint and new sliding mechanisms replaced, removal of whole window would be necessary

Draught-Proofing Option: repairs would have to be completed before adding draught-proofing to the sliding panels

uPVC Option: quickest option and would allow double glazing to be installed, style can be imitated to look exactly like the existing

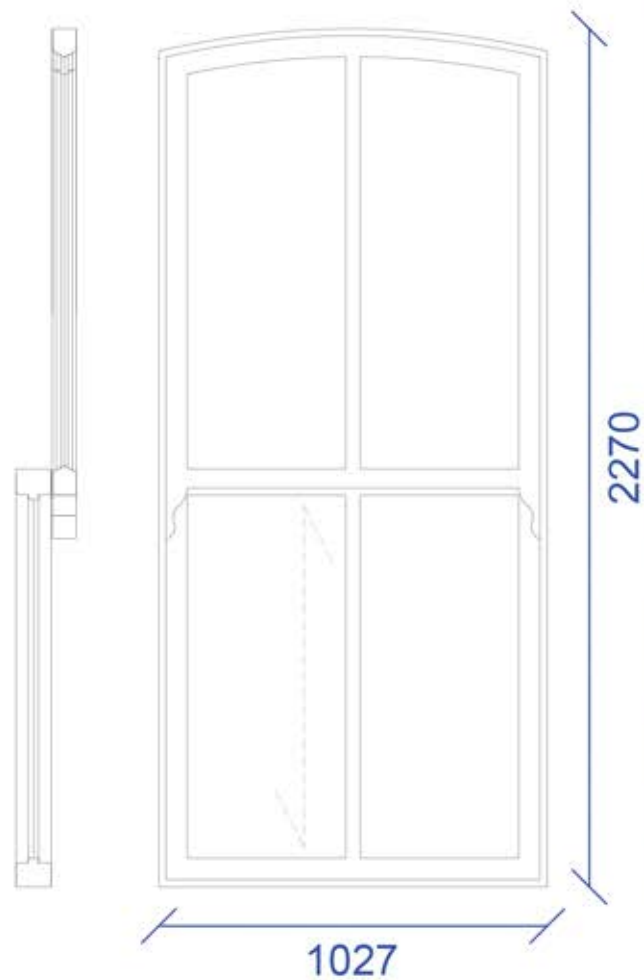
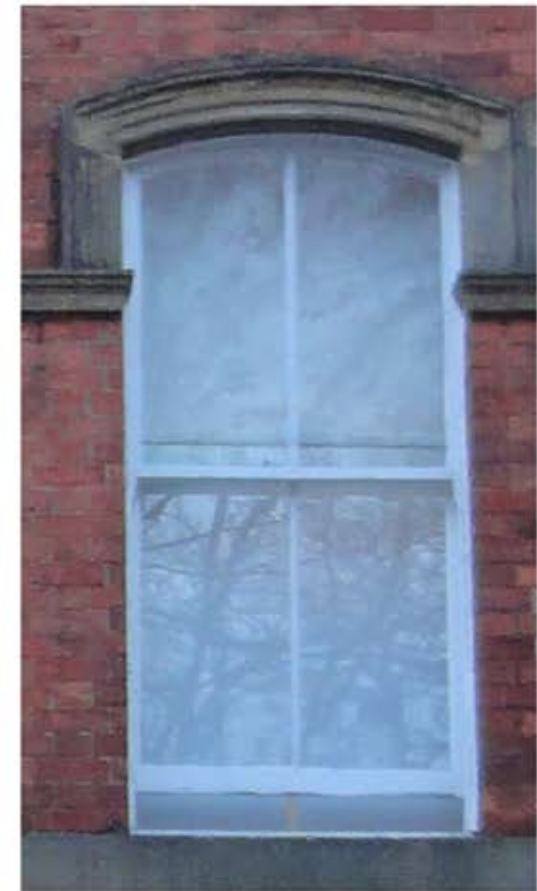
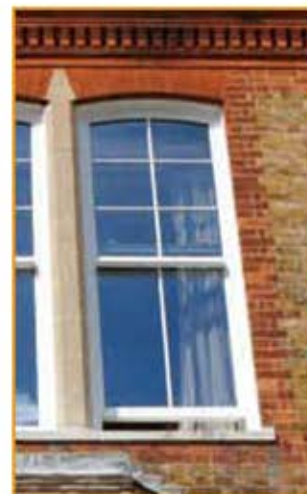
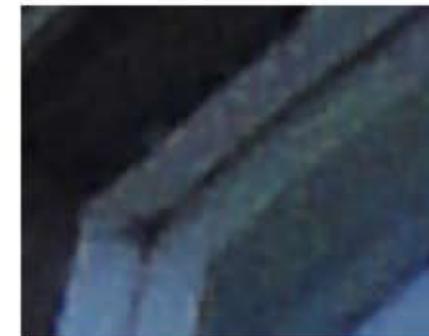
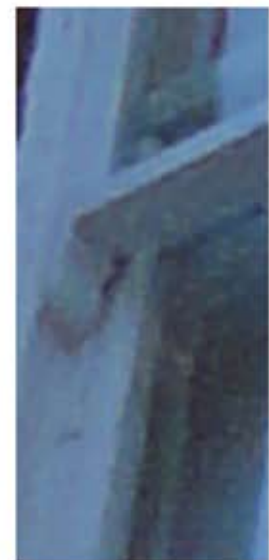
#57

Description: Centre-bar sliding sash windows with sash horns and swept arch

Defects: gaps between panes and sliding sections, build up of paint hides crack and heavy old windows do not open for ventilation, broken timber parts along sliding track and broken sliding ropes

Joinery Fixing Option: sand down paint and new sliding mechanisms replaced, removal of whole window would be necessary

Draught-Proofing Option: repairs would have to be completed before adding draught-proofing to the sliding panels

uPVC Option: quickest option and would allow double glazing to be installed, style can be imitated to look exactly like the existing

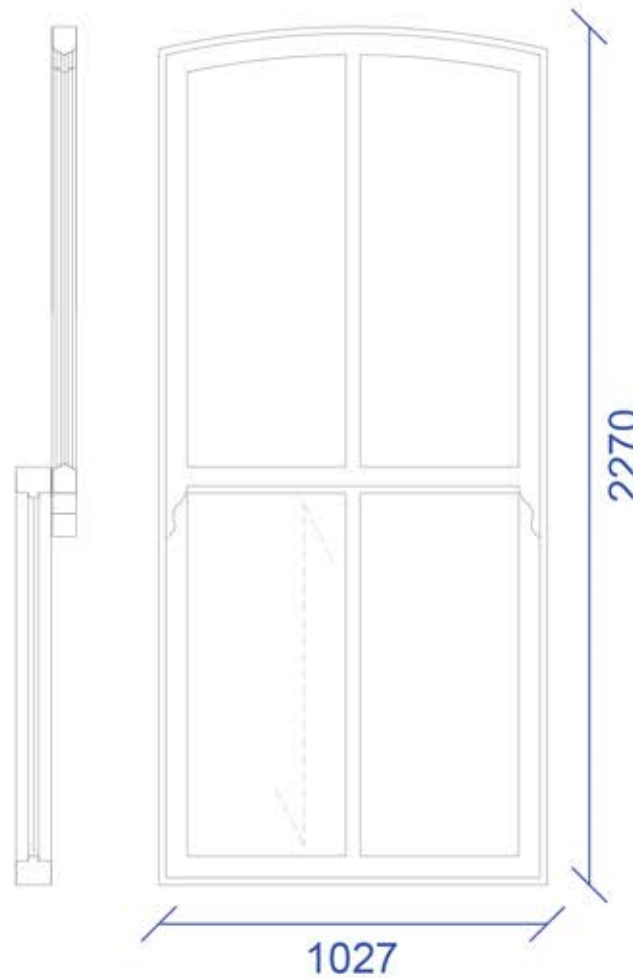
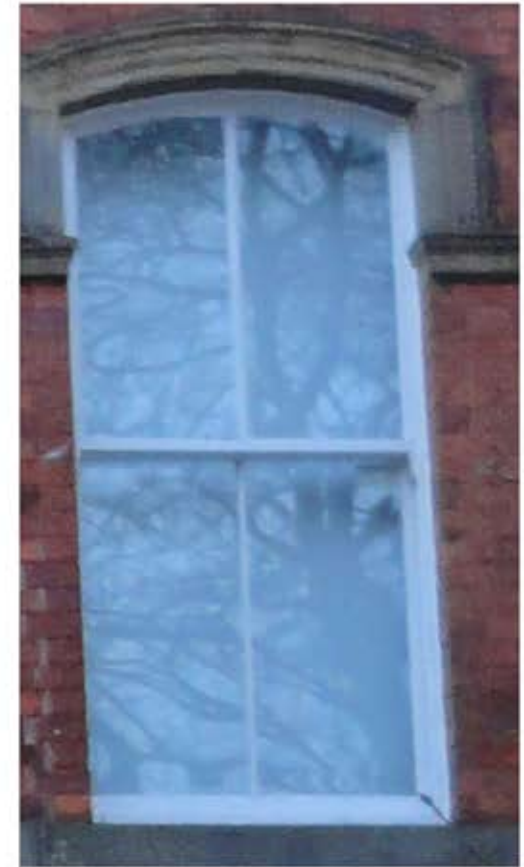
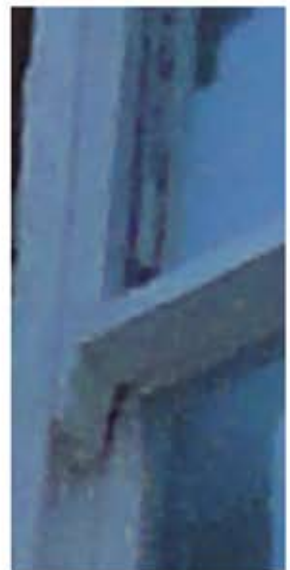
#58

Description: Top hung casement window, top half opening, styled to match sash windows without central bars and sash horns.

Defects: difficulty shutting top hung panel due to damage to hinges, mould growing into the frame around the single glazing, cracked timber frame

Joinery Fixing Option: fill in gaps around the outside, replace rotten and cracked timber pieces

Draught-Proofing Option: repairs would have to be completed before adding draught-proofing to the openings

uPVC Option: quickest option and would allow double glazing to be installed, style can be imitated to look exactly like the existing

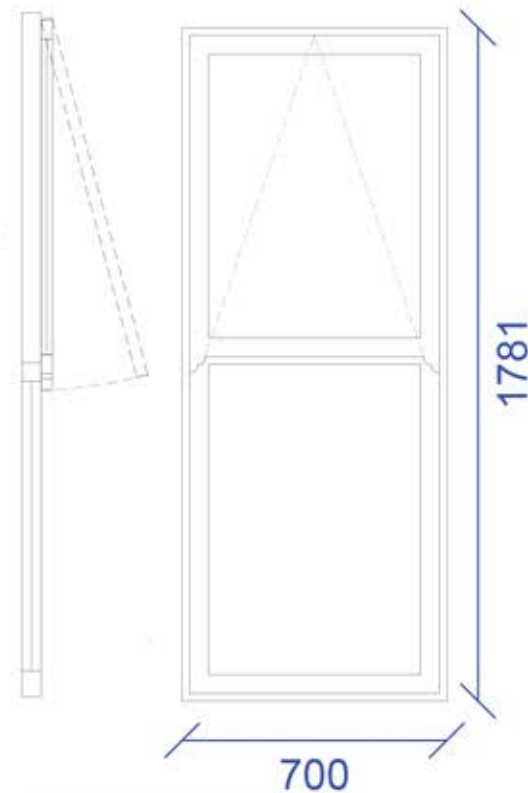
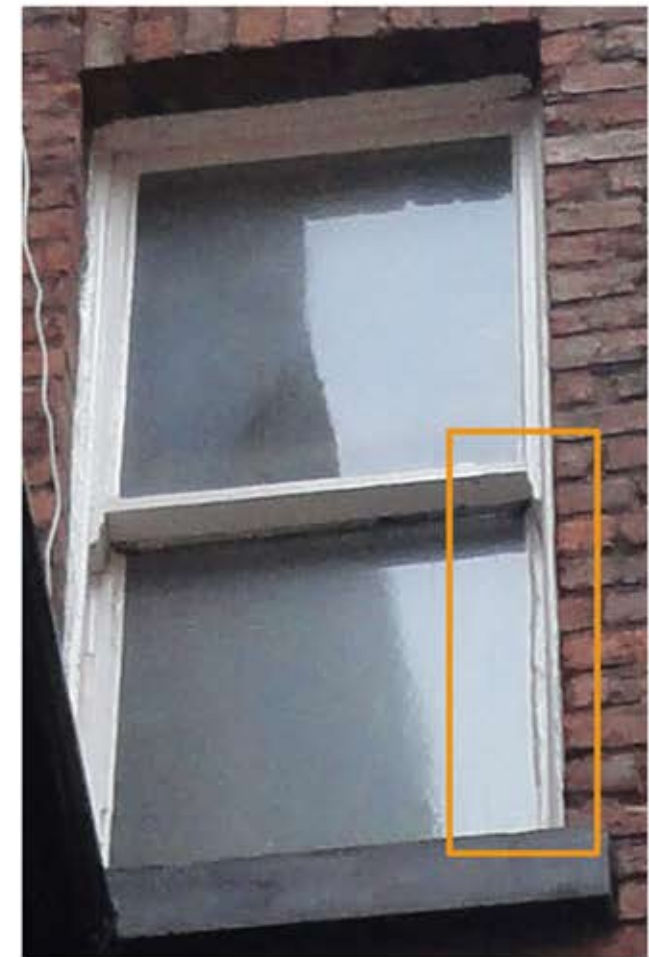
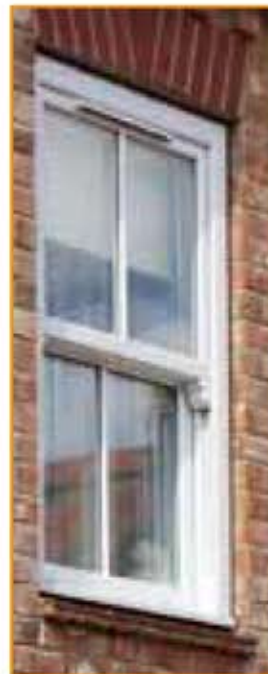
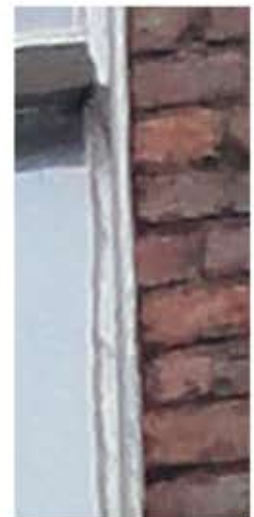
#59

Description: Top hung casement window, top half opening, styled to match sash windows without central bars and sash horns.

Defects: difficulty shutting top hung panel due to damage to hinges, mould growing into the frame around the single glazing

Joinery Fixing Option: fill in gaps around the outside, replace rotten timber pieces

Draught-Proofing Option: repairs would have to be completed before adding draught-proofing to the openings

uPVC Option: quickest option and would allow double glazing to be installed, style can be imitated to look exactly like the existing

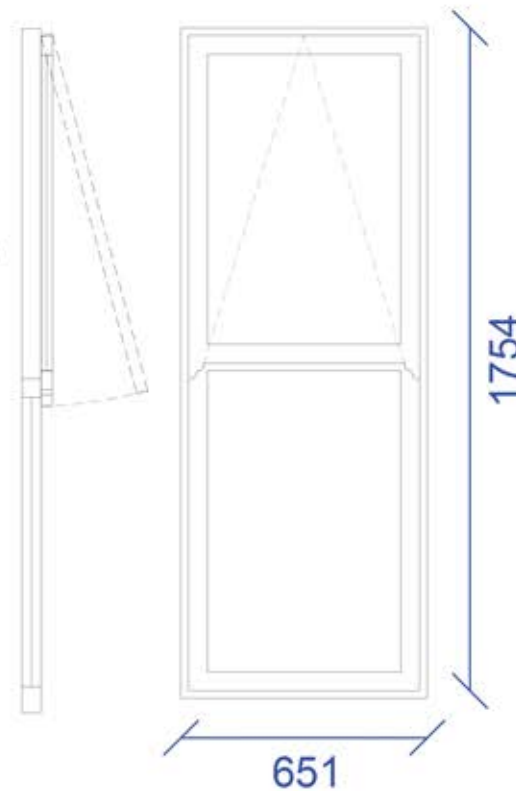
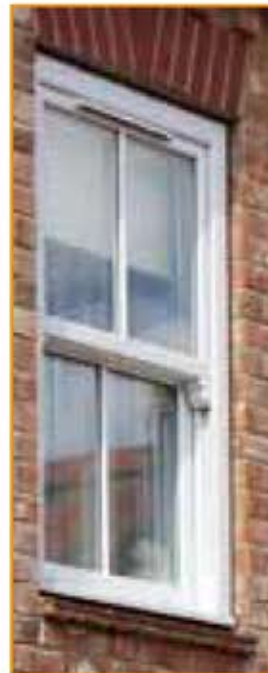
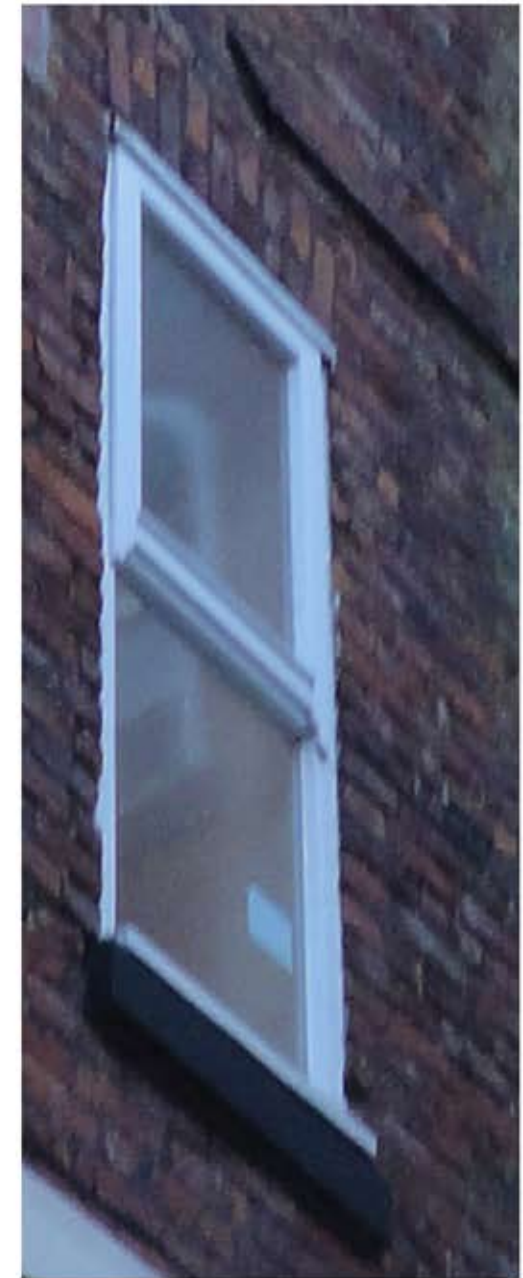
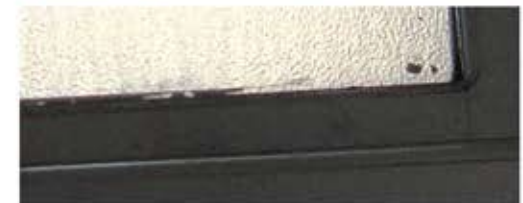
#60

Description: Top hung casement window, top half opening, styled to match sash windows without central bars and with sash horns.

Defects: damage to hinges, mould growing into frame around the single glazing, gap inside between top swing panel and fixed panel

Joinery Fixing Option: fill in gaps around the outside, replace rotten timber pieces

Draught-Proofing Option: repairs would have to be completed before adding draught-proofing to the openings

uPVC Option: quickest option and would allow double glazing to be installed, style can be imitated to look exactly like the existing

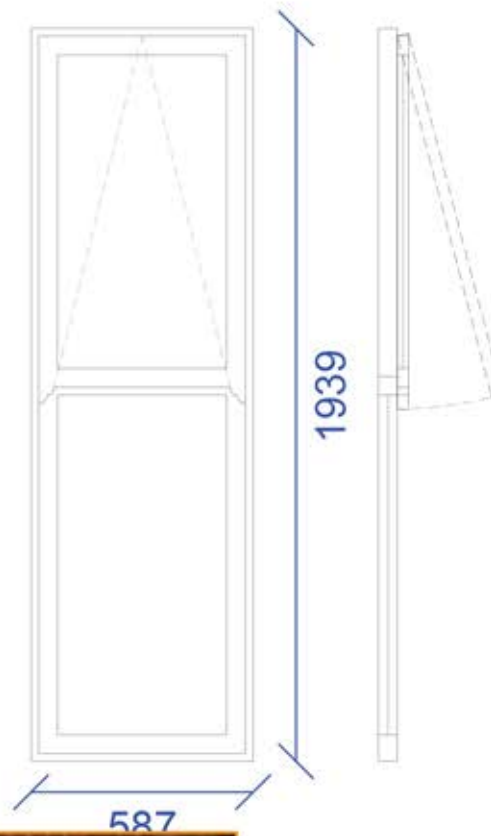
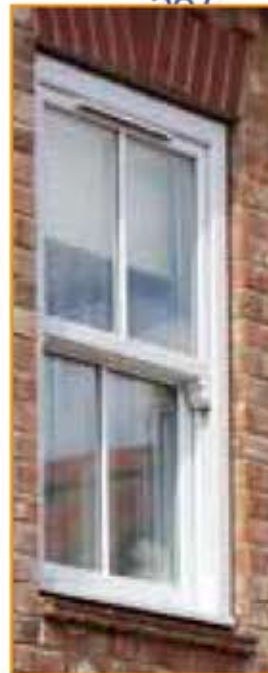
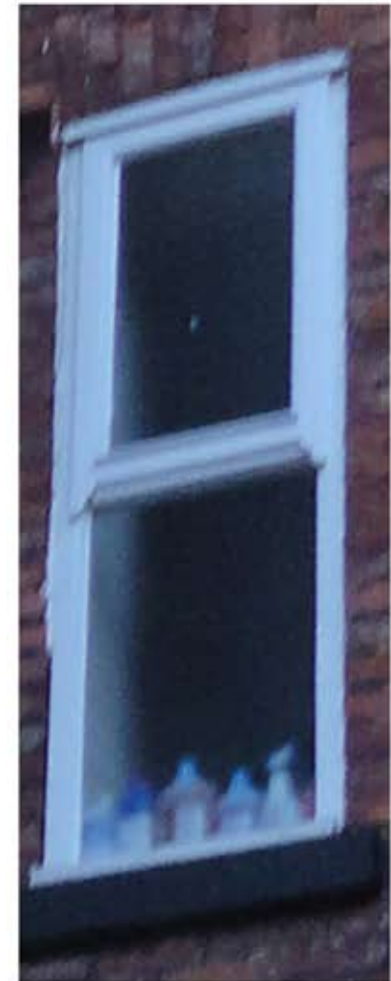
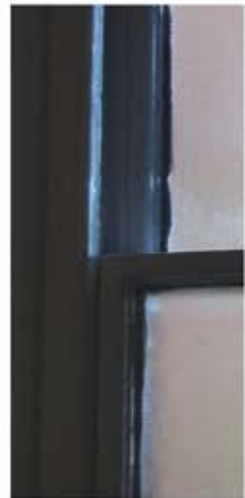
#61

Description: Top hung casement window, top half opening, styled to match sash windows with central bars and sash horns.

Defects: damage to hinges, mould growing into frame around the single glazing, holes in timber frames

Joinery Fixing Option: fill in gaps around the outside, replace rotten timber pieces and broken hinges

Draught-Proofing Option: repairs would have to be completed before adding draught-proofing to the openings

uPVC Option: quickest option and would allow double glazing to be installed, style can be imitated to look exactly like the existing

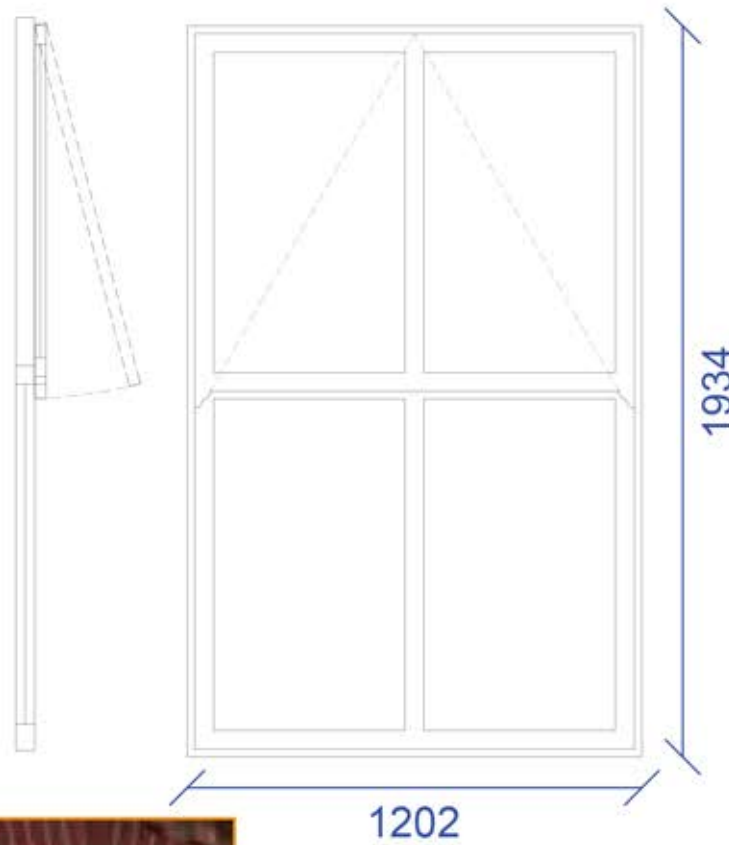
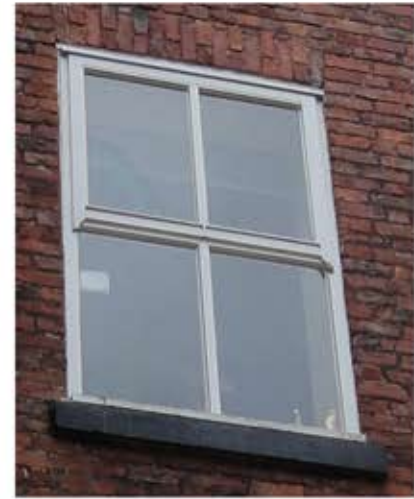
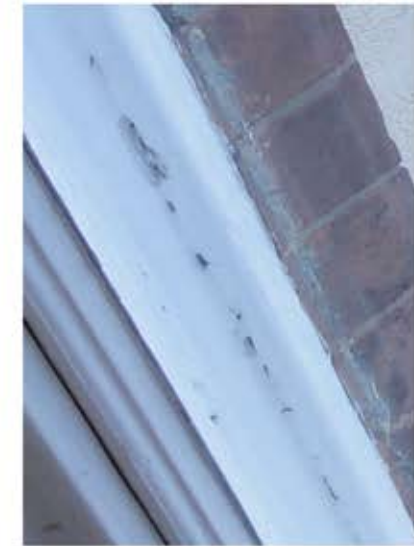
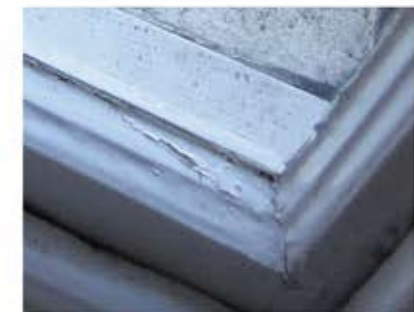
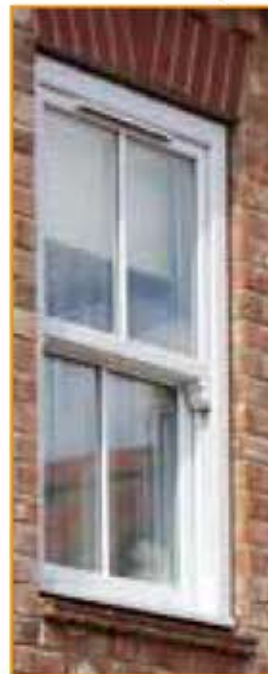
#62

Description: Top hung casement window, top half opening, styled to match sash windows with sash horns.

Defects: mould growing into frame around the single glazing, holes in timber frames, gaps between frame and walls

Joinery Fixing Option: fill in gaps around the outside, replace rotten timber pieces

Draught-Proofing Option: repairs would have to be completed before adding draught-proofing to the openings

uPVC Option: quickest option and would allow double glazing to be installed, style can be imitated to look exactly like the existing

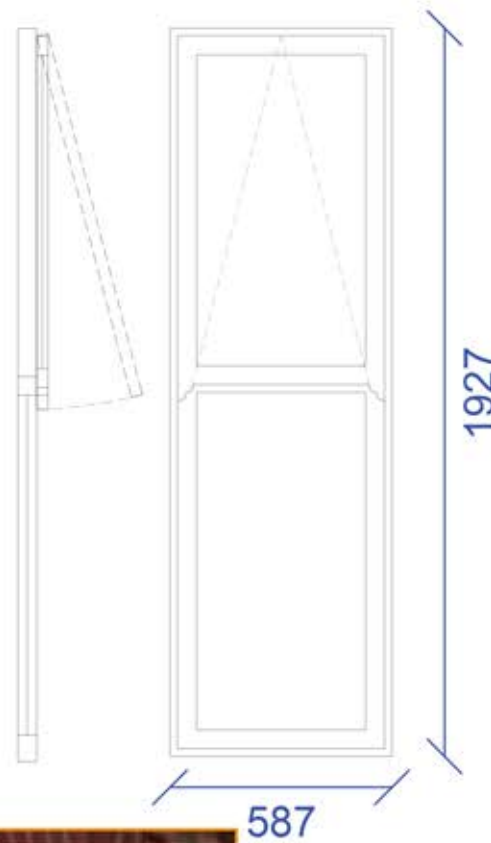
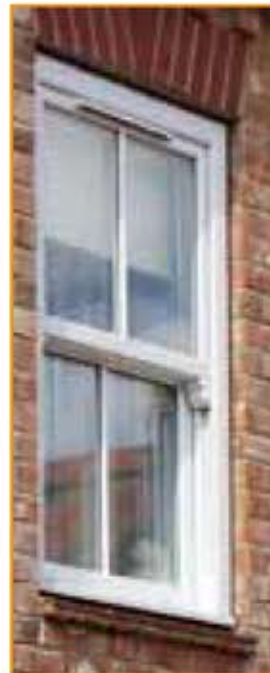
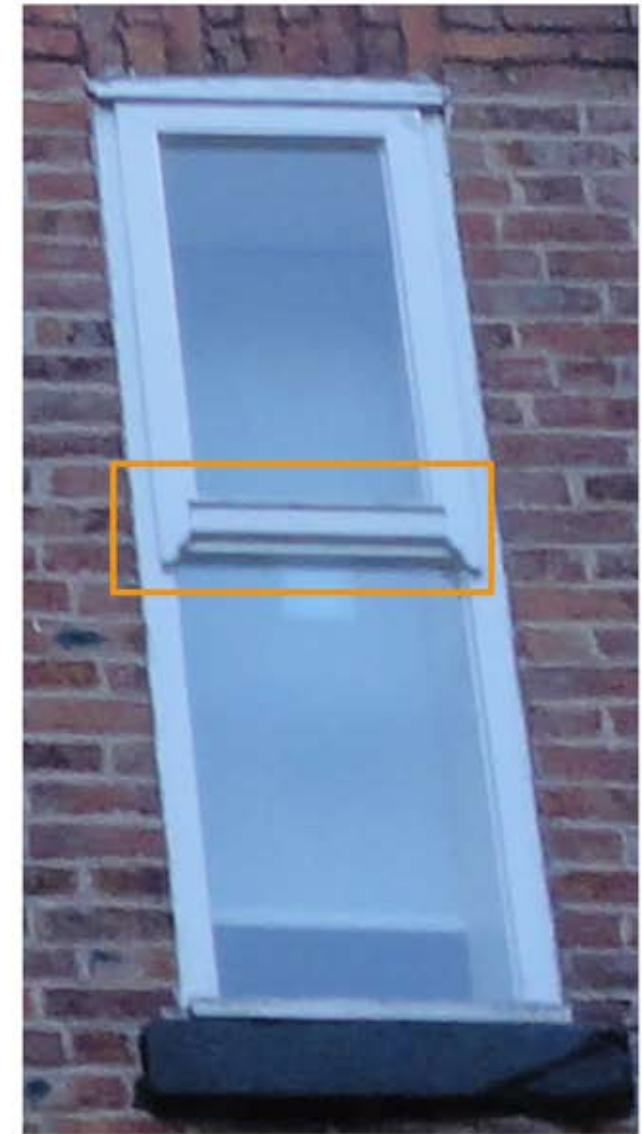
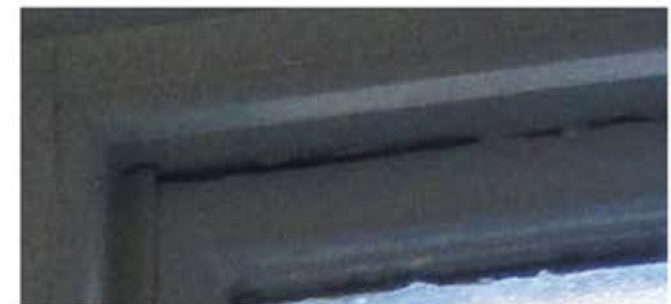
#63

Description: Top hung casement window, top half opening, styled to match sash windows with sash horns.

Defects: mould growing into frame around the single glazing, holes in timber frames, gaps between frame and walls, cracked bottom timber piece

Joinery Fixing Option: fill in gaps around the outside, replace rotten and broken timber pieces

Draught-Proofing Option: repairs would have to be completed before adding draught-proofing to the openings

uPVC Option: quickest option and would allow double glazing to be installed, style can be imitated to look exactly like the existing

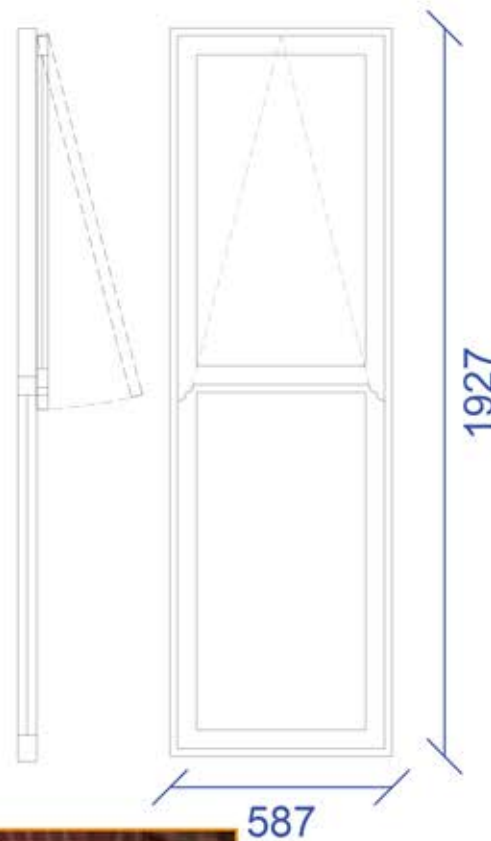
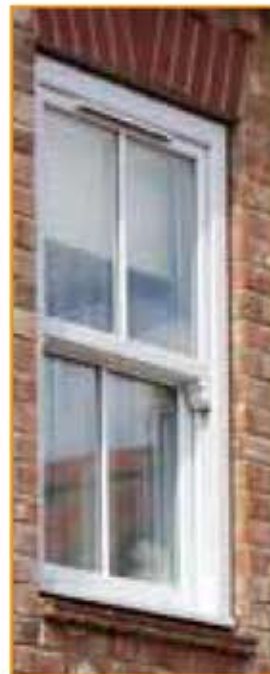
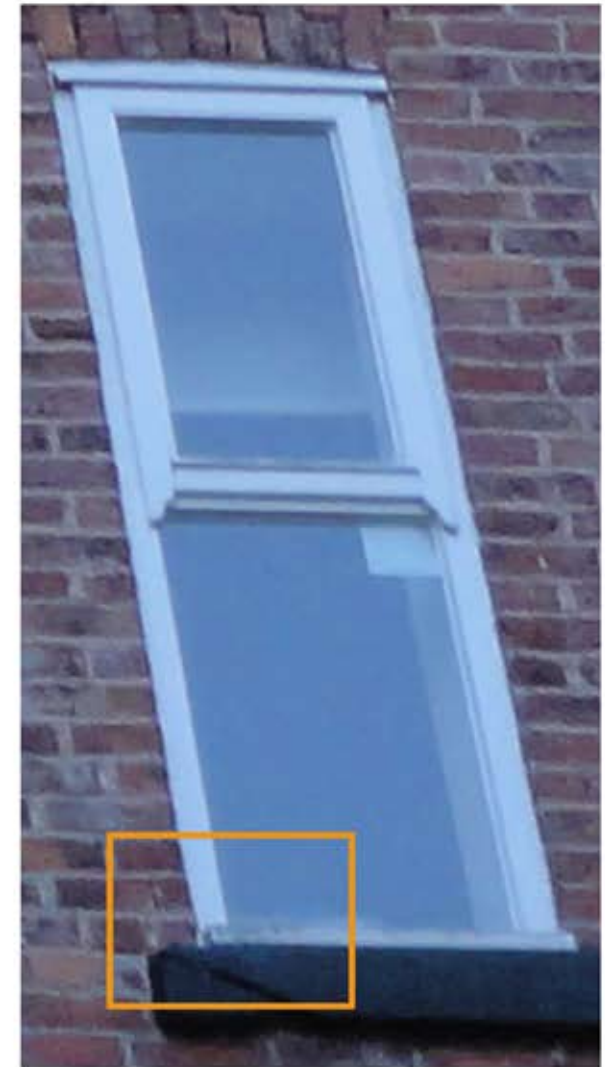
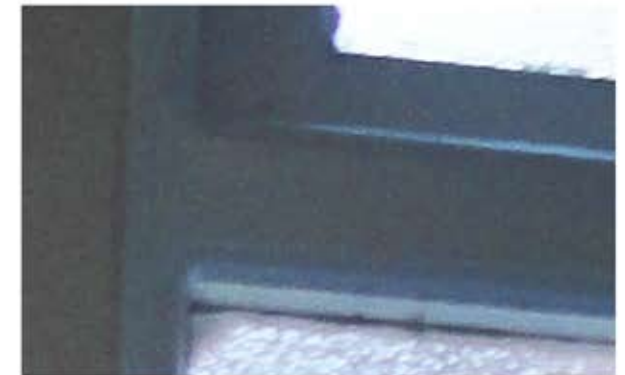
#64

Description: Top hung casement window, top half opening, styled to match sash windows with central bars and sash horns.

Defects: damage to corners, mould growing into frame around the single glazing, holes in timber frames

Joinery Fixing Option: fill in gaps around the outside, replace rotten and damaged timber pieces

Draught-Proofing Option: repairs would have to be completed before adding draught-proofing to the openings

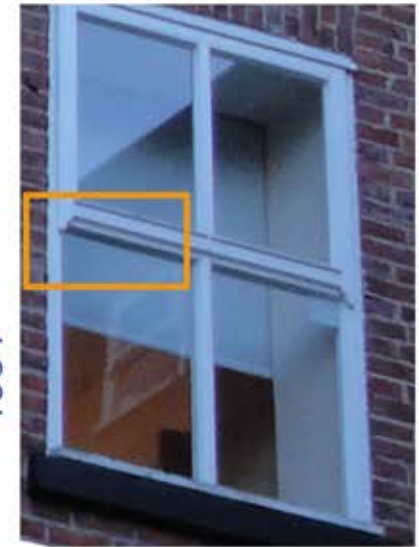
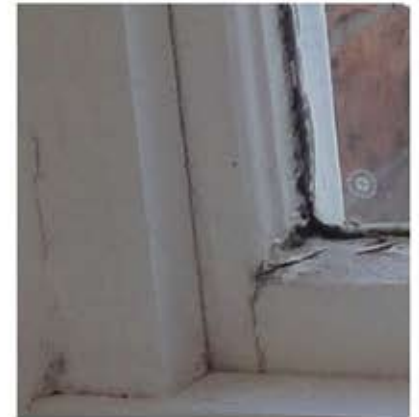
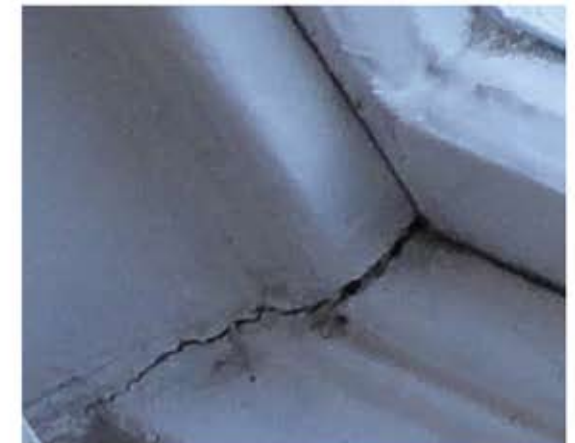
#65

Description: Top hung casement window, top half opening, styled to match sash windows without central bars and with sash horns.

Defects: mould growing into frame around the single glazing, gap inside between top swing panel and fixed panel

Joinery Fixing Option: fill in gaps around the outside, replace rotten timber pieces

Draught-Proofing Option: repairs would have to be completed before adding draught-proofing to the openings

uPVC Option: quickest option and would allow double glazing to be installed, style can be imitated to look exactly like the existing

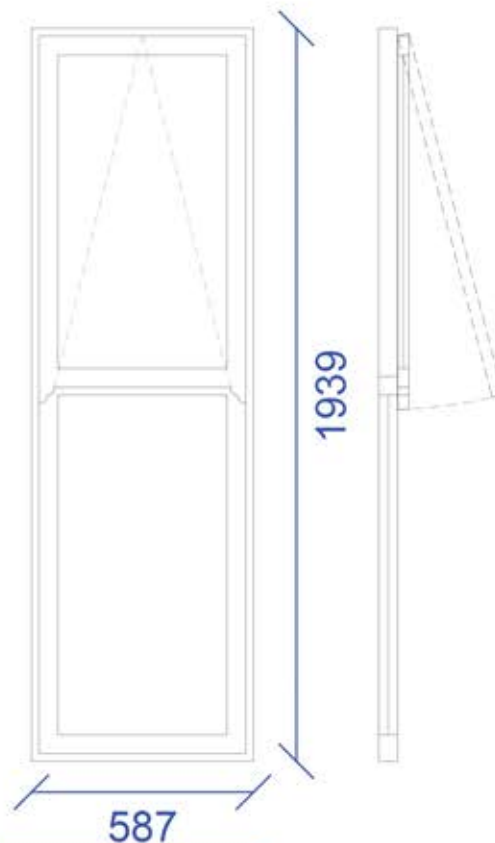
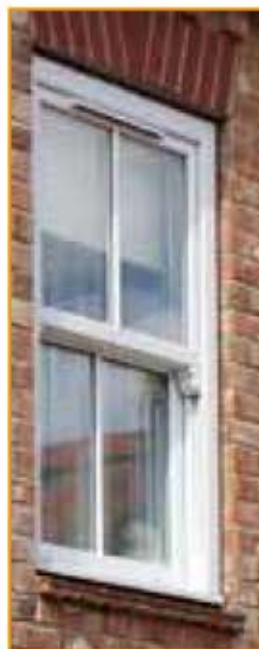
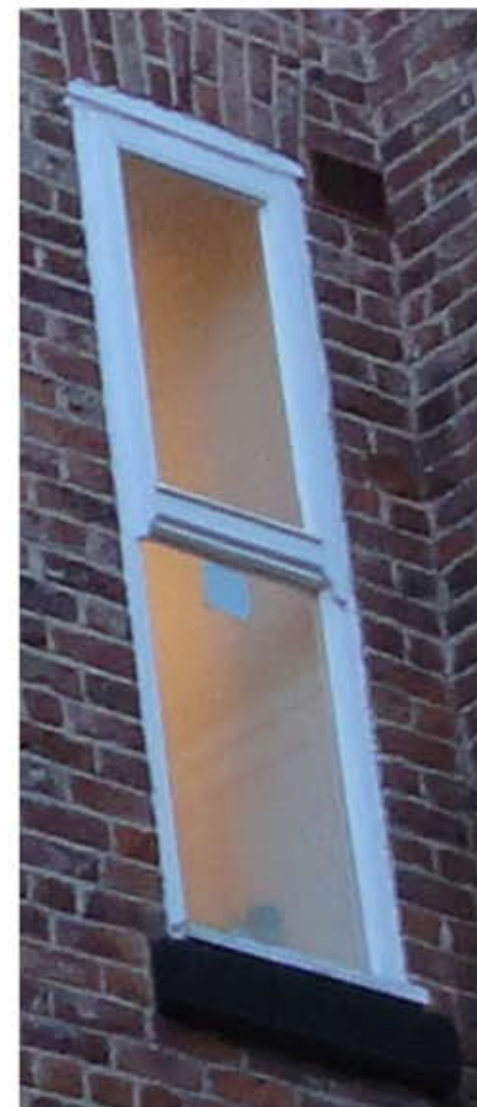
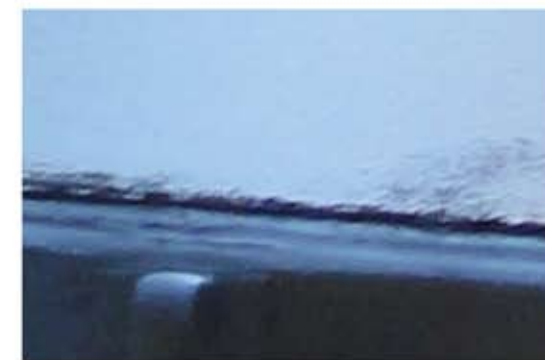
#66

Description: Top hung casement window, top half opening, styled to match sash windows with central bars and sash horns.

Defects: mould growing into frame around the single glazing, gap inside between top swing panel and fixed panel

Joinery Fixing Option: fill in gaps around the outside, replace rotten timber pieces

Draught-Proofing Option: repairs would have to be completed before adding draught-proofing to the openings

uPVC Option: quickest option and would allow double glazing to be installed, style can be imitated to look exactly like the existing

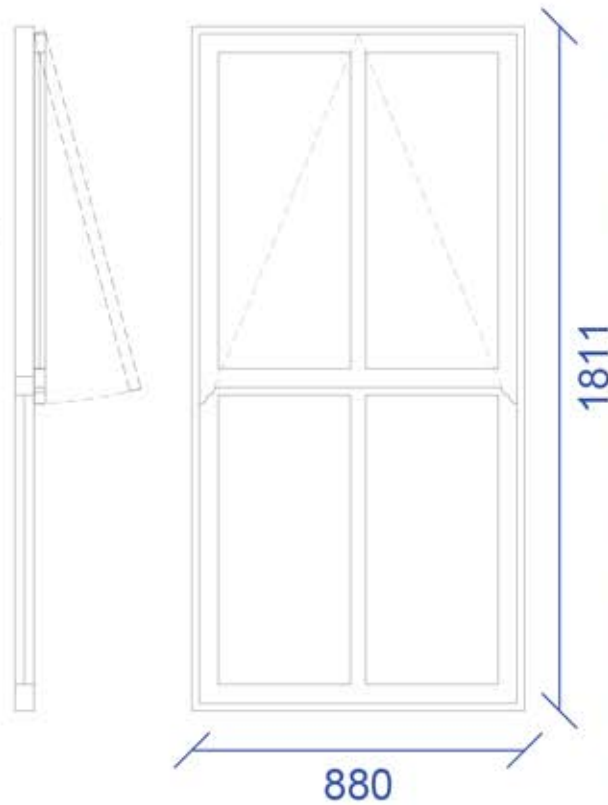
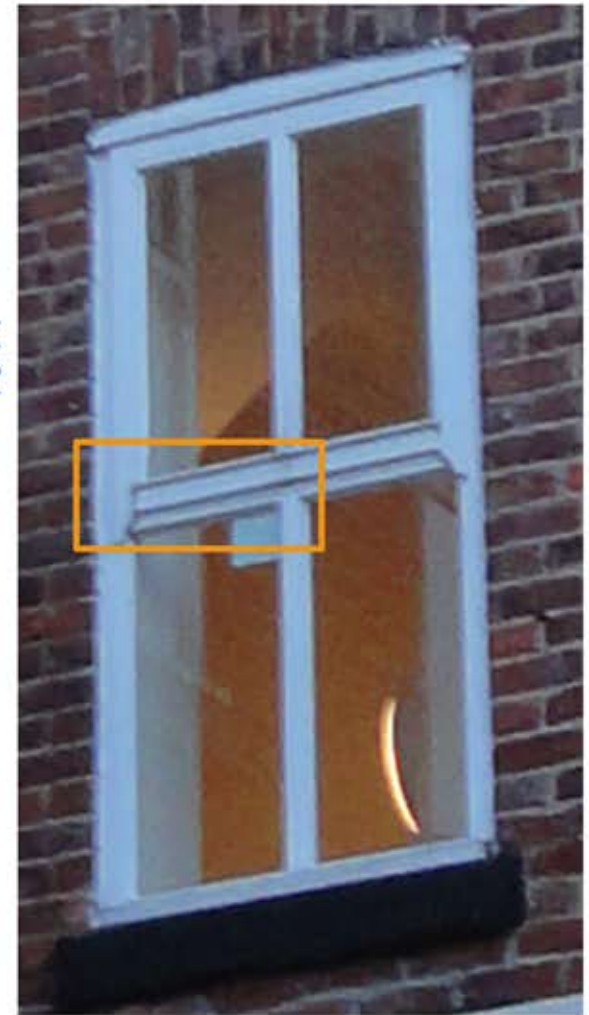
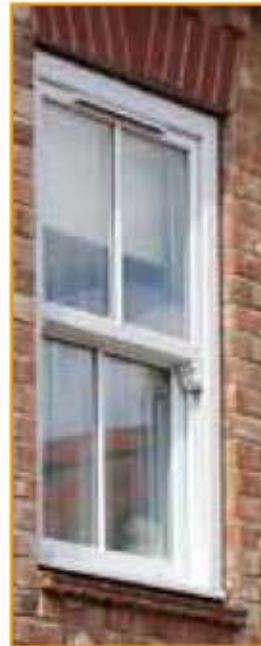
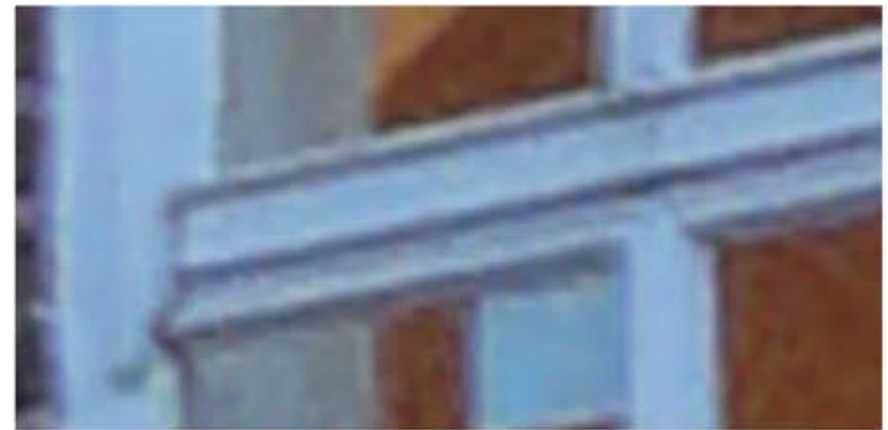
#67

Description: Top hung casement window, top half opening, styled to match sash windows without central bars and sash horns.

Defects: difficulty shutting top hung panel due to damage to hinges and swelling, mould growing into the frame around the single glazing

Joinery Fixing Option: fill in gaps around the outside, replace rotten timber pieces

Draught-Proofing Option: repairs would have to be completed before adding draught-proofing to the openings

uPVC Option: quickest option and would allow double glazing to be installed, style can be imitated to look exactly like the existing

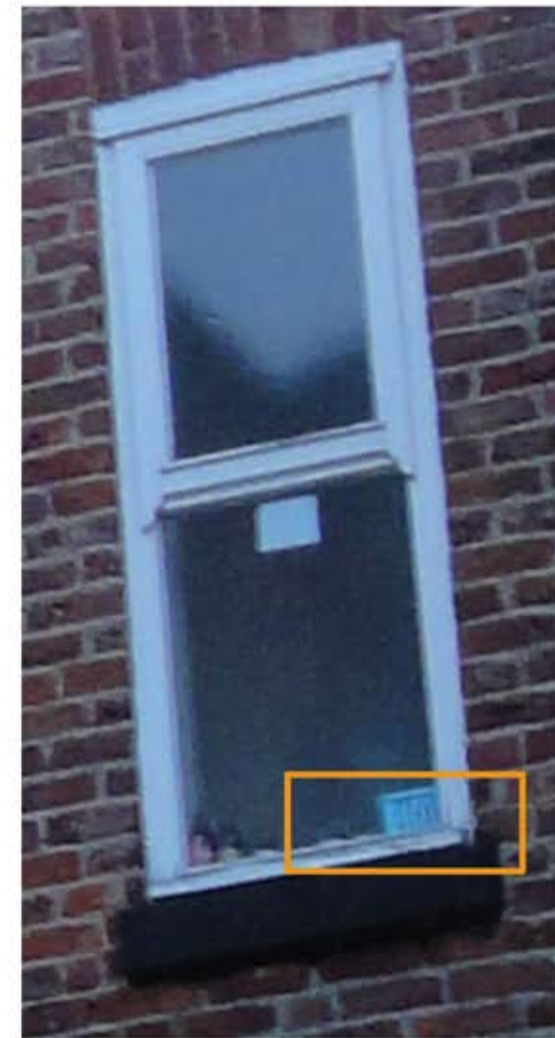
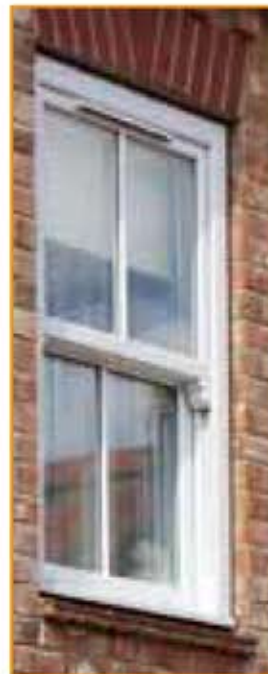
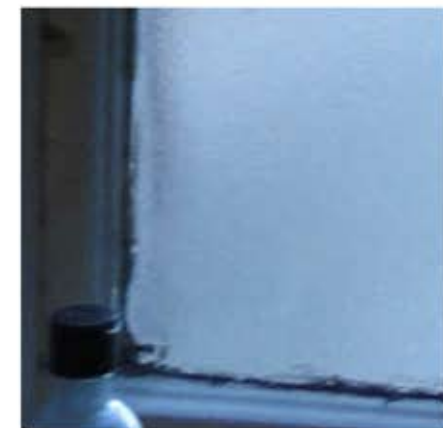
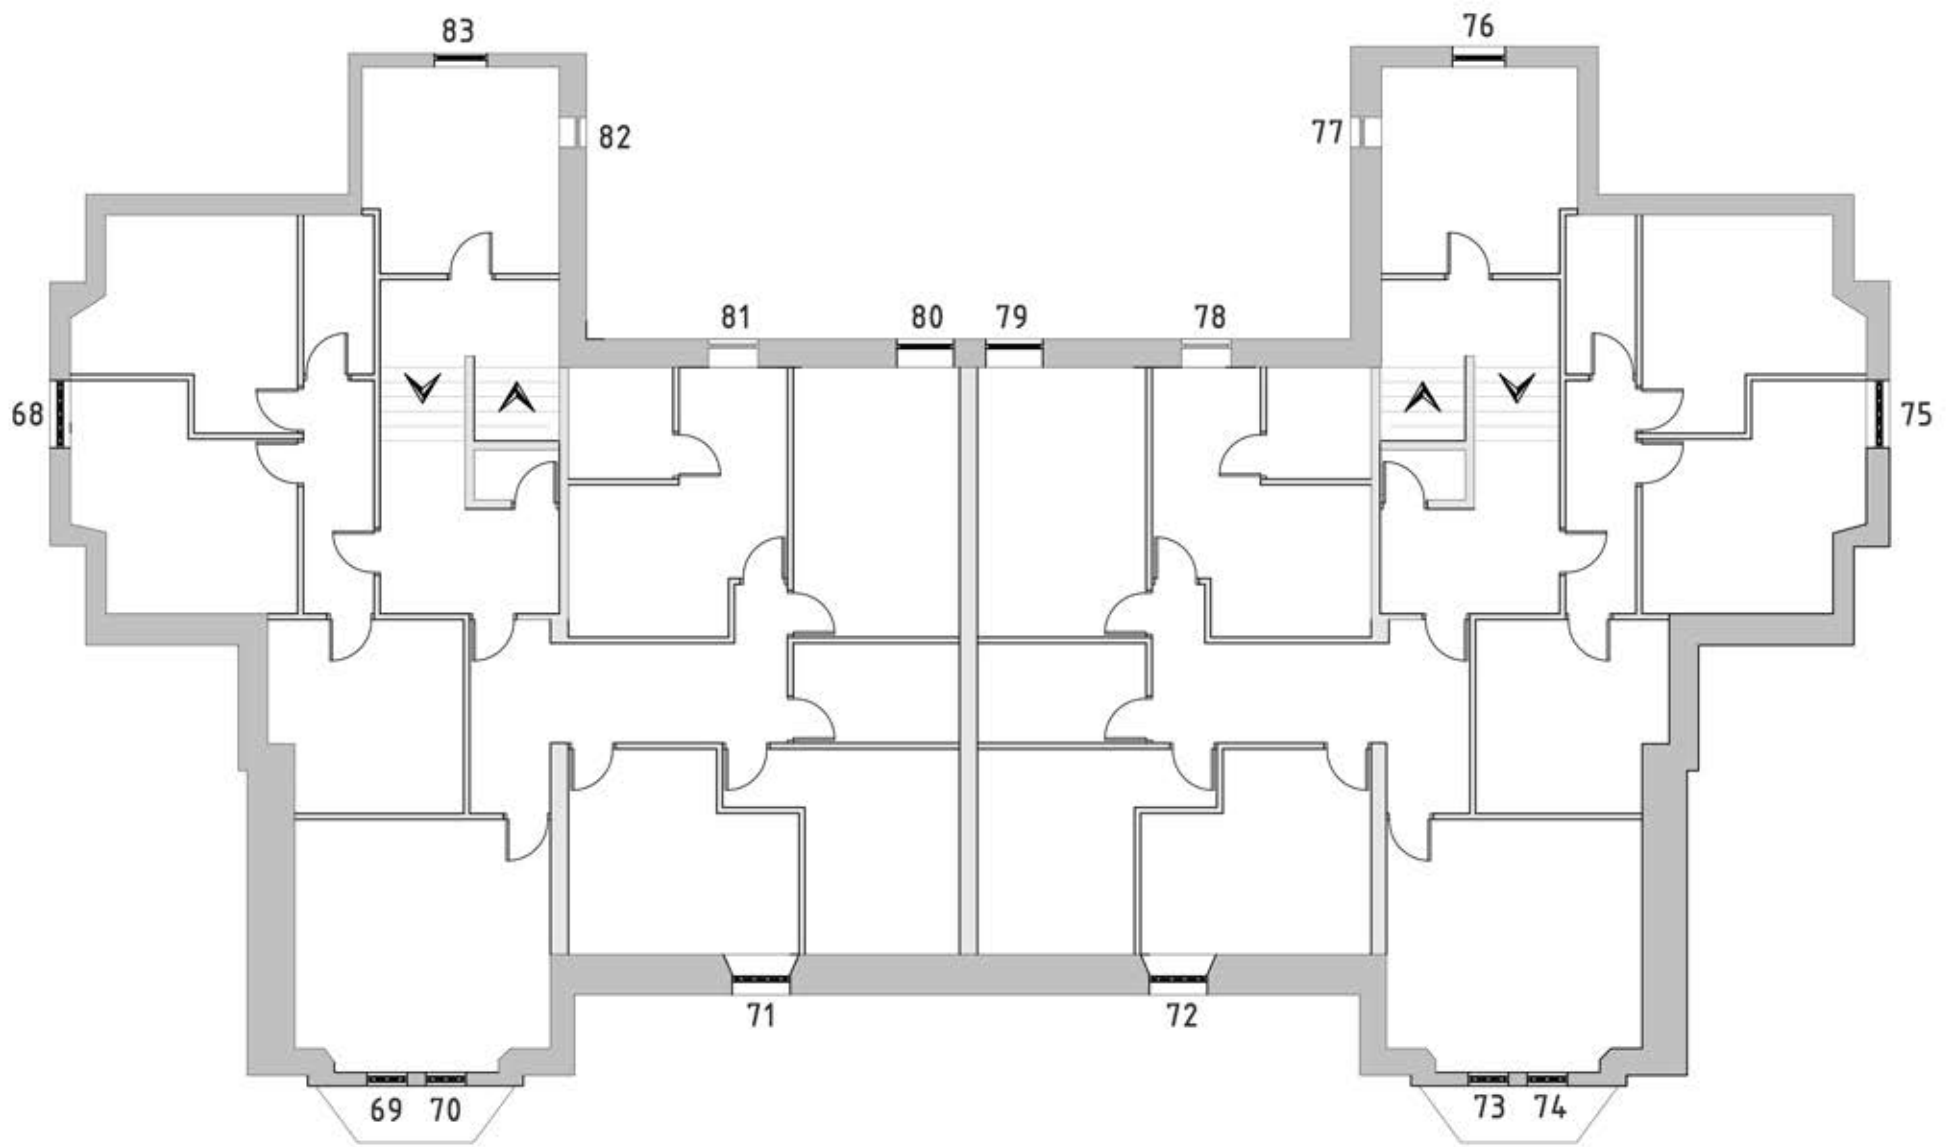
#68

Defects: gaps between panes and sliding sections, build up of paint hides crack and heavy old windows do not open for ventilation, replacement timber bottom piece still allowing water in

Joinery Fixing Option: sand down paint and new sliding mechanisms replaced, removal of whole window would be necessary

Draught-Proofing Option: repairs would have to be completed before adding draught-proofing to the sliding panels

uPVC Option: quickest option and would allow double glazing to be installed, style can be imitated to look exactly like the existing

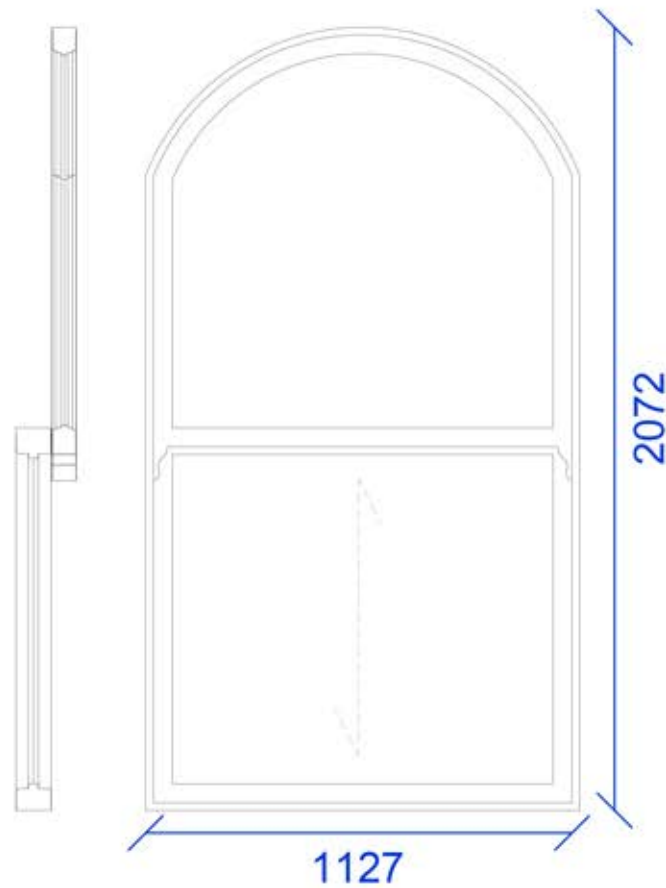
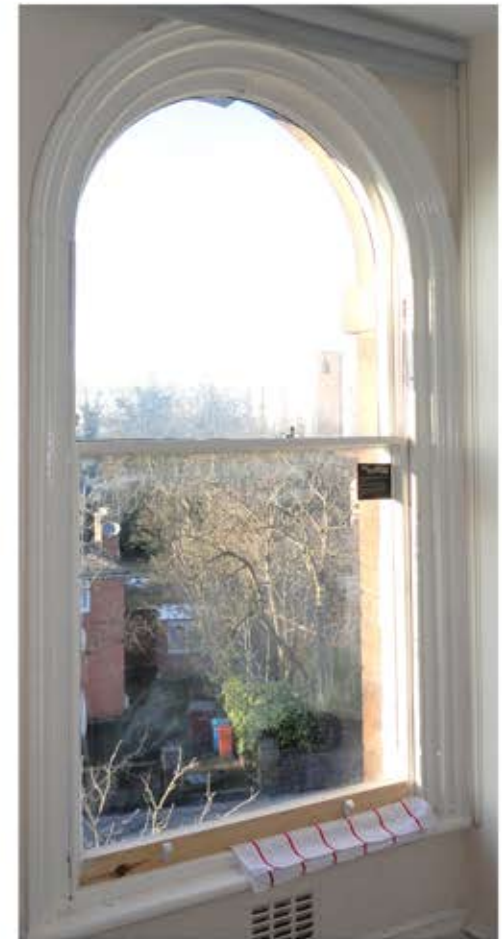
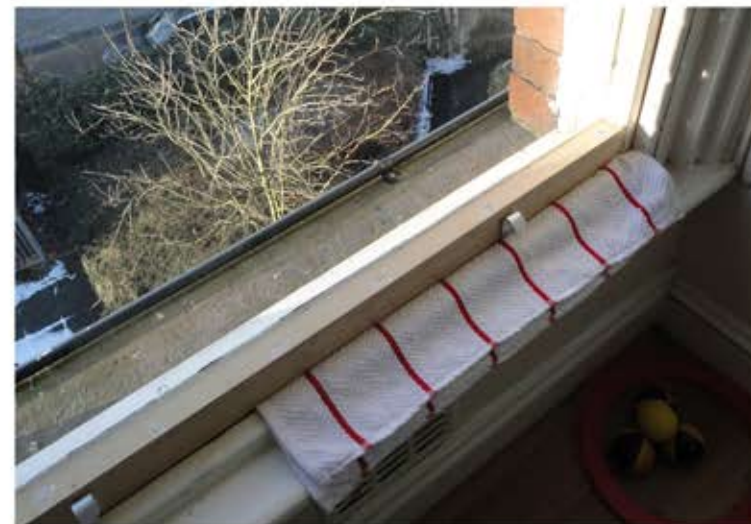
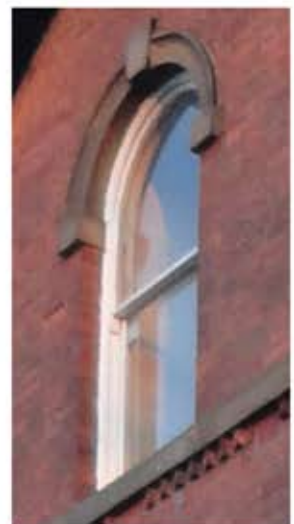
#69

Description: Non-bar sliding sash windows with sash horns and true arch

Defects: gaps between panes and sliding sections, build up of paint hides cracks and holes in the frame with mould growing in corners and near the single glazing

Joinery Fixing Option: sand down paint and new sliding mechanisms replaced, removal of whole window would be necessary

Draught-Proofing Option: repairs would have to be completed before adding draught-proofing to the sliding panels

uPVC Option: quickest option and would allow double glazing to be installed, style can be imitated to look exactly like the existing
