Daisybank Villas
5-7 Anson Road
Manchester
M14 5BR

Window Replacement
Justification

May 2018

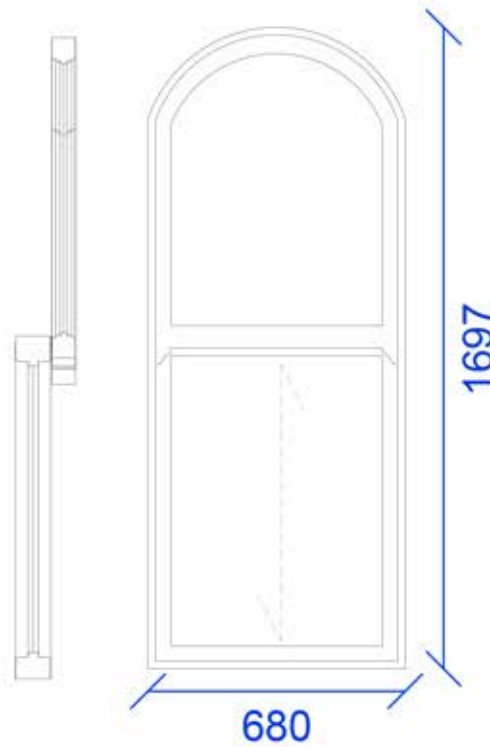
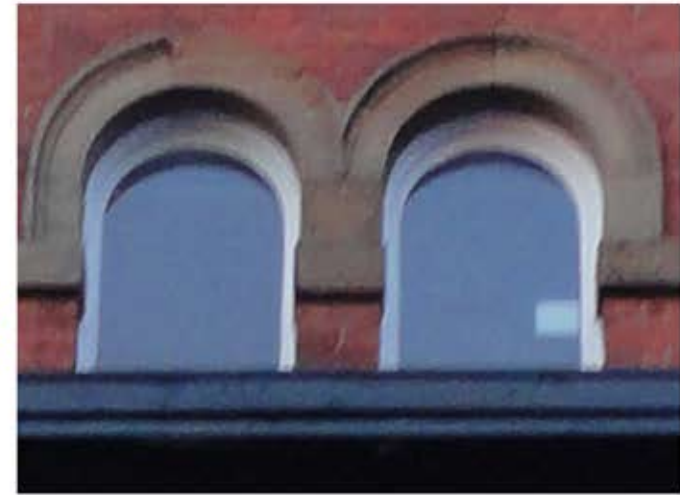
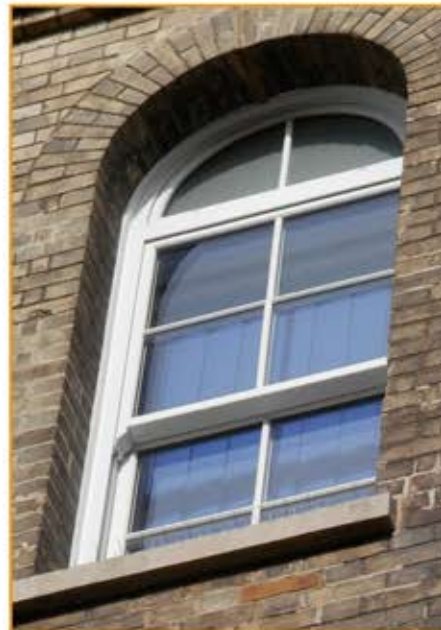
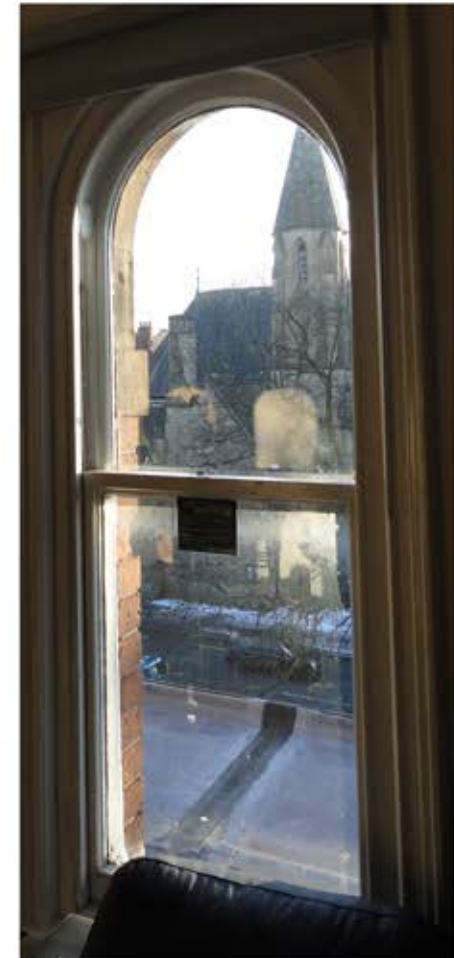
#70

Description: Non-bar sliding sash windows with sash horns and true arch

Defects: gaps between panes and sliding sections, build up of paint hides cracks and holes in the frame with mould growing in corners and near the single glazing

Joinery Fixing Option: sand down paint and new sliding mechanisms replaced, removal of whole window would be necessary

Draught-Proofing Option: repairs would have to be completed before adding draught-proofing to the sliding panels

uPVC Option: quickest option and would allow double glazing to be installed, style can be imitated to look exactly like the existing

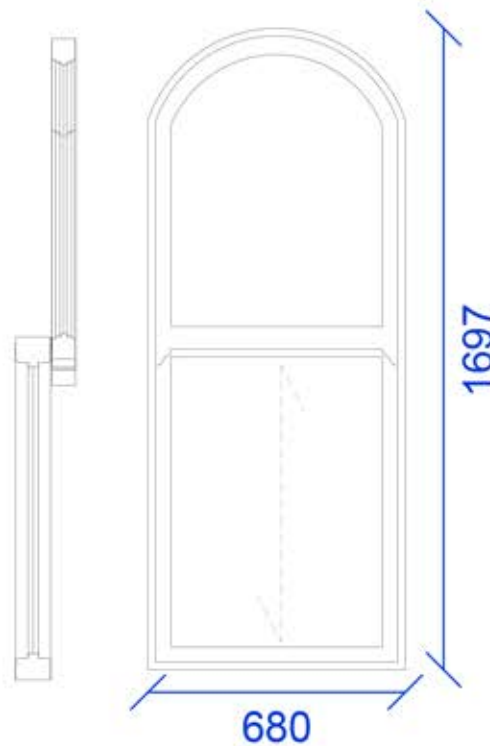
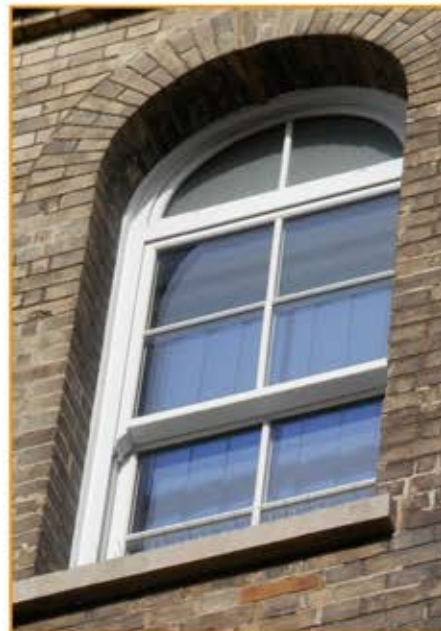
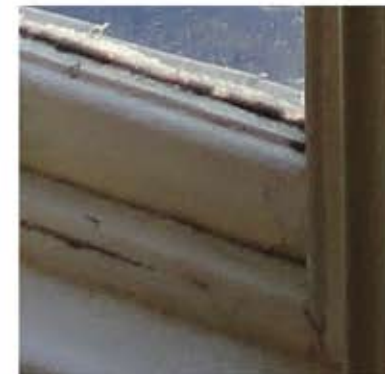
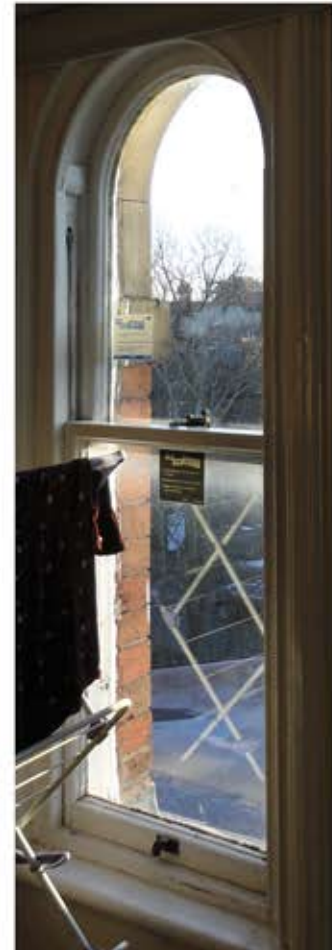
#71

Description: Non-bar sliding sash windows with sash horns and true arch

Defects: gaps between panes and sliding sections, build up of paint hides cracks and holes in the frame with mould growing in corners and near the single glazing, damage timber sills

Joinery Fixing Option: sand down paint and new sliding mechanisms replaced, removal of whole window would be necessary

Draught-Proofing Option: repairs would have to be completed before adding draught-proofing to the sliding panels

uPVC Option: quickest option and would allow double glazing to be installed, style can be imitated to look exactly like the existing

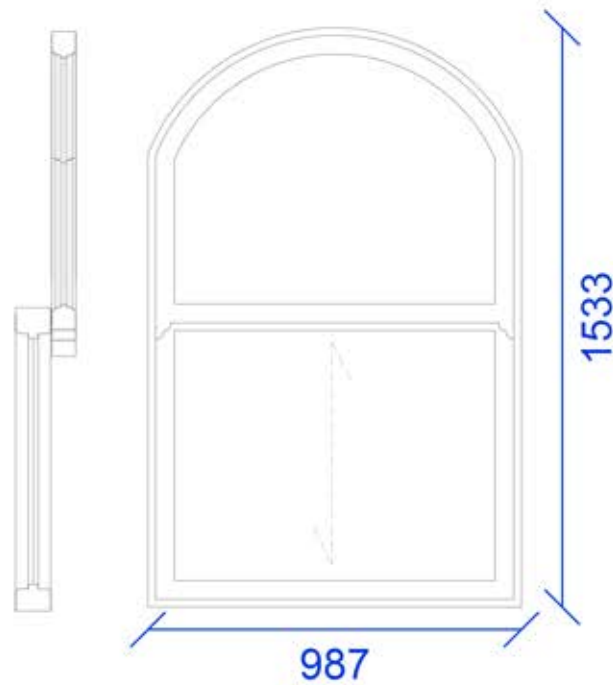
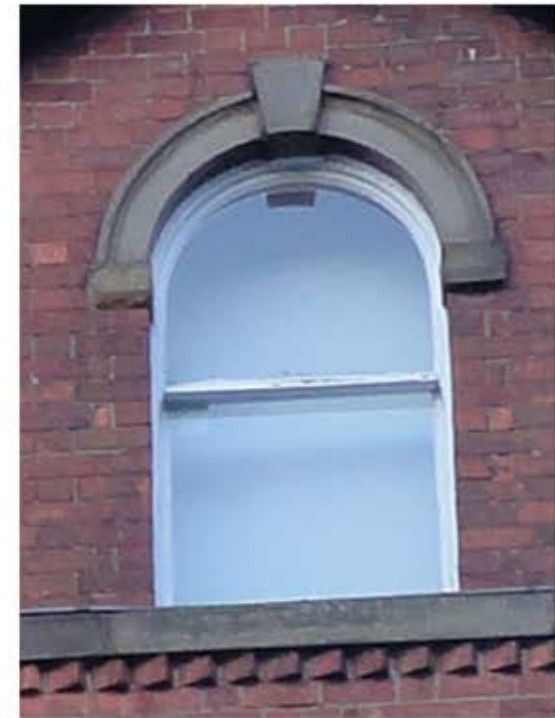
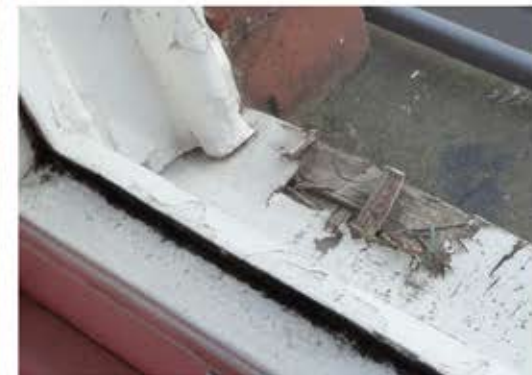
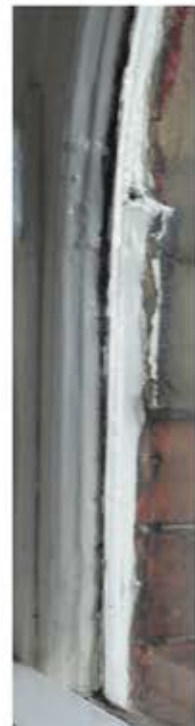
#72

Description: Non-bar sliding sash windows with sash horns and true arch

Defects: gaps between panes and sliding sections, build up of paint hides cracks and holes in the frame with mould growing in corners and near the single glazing, damage timber

Joinery Fixing Option: sand down paint and new sliding mechanisms replaced, removal of whole window would be necessary

Draught-Proofing Option: repairs would have to be completed before adding draught-proofing to the sliding panels

uPVC Option: quickest option and would allow double glazing to be installed, style can be imitated to look exactly like the existing

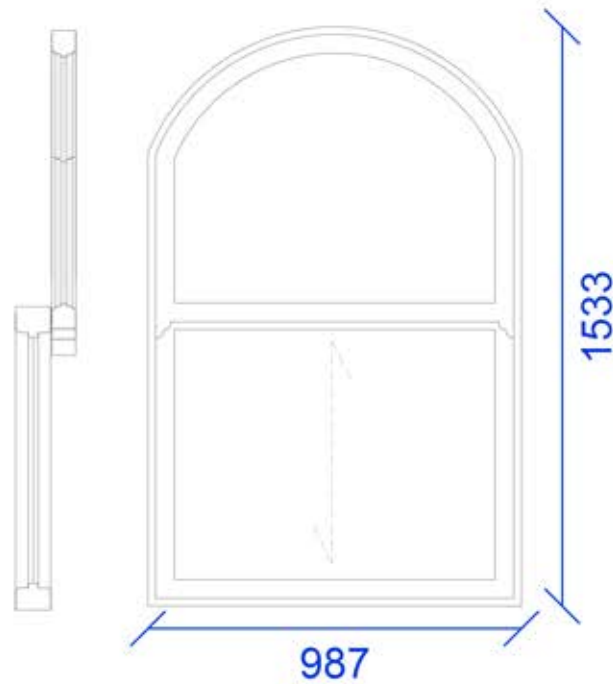
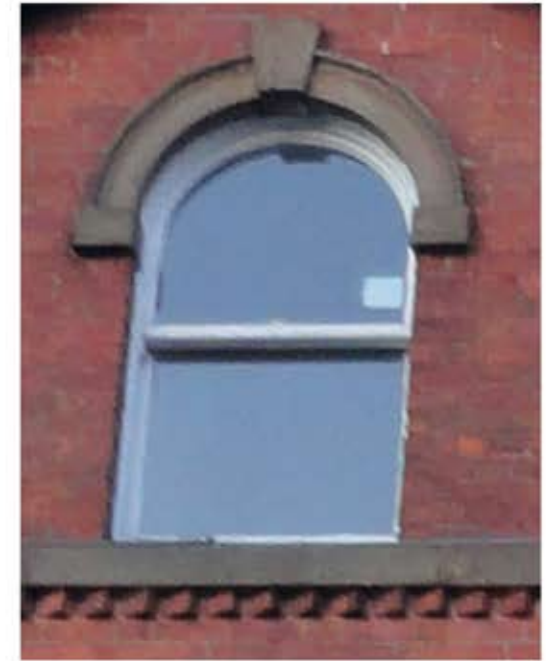
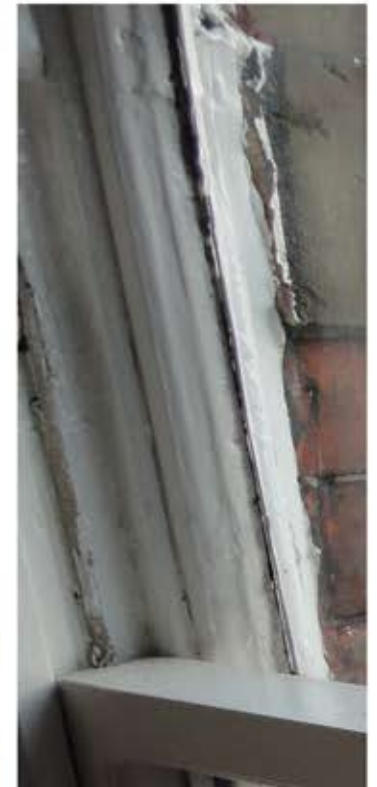
#73

Description: Non-bar sliding sash windows with sash horns and true arch

Defects: gaps between panes and sliding sections, build up of paint hides cracks and holes in the frame with mould growing in corners and near the single glazing

Joinery Fixing Option: sand down paint and new sliding mechanisms replaced, removal of whole window would be necessary

Draught-Proofing Option: repairs would have to be completed before adding draught-proofing to the sliding panels

uPVC Option: quickest option and would allow double glazing to be installed, style can be imitated to look exactly like the existing

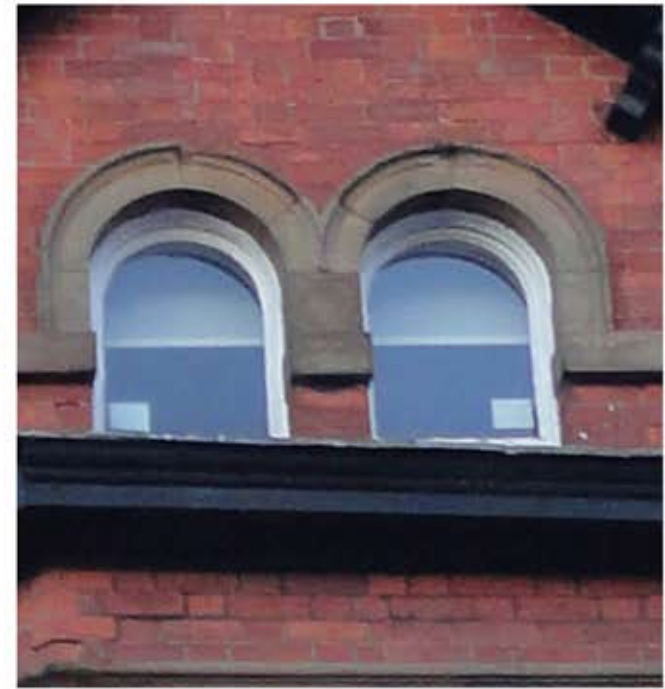
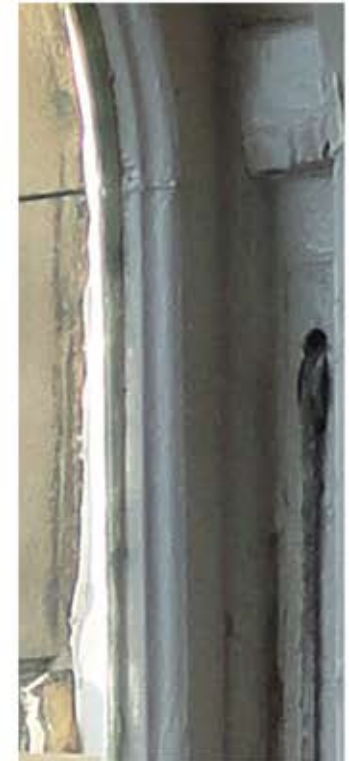
#74

Description: Non-bar sliding sash windows with sash horns and true arch

Defects: gaps between panes and sliding sections, build up of paint hides cracks and holes in the frame with mould growing in corners and near the single glazing

Joinery Fixing Option: sand down paint and new sliding mechanisms replaced, removal of whole window would be necessary

Draught-Proofing Option: repairs would have to be completed before adding draught-proofing to the sliding panels

uPVC Option: quickest option and would allow double glazing to be installed, style can be imitated to look exactly like the existing

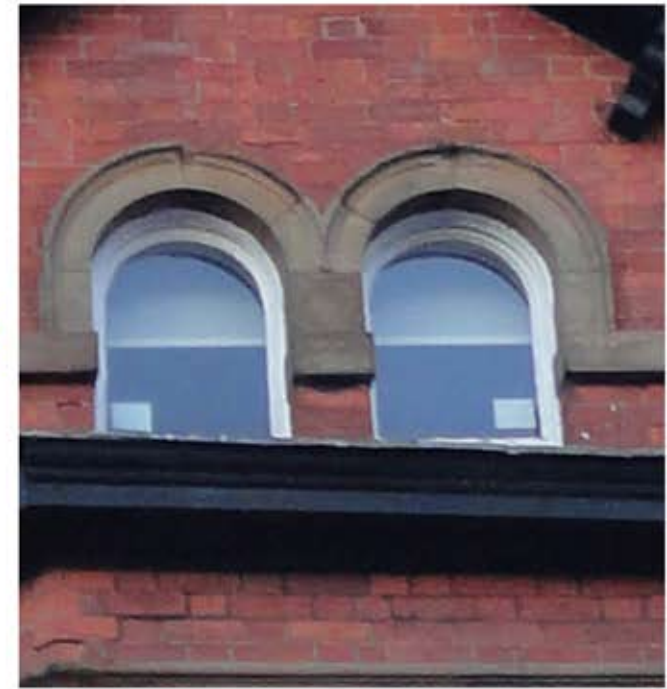
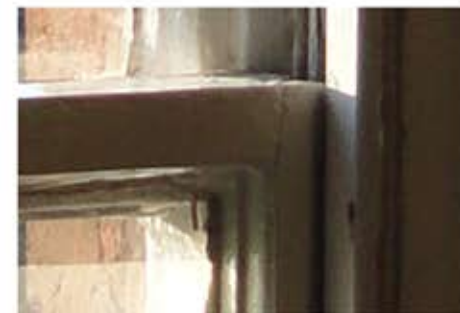
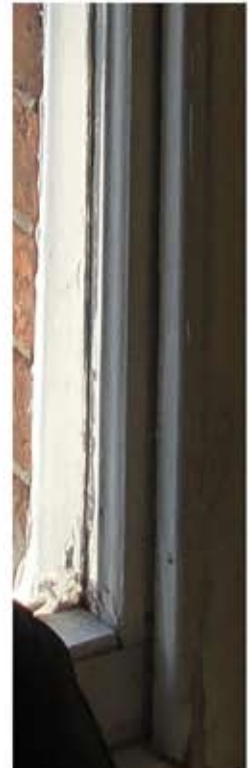
#75

Description: Non-bar sliding sash windows with sash horns and true arch

Defects: gaps between panes and sliding sections, build up of paint hides crack and heavy old windows do not open for ventilation, middle rail coming away from glass

Joinery Fixing Option: sand down paint and new sliding mechanisms and timber rails replaced, removal of whole window would be necessary

Draught-Proofing Option: repairs would have to be completed before adding draught-proofing to the sliding panels

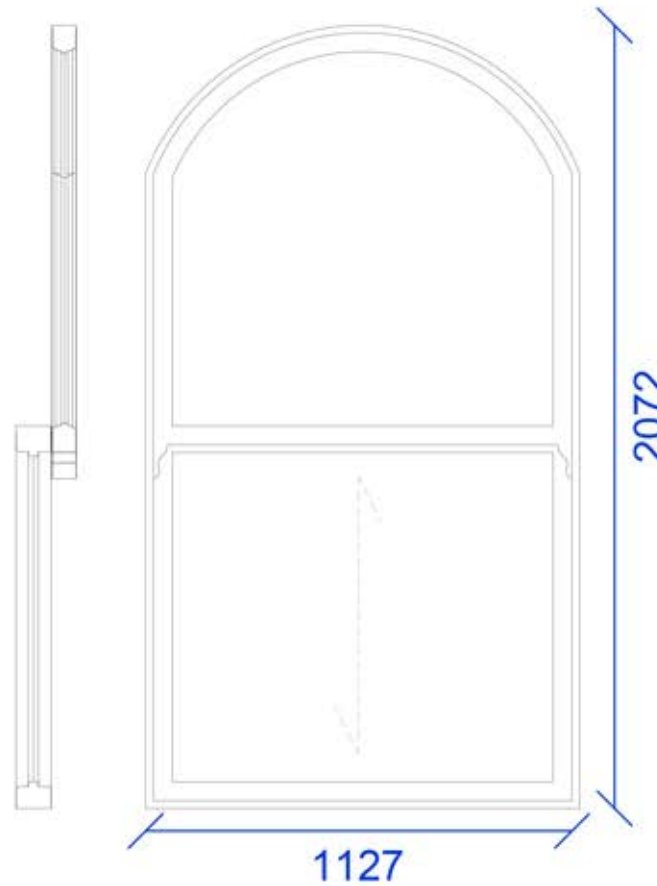
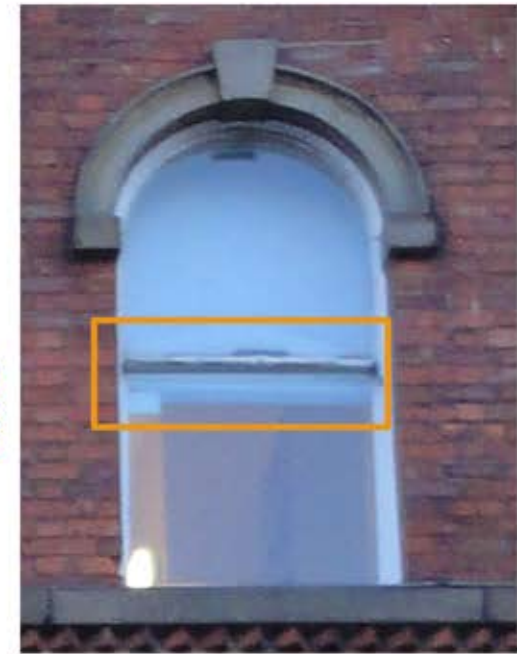
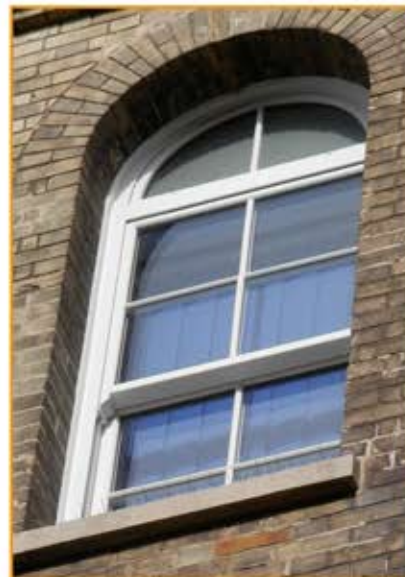
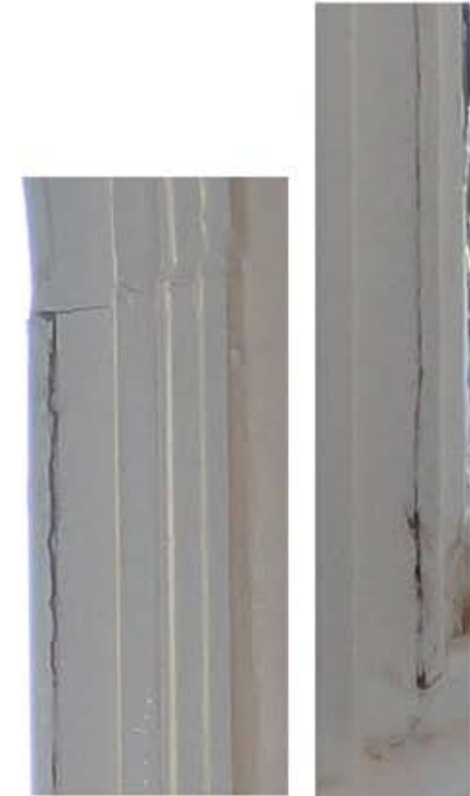
#76

Defects: mould in corners and between glazing and timber frames, condensation issues internally, broken and cracked timber frame, water settled on window sill

Joinery Fixing Option: every timber piece needs to be replaced, removal of whole window would be necessary

Draught-Proofing Option: repairs would have to be completed before adding draught-proofing to the sliding panels

uPVC Option: quickest option and would allow double glazing to be installed, style can be imitated to look exactly like the existing

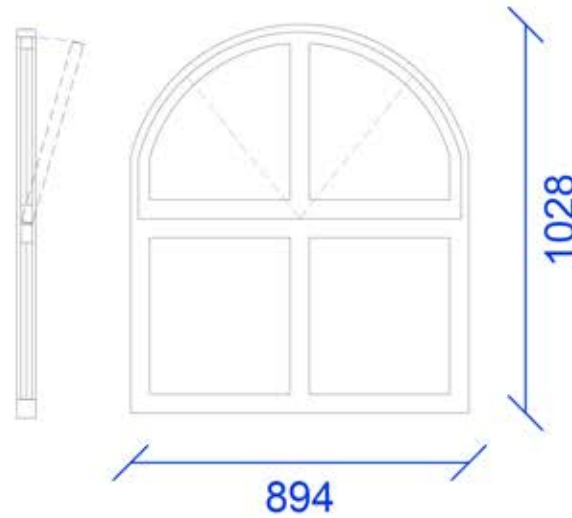
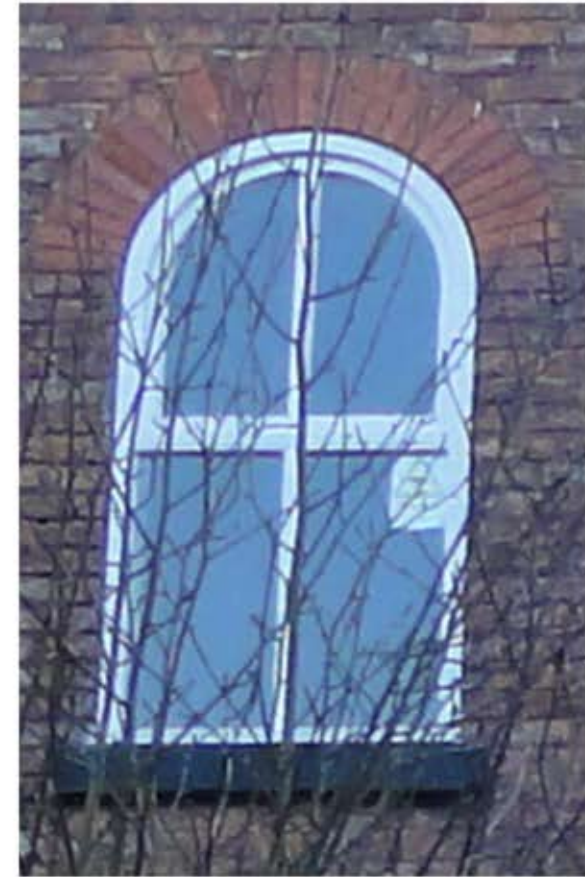
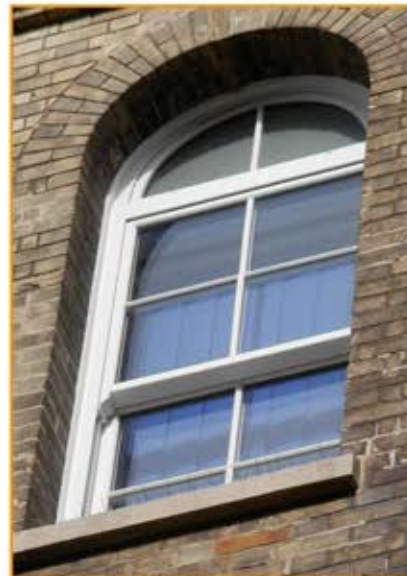
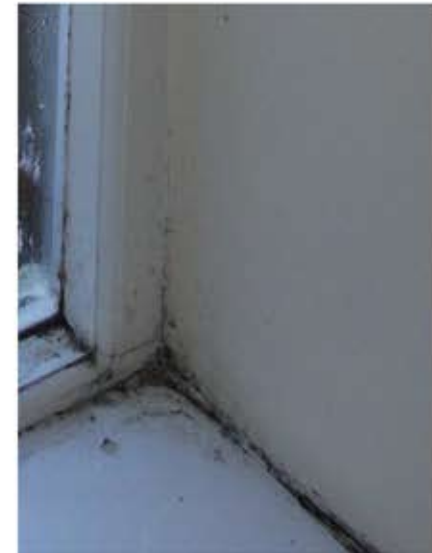
#77

Defects: difficulty shutting top hung panel due to damage to hinges, mould growing into the frame around the single glazing, cracked timber frame

Joinery Fixing Option: fill in gaps around the outside, replace rotten and cracked timber pieces

Draught-Proofing Option: repairs would have to be completed before adding draught-proofing to the openings

uPVC Option: quickest option and would allow double glazing to be installed, style can be imitated to look exactly like the existing

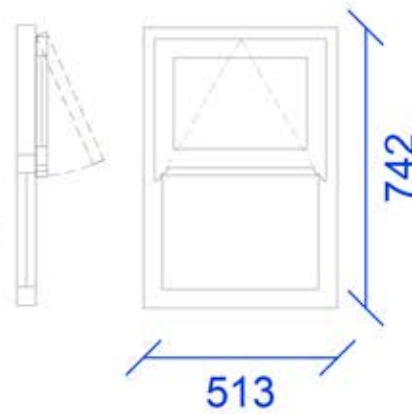
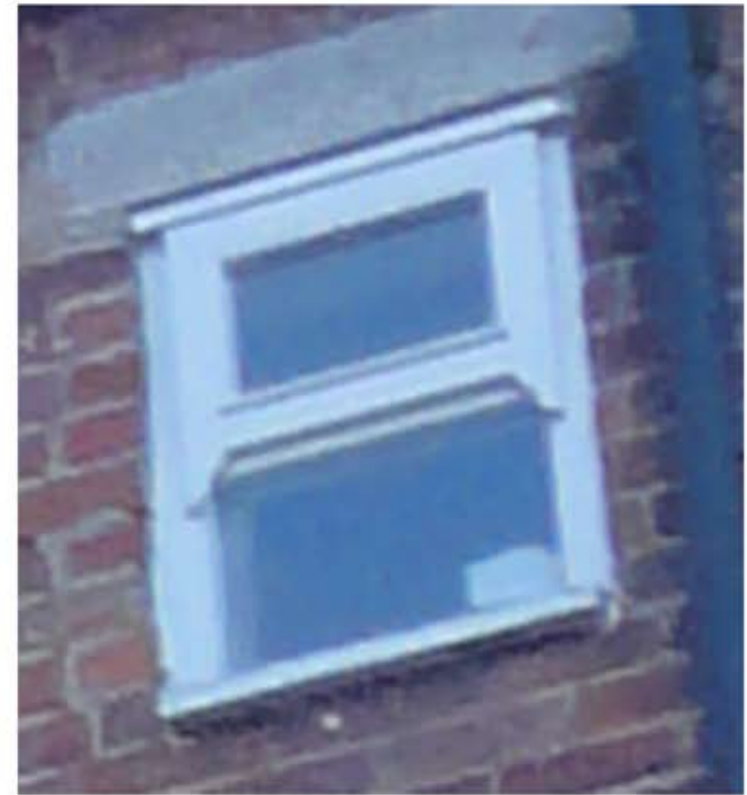
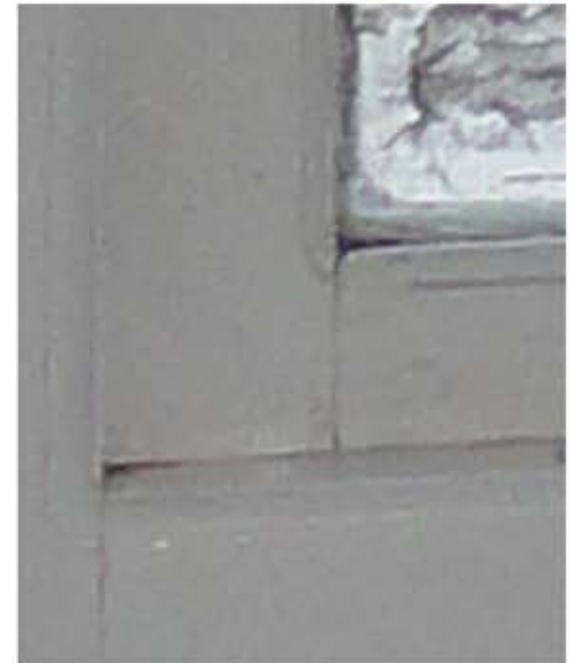
#78

Defects: mould in corners and between glazing and timber frames, condensation issues internally, broken and cracked timber frame, water settled on window sill

Joinery Fixing Option: every timber piece needs to be replaced, removal of whole window would be necessary

Draught-Proofing Option: repairs would have to be completed before adding draught-proofing to the sliding panels

uPVC Option: quickest option and would allow double glazing to be installed, style can be imitated to look exactly like the existing

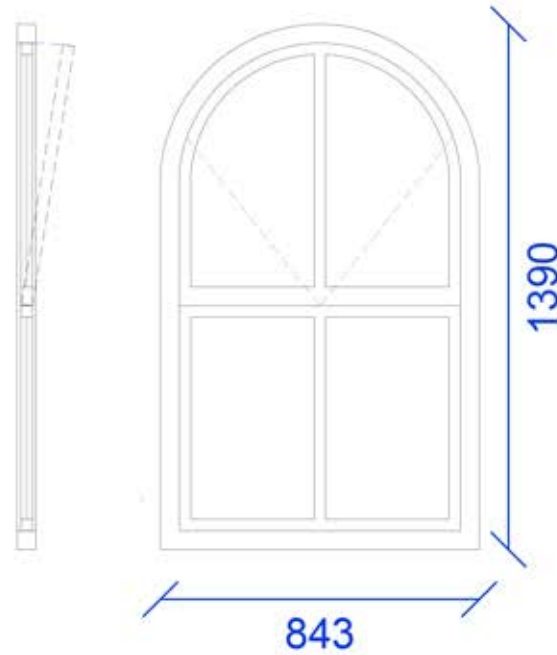
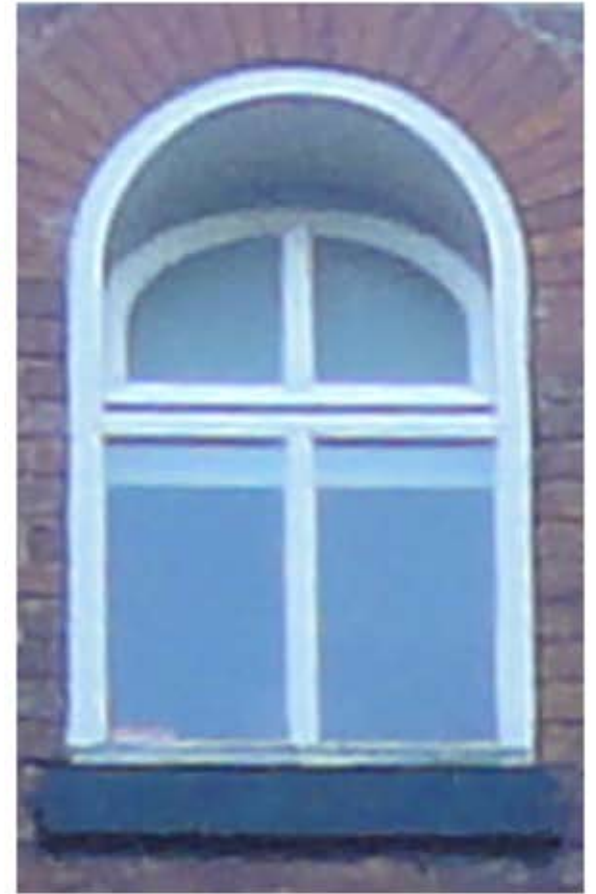
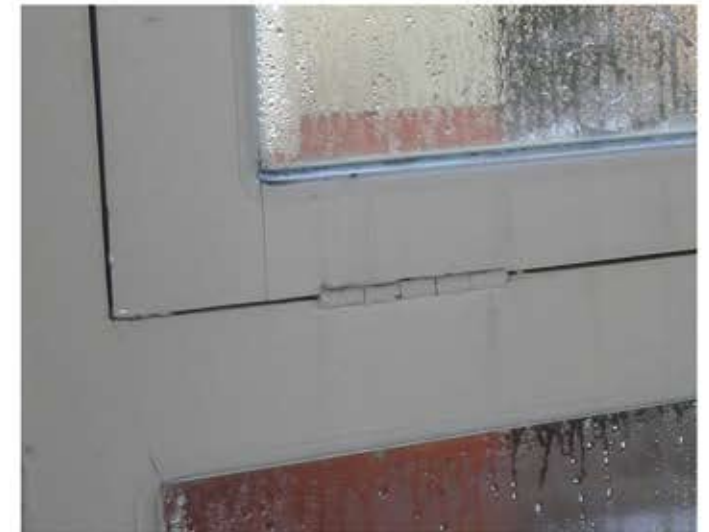
#79

Defects: difficulty shutting top hung panel due to damage to hinges, mould growing into the frame around the single glazing, cracked timber frame

Joinery Fixing Option: fill in gaps around the outside, replace rotten and cracked timber pieces

Draught-Proofing Option: repairs would have to be completed before adding draught-proofing to the openings

uPVC Option: quickest option and would allow double glazing to be installed, style can be imitated to look exactly like the existing

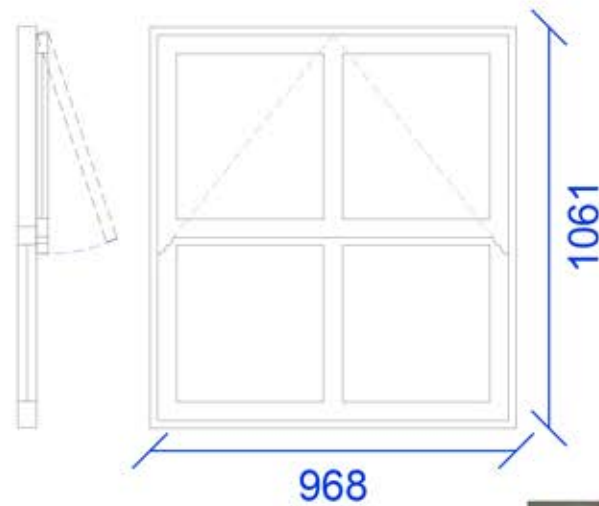
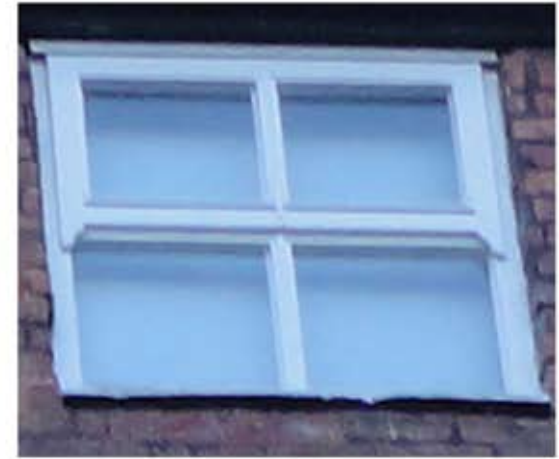
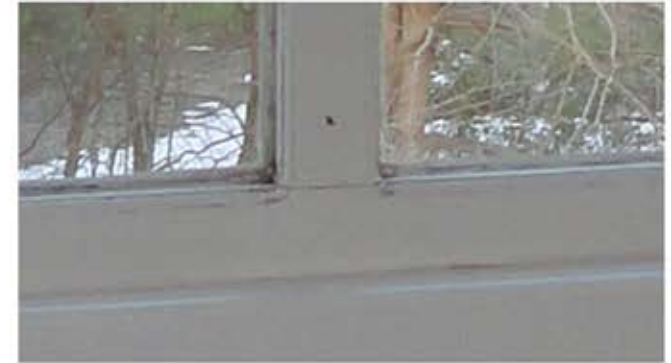
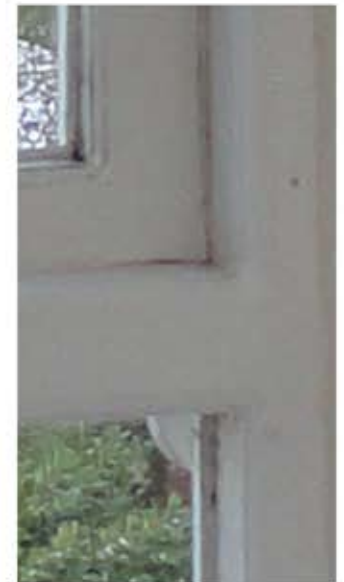
#80

Defects: difficulty shutting top hung panel due to damage to hinges, mould growing into the frame around the single glazing, cracked timber frame

Joinery Fixing Option: fill in gaps around the outside, replace rotten and cracked timber pieces

Draught-Proofing Option: repairs would have to be completed before adding draught-proofing to the openings

uPVC Option: quickest option and would allow double glazing to be installed, style can be imitated to look exactly like the existing

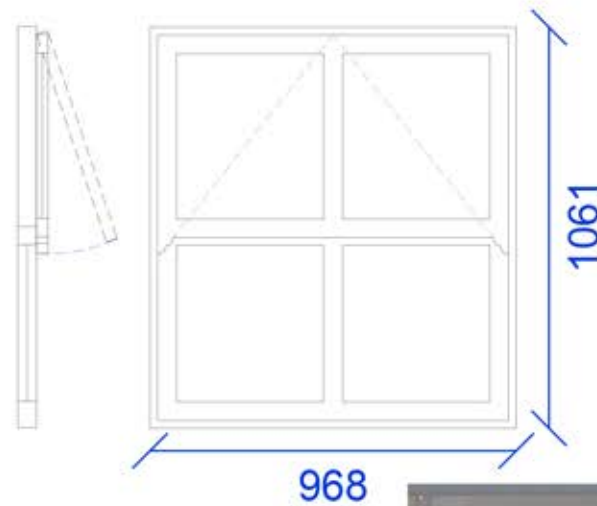
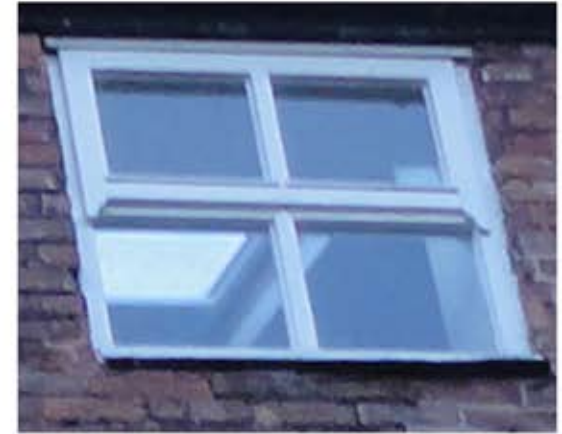
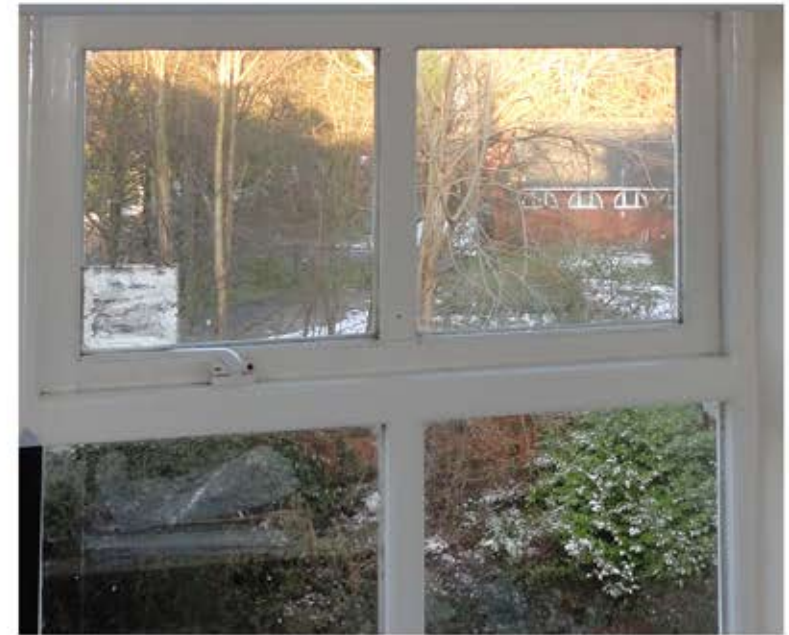
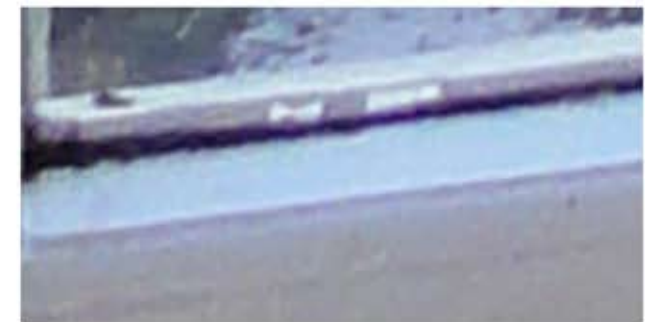
#81

Defects: mould in corners and between glazing and timber frames, condensation issues internally, broken and cracked timber frame, water settled on window sill

Joinery Fixing Option: every timber piece needs to be replaced, removal of whole window would be necessary

Draught-Proofing Option: repairs would have to be completed before adding draught-proofing to the sliding panels

uPVC Option: quickest option and would allow double glazing to be installed, style can be imitated to look exactly like the existing

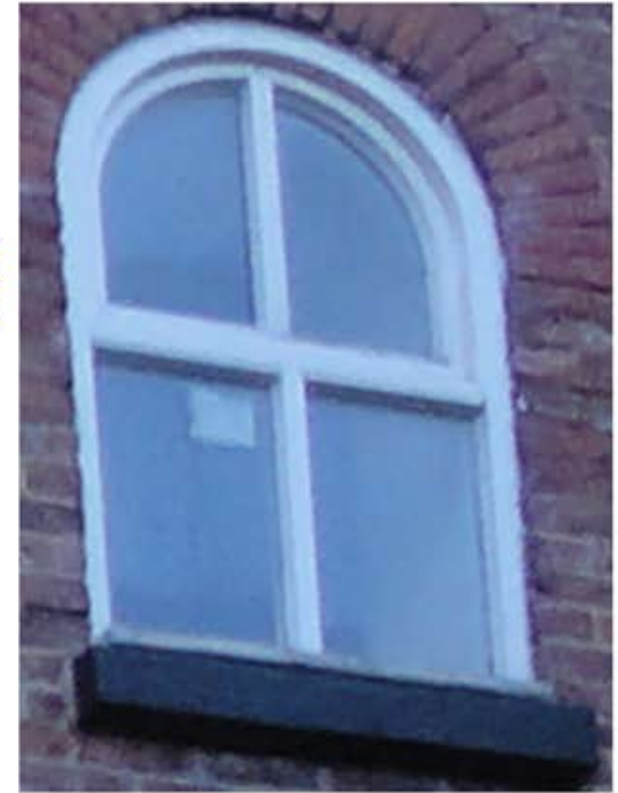
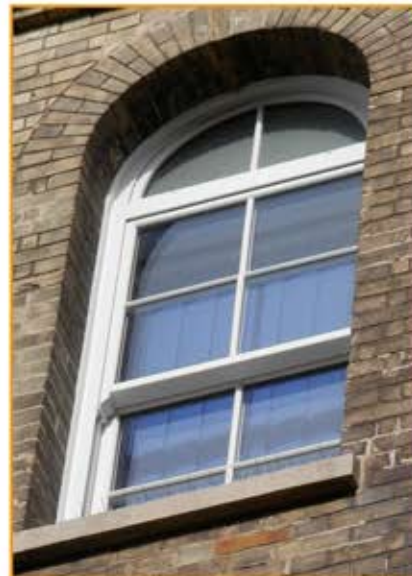
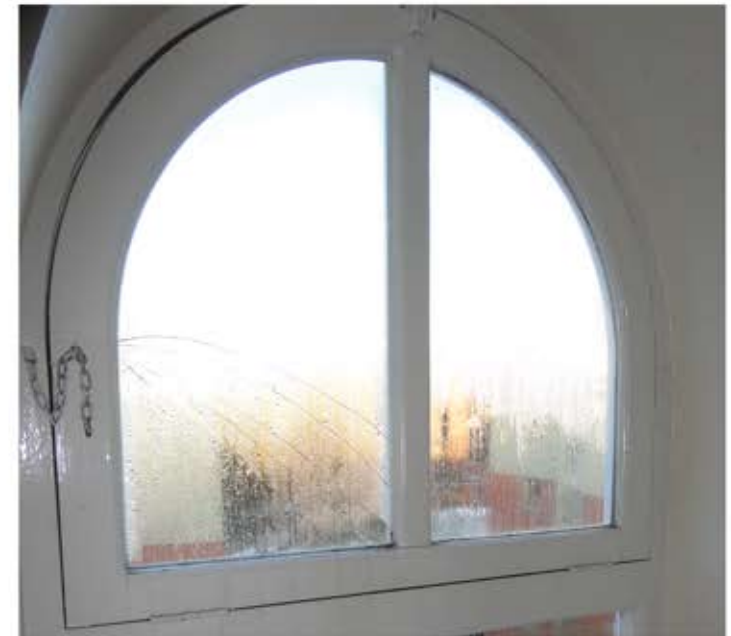
#82

Defects: difficulty shutting top hung panel due to damage to hinges, mould growing into the frame around the single glazing, cracked timber frame

Joinery Fixing Option: fill in gaps around the outside, replace rotten and cracked timber pieces

Draught-Proofing Option: repairs would have to be completed before adding draught-proofing to the openings

uPVC Option: quickest option and would allow double glazing to be installed, style can be imitated to look exactly like the existing

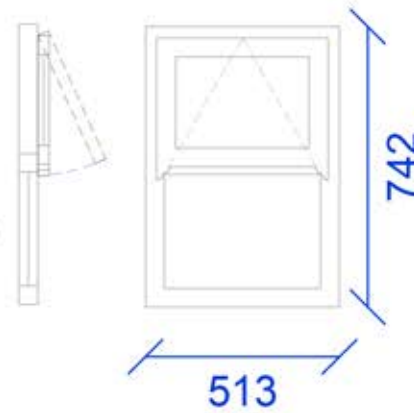
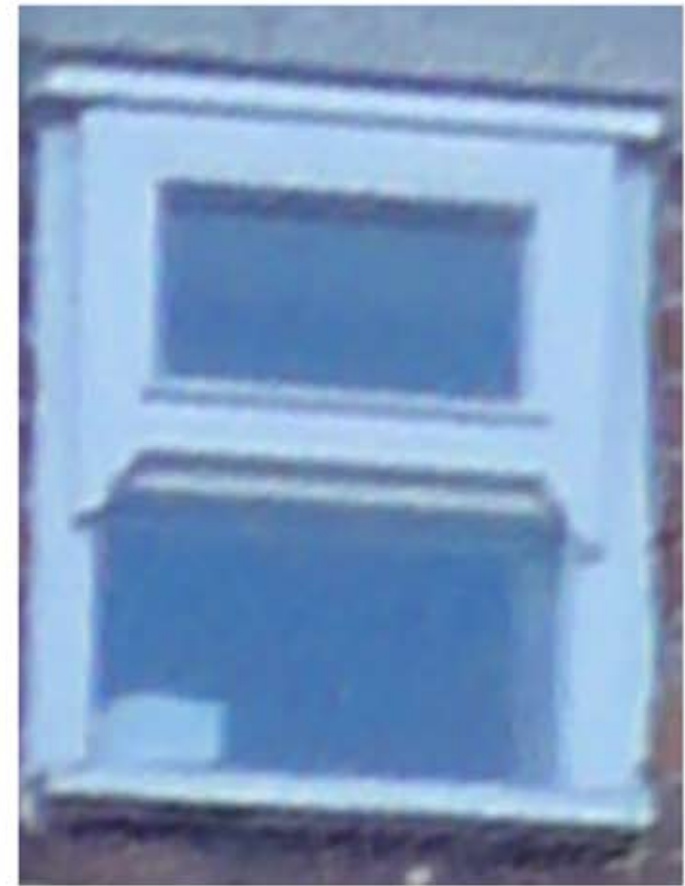
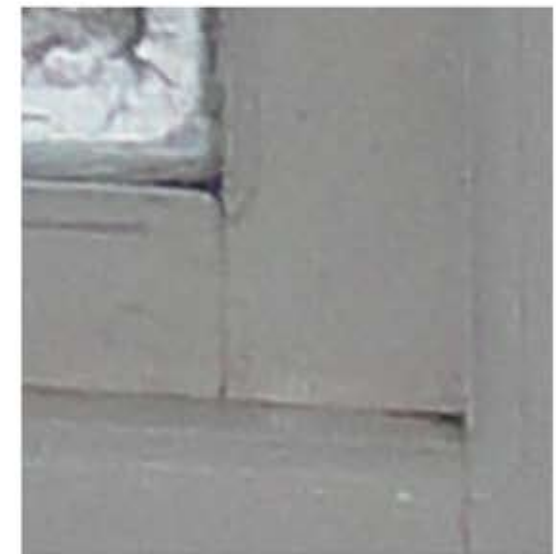
#83

Defects: mould in corners and between glazing and timber frames, condensation issues internally, broken and cracked timber frame

Draught-Proofing Option: repairs would have to be completed before adding draught-proofing to the sliding panels

uPVC Option: quickest option and would allow double glazing to be installed, style can be imitated to look exactly like the existing
